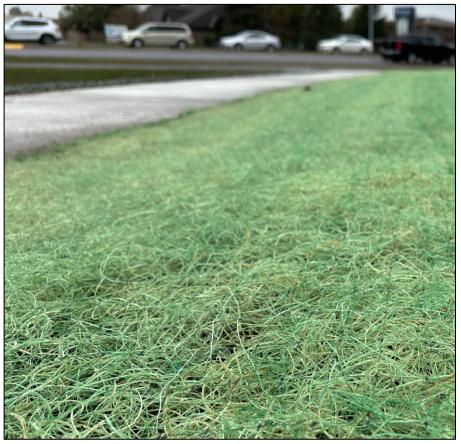
Figure 1. An erosion control blanket (ECB), Curlex<sup>®</sup> II QuickGRASS<sup>®</sup>, installed on a newly constructed section of the project area.

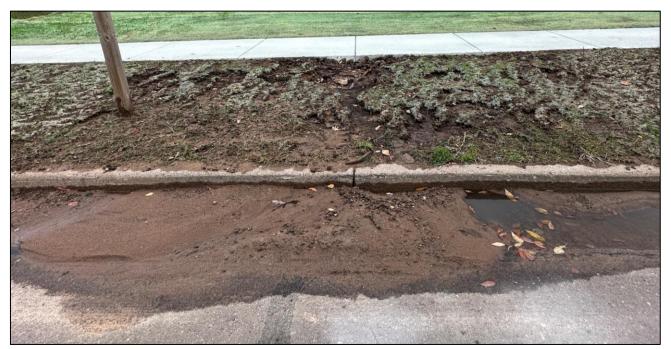
The hydraulic mulch was not applied to the curbside areas until mid/late September. Within several days of its initial application, the site experienced two rainfall events. These events led to a partial washout of the hydraulic mulch material (see Figure 3). The washed-out areas saw rills, uneven vegetative growth, and instances of severe erosion (see Figure 4). Some of the eroded sediment washed into the street and reached nearby stormwater drains before site personnel were able to clean up the area. Expenses due to cleanup, buying new BMPs to replace the failed hydraulic mulch, and the reinstallation of the new BMPs were all additional unplanned costs to the project.

Figure 4. Severe failure of a hydraulic mulch application.

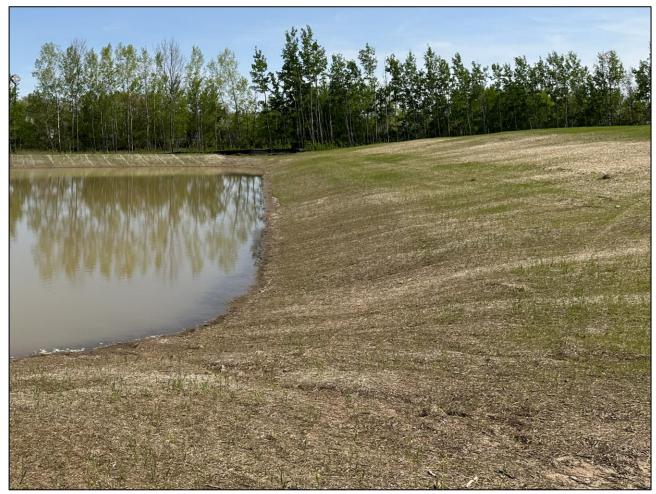
Straw ECBs did offer more erosion protection than the blown straw and hydraulic mulch installations. However, the straw ECBs did not fully protect the slopes from soil loss and seed migration during the precipitation events (see Figure 5). Some of the straw blankets had to be replaced by higher-performing ECBs, which added to the list of unplanned project expenses.

Depending on its Manning's *n* value, an ECB's fiber type can either have an increasing or decreasing effect on the energy of sheet flow. Manning's *n* is a measure of a product's hydraulic roughness, and a higher Manning's *n* helps decrease energy, slow water flow, increase water infiltration, and keep the underlying seed and soil in place. Straw fibers have a lower Manning's *n* than other ECB fibers, such as aspen excelsior.

Figure 5. Evidence of seed migration from a straw ECB installation surrounding an on-site sediment retention pond.

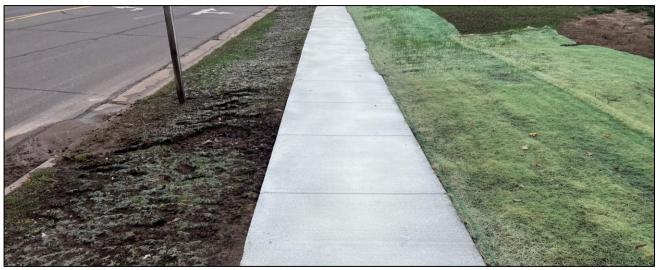
In contrast to the other BMPs, even when installed on steeper slopes, the Curlex ECBs saw minimal soil erosion and seed migration after the same precipitation events that the other BMPs were exposed to (see Figure 6). Just imagine how much money could have been saved if the Curlex ECBs would have been installed across the site. Material and installation costs would only have been incurred once, cleanup costs would have been virtually eliminated, and the stormwater drains, nearby wetlands, and impaired river would not have been exposed to the level of contamination they received from the failures of the other BMPs that were chosen based on material cost and not project cost.

Figure 6. Curlex II QuickGRASS installed opposite the hydraulic mulch installation shown in Figure 4.

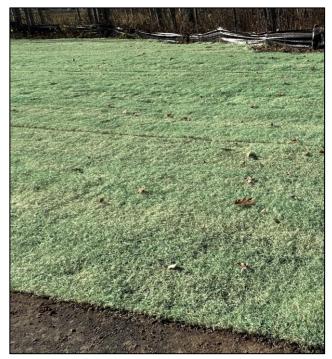
Figure 7. Curlex II QuickGRASS installation.

Curlex<sup>®</sup> II QuickGRASS<sup>®</sup> (see Figure 7) was used on most of the flatter and shallow-sloping curbside and inland areas following the failures of the other BMPs. Curlex fibers' ability to create a "greenhouse effect" when exposed to moisture fosters favorable seed germination and establishment conditions. Curlex<sup>®</sup> II FibreNet<sup>™</sup> was installed on many of the roadside slopes near the sediment retention ponds and wetlands (see Figure 8). It provides all the features and benefits of other Curlex products while encasing the Curlex fiber matrix between two layers of 100% biodegradable jute netting with non-welded slip joints.

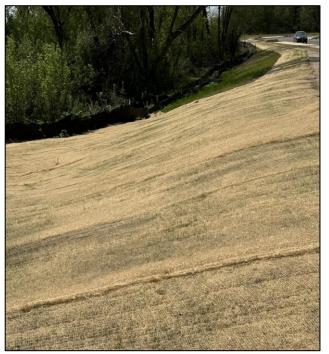
Figure 8. Curlex<sup>®</sup> II FibreNet<sup>™</sup> installed across the length of a roadside slope.

Two Curlex ECB products were installed in the remaining new development areas as well as the locations where the blown straw, straw ECB, and hydraulic mulch BMPs had previously failed.
