Introduction

A housing development encountered significant rainfall shortly after initial site preparation had begun. Most areas were not yet protected with erosion and sediment control Best Management Practices (BMPs) (see Figure 1).

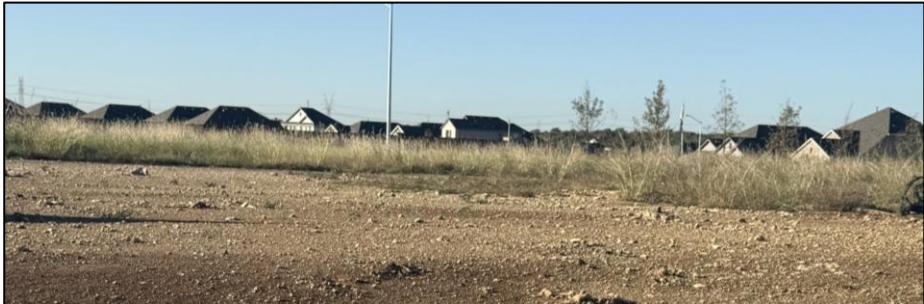
Figure 1: Unvegetated area within a housing development in which erosion and sediment control/revegetation BMPs had not yet been installed.

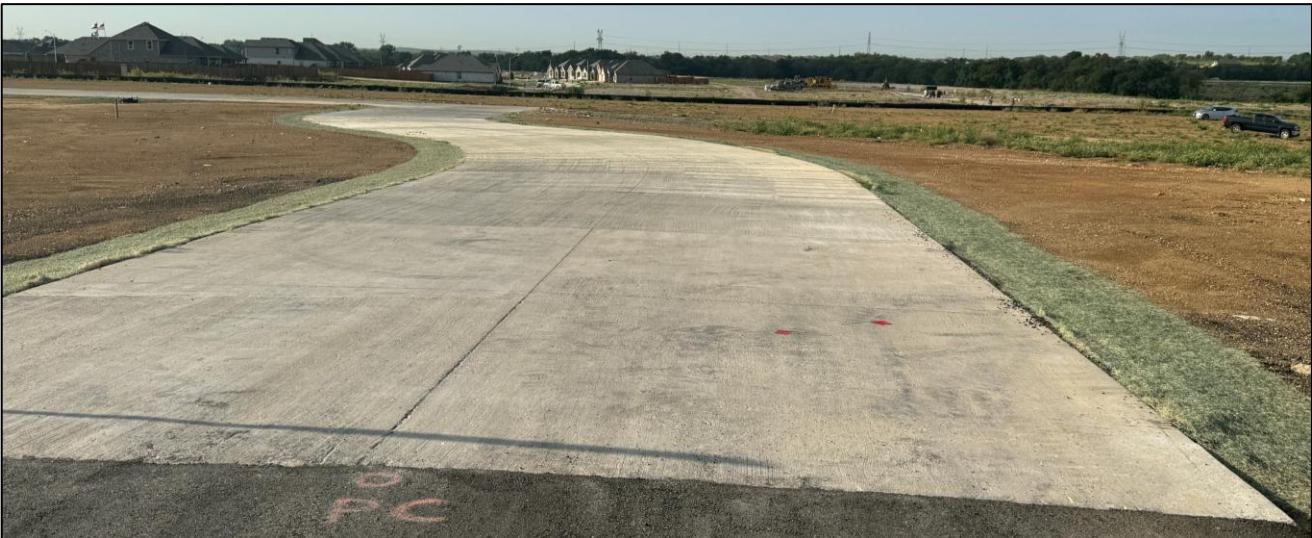
Figure 2: Curlex SiltTRAP installed on a street within the development.

- Curlex SiltTRAP (see Figure 2) and straw buffer strips were installed to help contain sediment and prevent it from entering the newly paved streets and nearby storm sewers.

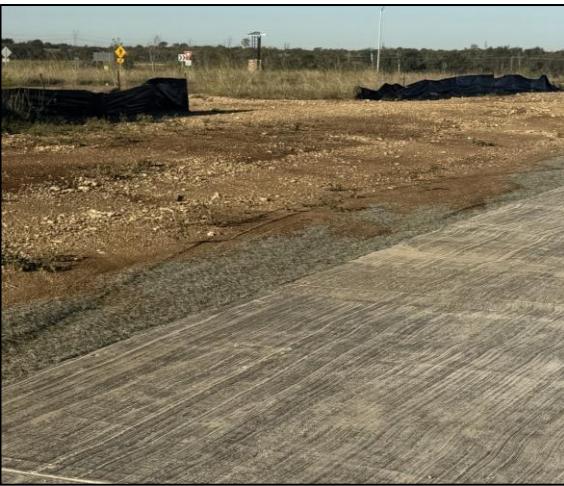
Figure 3: Curlex SiltTRAP installation where sediment was retained within the SiltTRAP and prevented from entering the street.

- When the area encountered a 1.5" rain event in early September, the Curlex SiltTRAP contained the flow of sediment because of its high Manning's n value (see Figures 3 and 4).

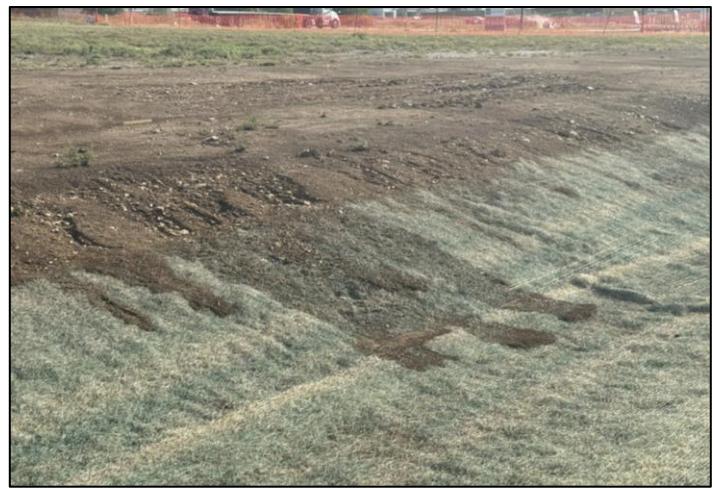
Figure 4: Curlex SiltTRAP installation that stopped flows of sediment.

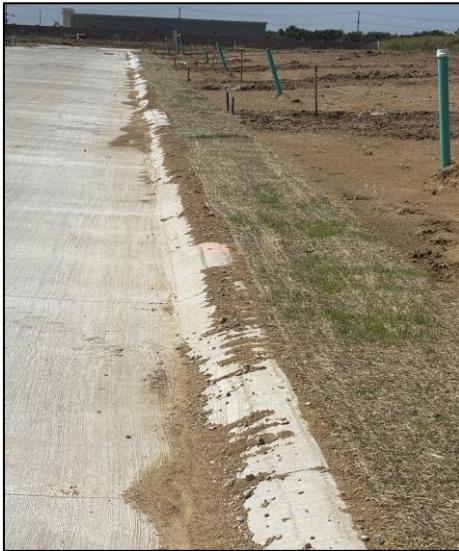
Figure 5: Failed straw buffer strip allowed sediment into the street approximately 14 days after installation.

- Because straw fibers are hollow, straight, and flat, the straw buffer strips provided insufficient protection/sediment control during the rain event (see Figures 5 and 6).

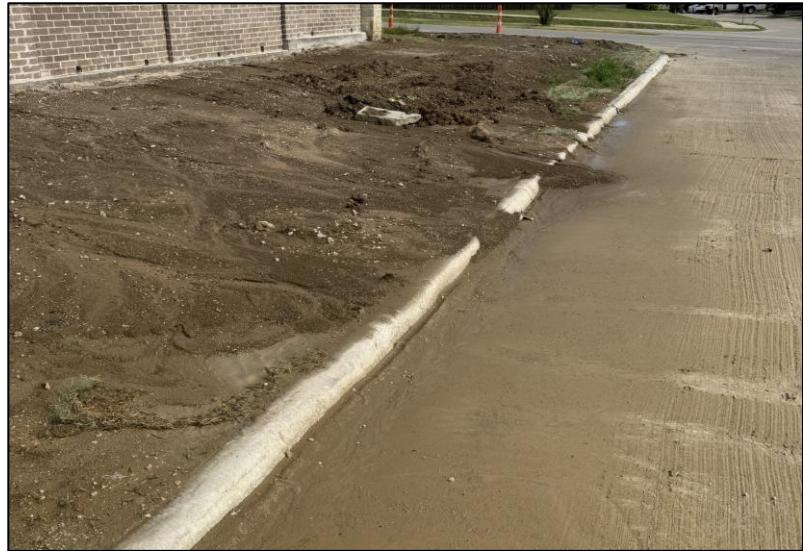
Figure 6: Failed straw buffer strip installation that was overrun by sediment-laden flows.

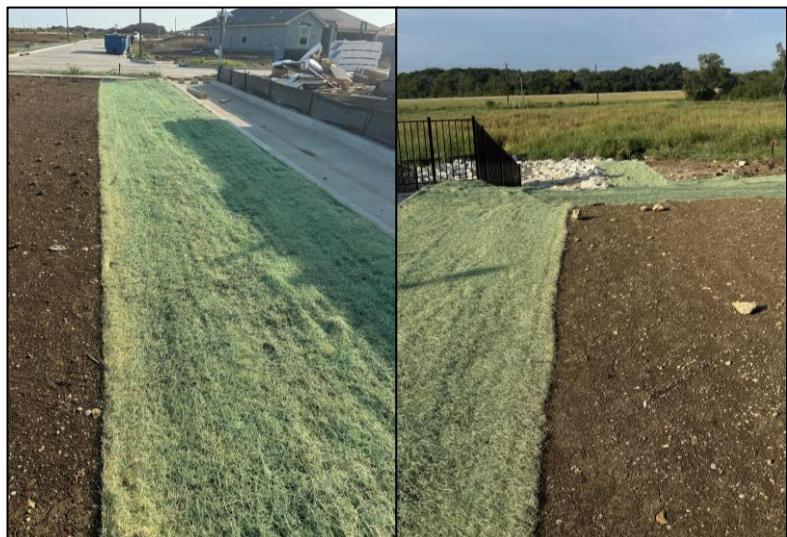
Figure 7: Recently installed Curlex SiltTRAP.

- Failed straw BMPs were replaced with Curlex SiltTRAP and its proven performance (see Figure 7). Curlex SiltTRAP installations at the site that prevented sediment from being transported into streets and storm sewers remain in place and continue to work well.
