Almost Schooled by the Florida Pan Handle Soils

by Kurt Kelsey, M.S., CPESC, CPSWQ & John Slupecki, CPESC

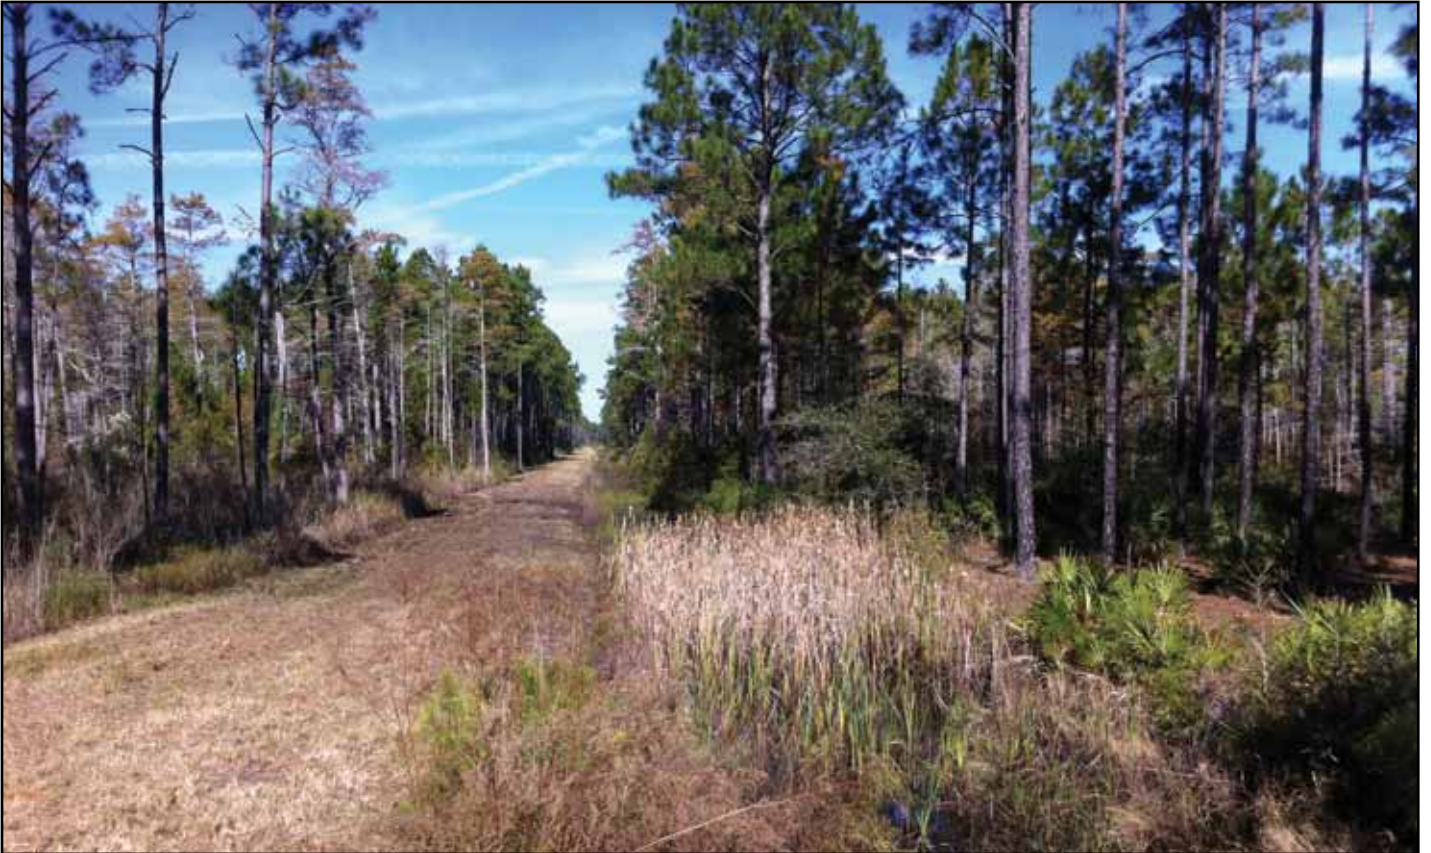
Protected bank today after the erosion control blankets have completed their job of controlling erosion until vegetation has become established.

The Third action was the use of erosion control blankets (ECBs) to prevent soil erosion and hasten vegetation efforts by protecting the seed bed. A single strip of Curlex® II excelsior matting, as provided by American Excelsior Company, Arlington, Texas, was installed along the road curb to prevent erosion along the shoulders. Sod strips were not used as an alternative

along the curb because sod may compete with adjacent native plantings if it becomes established. This matting was selected because of its performance capabilities and extended functional longevity as compared to other erosion control product options. It was also installed along areas where concentrated flow conditions were anticipated or areas that were deemed highly erodible. These areas included the drainage channels and slopes. Curlex ECBs were chosen for these applications because of the “Velcro-like” connection they make with soil. As rain hits the excelsior ECBs the soil beneath is protected and held in place by the wood fiber matrix within the blanket. Rain water is absorbed by the matrix, which aids in vegetation establishment especially during droughty conditions. Moisture is released back to the seedbed from the Curlex fibers as the soil begins to dry. The engineered fibers curl, expand, and interlock with each other when wetted. The engineered denier and curl of the fibers produce a product that intimately intermingles with soil for a period of time that provides a superior performance-based cover factor to prevent erosion and provide beneficial seed bed conditions. In addition, these products

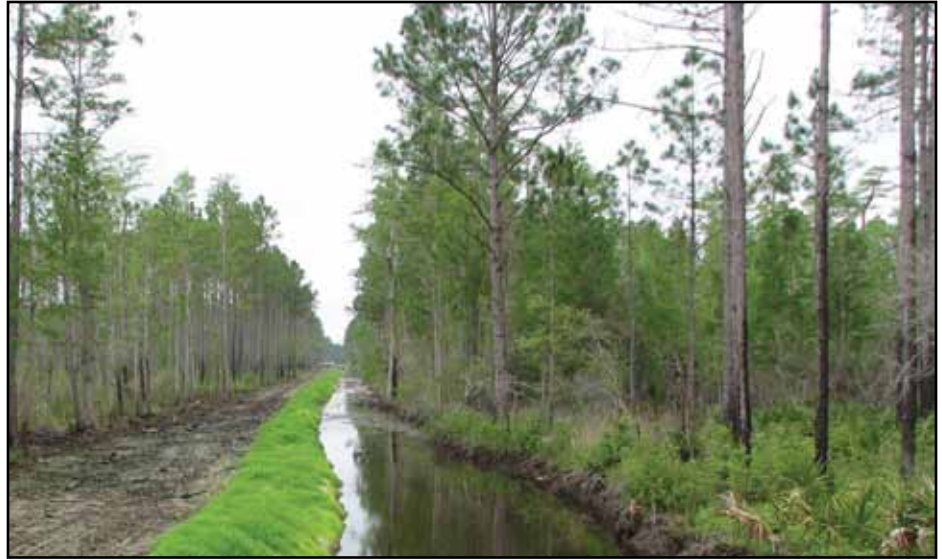
Vegetated erosion control blankets protecting bank a few weeks after installation (left side of photo).
