Almost Schooled by the Florida Pan Handle Soils

RiverCamps on Crooked Creek is a 1,500 acre unique product by The St. Joe Company that was created with the vision of providing its owners the ability to enjoy and discover West Bay. The residential development is located in Northwest Florida's Emerald Coast in Panama City Beach. The JOE community is carefully nestled in a secluded woodland preserve along the sparkling waters of Crooked Creek and the spectacular 18,000 acre expanse of West Bay. Nearly two thirds of RiverCamps has been set aside for conservation. The development consists of 408

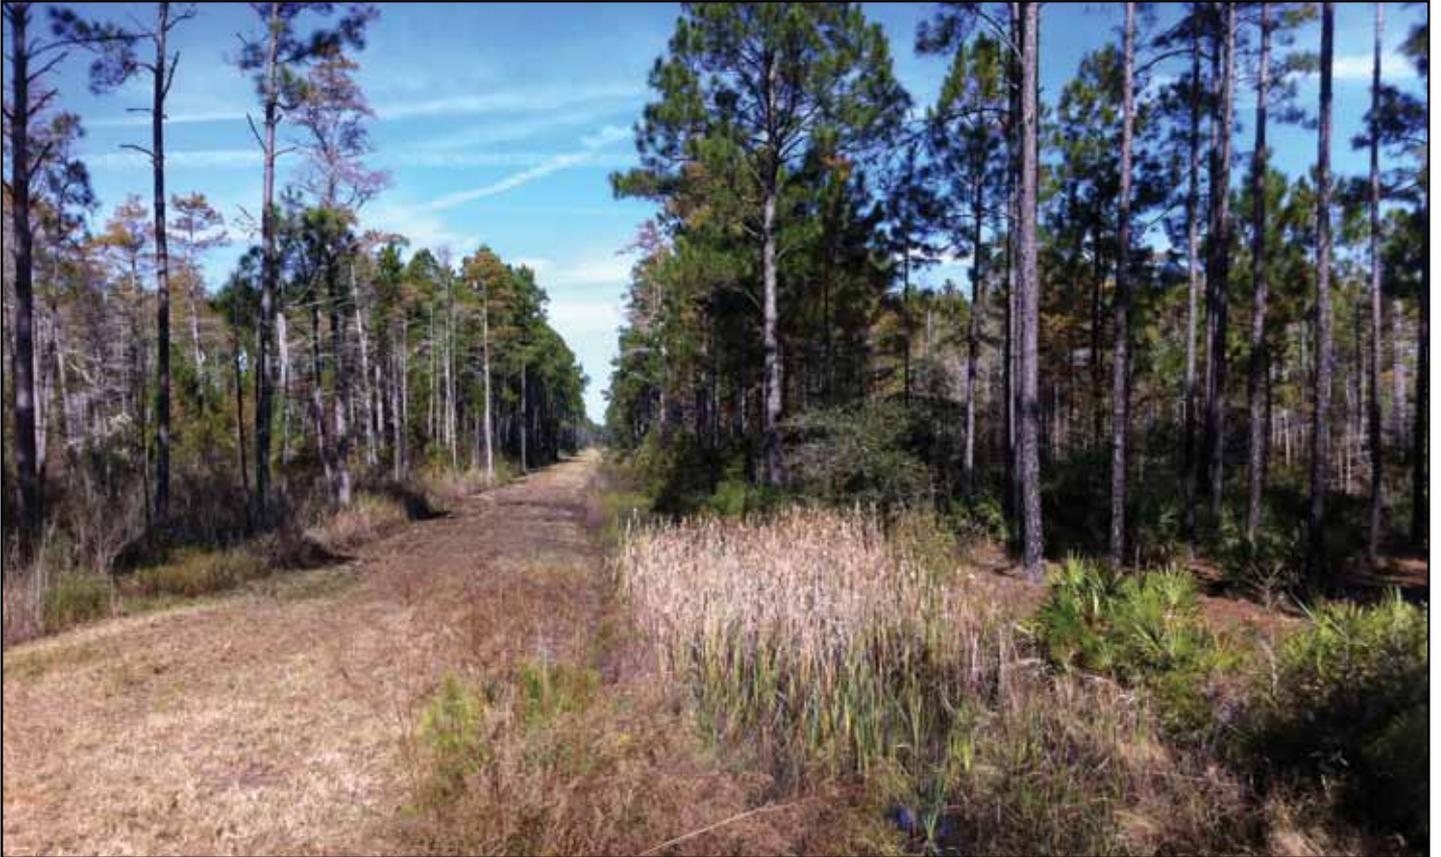
Protected bank today after the erosion control blankets have completed their job of controlling erosion until vegetation has become established.

The Third action was the use of erosion control blankets (ECBs) to prevent soil erosion and hasten vegetation efforts by protecting the seed bed. A single strip of Curlex® II excelsior matting, as provided by American Excelsior Company, Arlington, Texas, was installed along the road curb to prevent erosion along the shoulders. Sod strips were not used as an alternative

along the curb because sod may compete with adjacent native plantings if it becomes established. This matting was selected because of its performance capabilities and extended functional longevity as compared to other erosion control product options. It was also installed along areas where concentrated flow conditions were anticipated or areas that were deemed highly erodible. These areas included the drainage channels and slopes. Curlex ECBs were chosen for these applications because of the “Velcro-like” connection they make with soil. As rain hits the excelsior ECBs the soil beneath is protected and held in place by the wood fiber matrix within the blanket. Rain water is absorbed by the matrix, which aids in vegetation establishment especially during droughty conditions. Moisture is released back to the seedbed from the Curlex fibers as the soil begins to dry. The engineered fibers curl, expand, and interlock with each other when wetted. The engineered denier and curl of the fibers produce a product that intimately intermingles with soil for a period of time that provides a superior performance-based cover factor to prevent erosion and provide beneficial seed bed conditions. In addition, these products

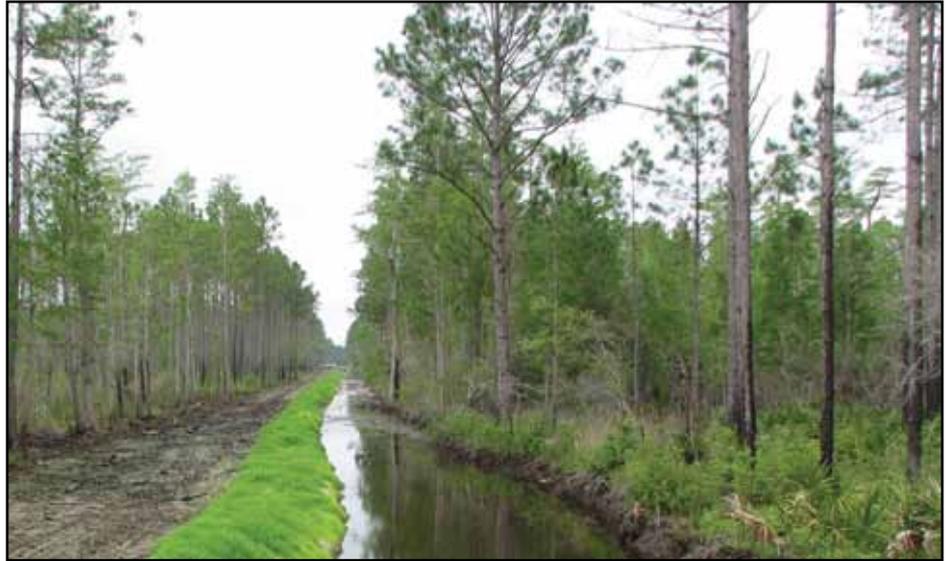
Vegetated erosion control blankets protecting bank a few weeks after installation (left side of photo).
