Revisiting a Classic-IDOT Route 6 Project

A Case History – Chillicothe, Illinois

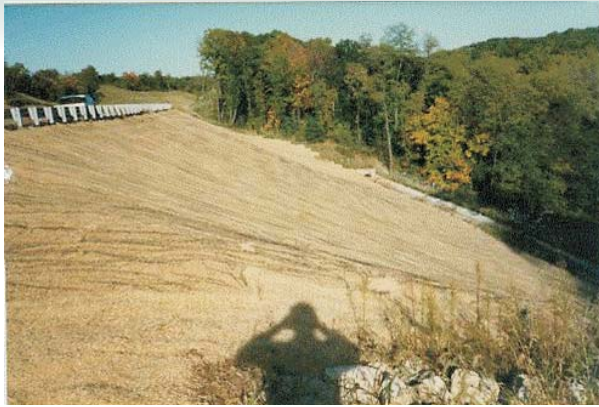
Figure 1. Curlex HV slopes in 1987.

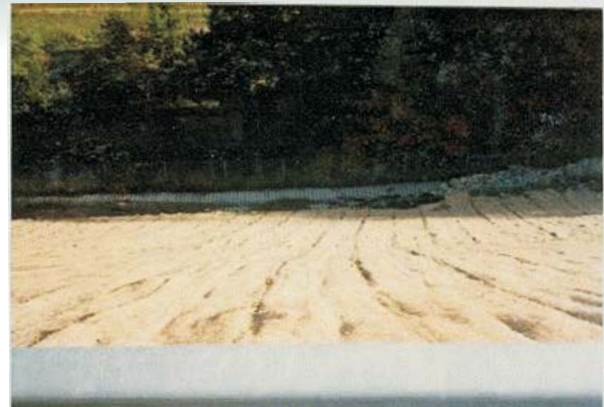
Figure 2. Steeper Curlex HV slopes 1987

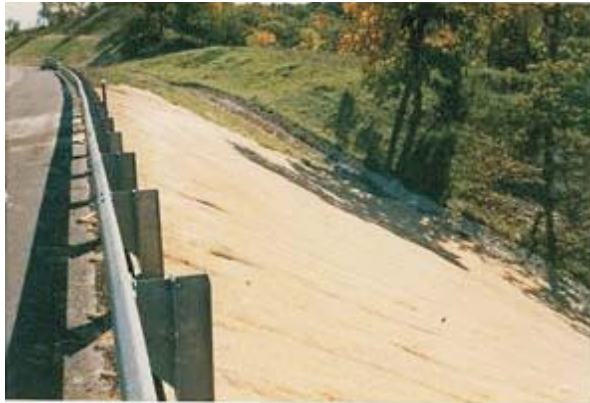
Figure 3. Curlex HV 1987.

All slopes consisted of loam soils and were seeded with IDOT standard roadside mix, which is comprised mainly of perennial rye, red fescue, and blue grass. 55,000 yd² of Curlex HV were installed on the steep road side slopes (1.5H:1V up to 200 ft long) and ditch bottoms at a rate of 600 yd² per man hour. 145,000 yd² of Curlex I were installed on the slopes along the remaining 3,000 linear feet of the project at a rate of approximately 30,000 yd² per day. The majority of the Curlex I slopes were 2.5H:1V and contained one terrace to break up the 300 ft long slopes.

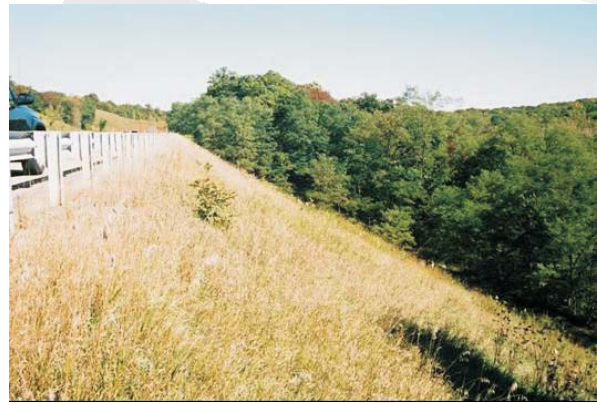
Figure 4. Figure 3 slope in 2004.

A look back at this exciting project shows the products did their jobs back in 1987. Curlex I slopes were established within a month and remain unblemished today. Curlex HV blankets did not biodegrade until almost four years after installation, thus the product provided heavy duty slope protection during the critical development phase of a structural root system into the long, steep slopes. The project remains a poster boy for the erosion control industry.

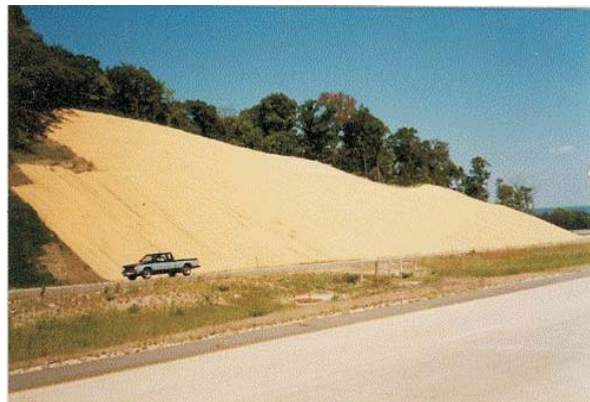
Figure 5. Curlex I slope 1987.

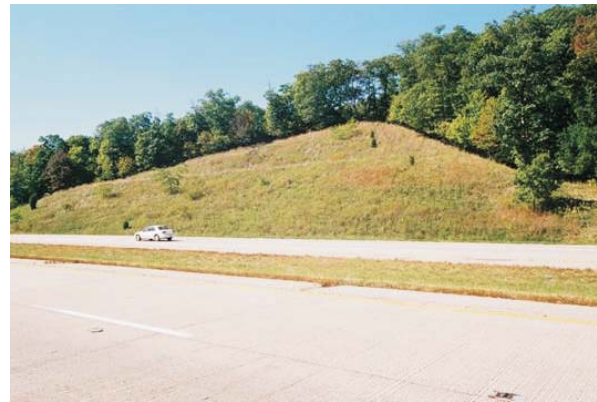
Figure 6. Figure 5 slope in 2004.
