Revisiting a Classic-IDOT Route 6 Project

A Case History - Chillicothe, Illinois

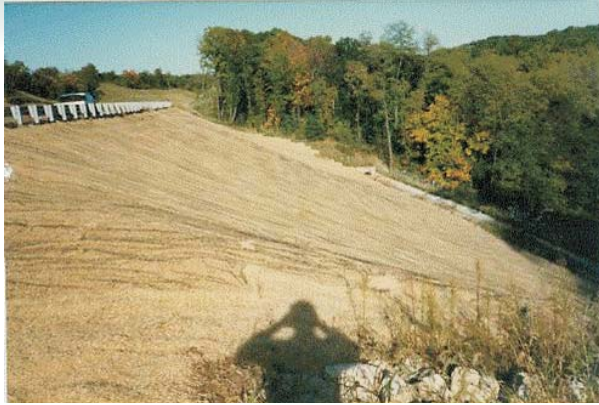
Figure 1. Curlex HV slopes in 1987.

All slopes consisted of loam soils and were seeded with IDOT standard roadside mix, which is comprised mainly of perennial rye, red fescue, and blue grass. 55,000 yd² of Curlex HV were installed on the steep road side slopes (1.5H:1V up to 200 ft long) and ditch bottoms at a rate of 600 yd² per man hour. 145,000 yd² of Curlex I were installed on the slopes along the remaining 3,000 linear feet of the project at a rate of approximately 30,000 yd² per day. The majority of the Curlex I slopes were 2.5H:1V and contained one terrace to break up the 300 ft long slopes.

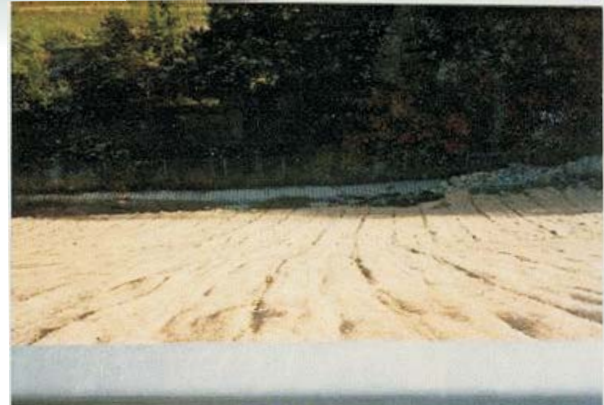
Figure 2. Steeper Curlex HV slopes 1987

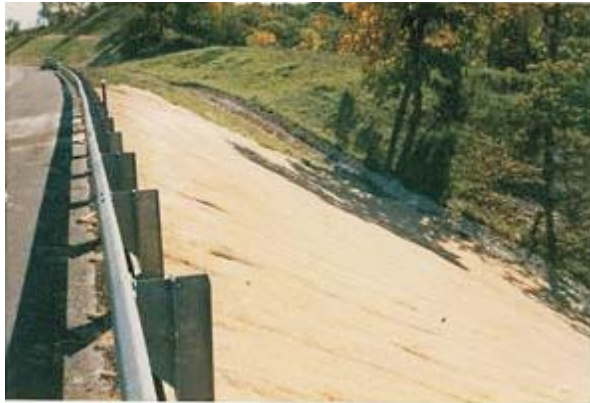
Figure 3. Curlex HV 1987.

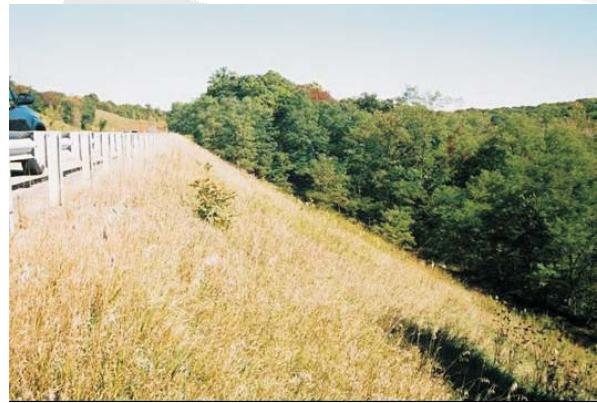
Figure 4. Figure 3 slope in 2004.

A look back at this exciting project shows the products did their jobs back in 1987. Curlex I slopes were established within a month and remain unblemished today. Curlex HV blankets did not biodegrade until almost four years after installation, thus the product provided heavy duty slope protection during the critical development phase of a structural root system into the long, steep slopes. The project remains a poster boy for the erosion control industry.

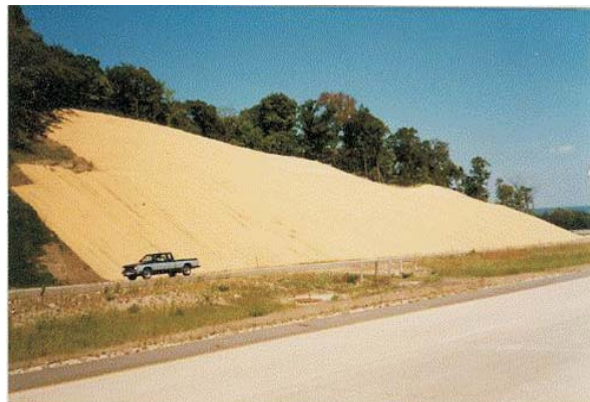
Figure 5. Curlex I slope 1987.

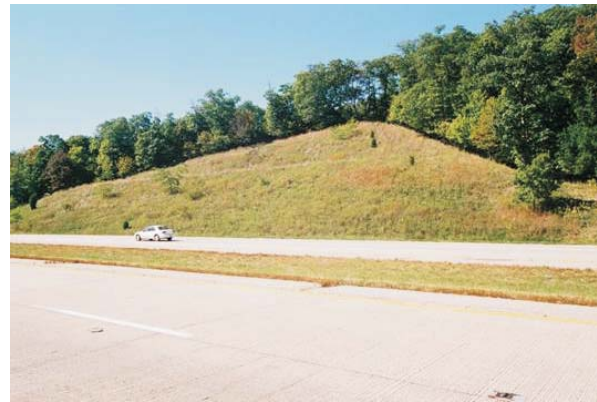
Figure 6. Figure 5 slope in 2004.
