Protecting Landfills with Rolled Erosion Control Products

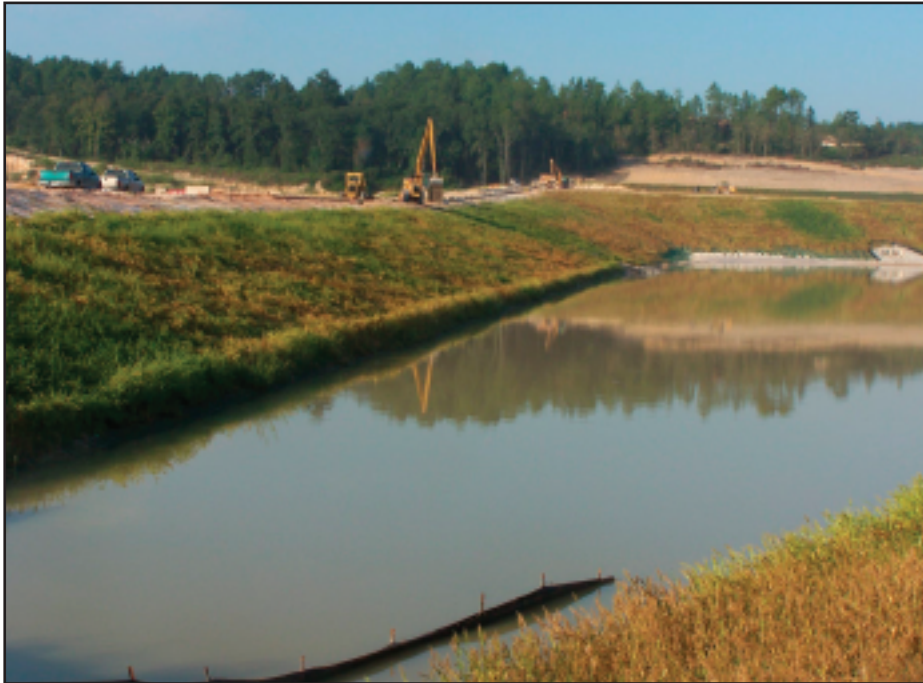
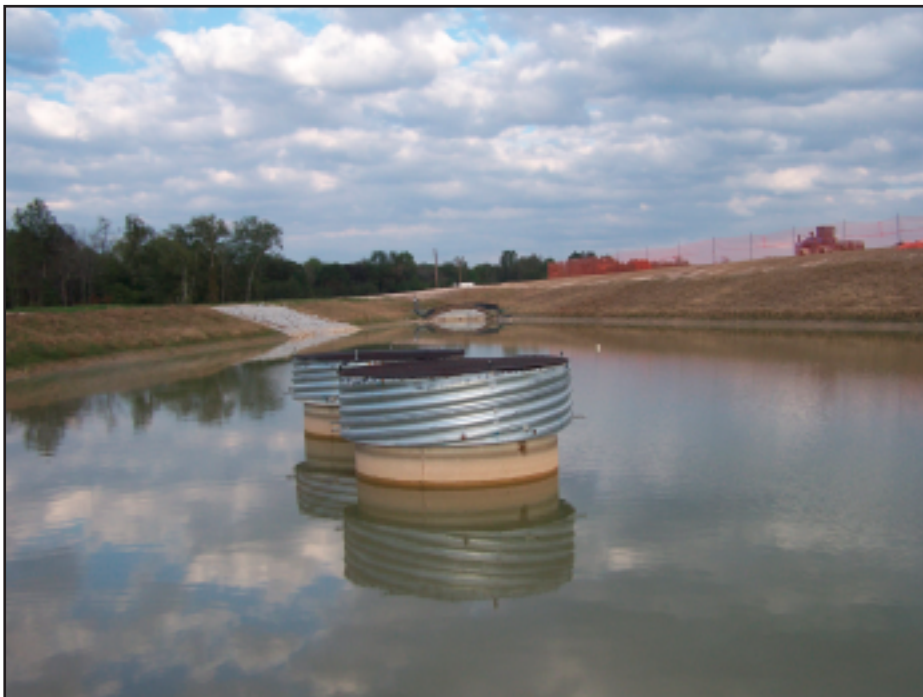
Top: Landfill expansion continues behind stormwater ponds. Below: Overflow structures in stormwater pond.

The new section of the landfill contained an approximate 80 acre drainage area. Jordan, Jones, and Goulding, project engineer from Norcross, GA, designed two stormwater ponds for the site. The three acre and five acre ponds were designed to a 25 year storm event

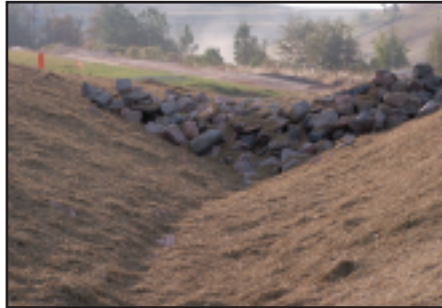
Rock check dam in ditch.

The general contractor for the expansion project, Cooper, Barnette, and Page (CBP) from Statham, GA, completed all earthwork activities including the excavation of both stormwater ponds. Rock rip rap check dams were installed to reduce flow velocities in down chutes leading to the ponds. CBP also installed silt fence lined with straw bales around the head-wall of the rip rap structures to prevent sediment from filling in the down chutes.

Little maintenance will be required at the site for years to come. Proper erosion control and stormwater planning prevented many potential maintenance issues. Silt fence lined with straw bales successfully kept the rip rap down chutes free of sediment. Rock check dams successfully reduced flow velocities,

which prevented scouring in the areas of concentrated flow. Erosion control blankets successfully protected the erodible slopes, which kept the soil on the slopes and out of the stormwater ponds. Lastly, the stormwater ponds safely and effectively contained runoff volumes from the drainage area.

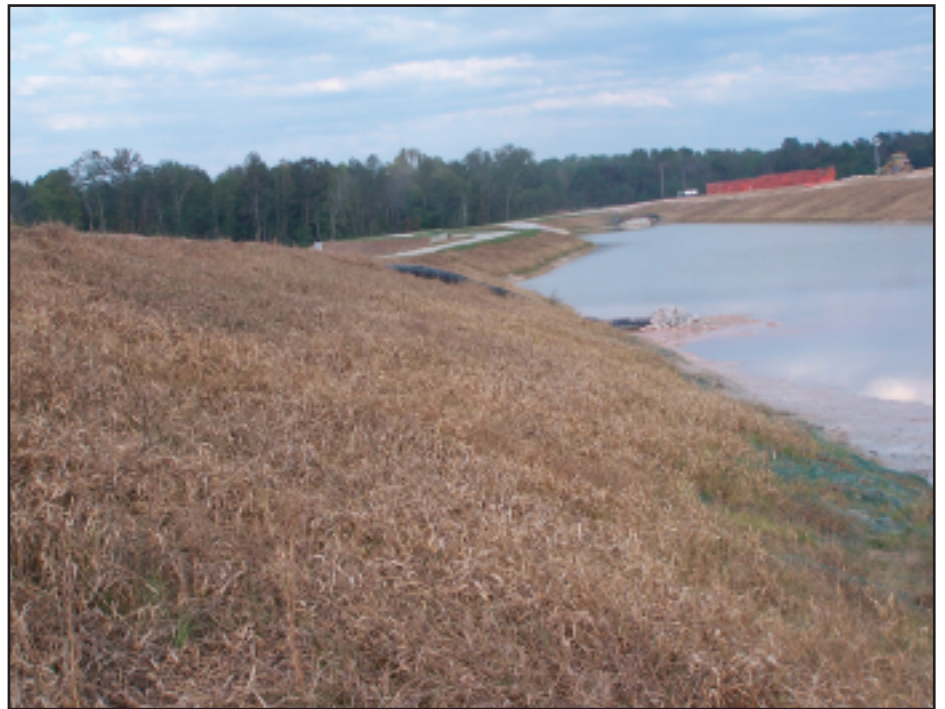
Vegetated side slope of stormwater pond.

The first step to protecting the slopes was to spread three inches of topsoil material across the surface. The topsoil material provided the necessary nutrients and organic matter for the vegetation to become established. The curled excelsior matrix of the ECBs enhanced the establishment of vegetation by storing moisture and slowly releasing it to the soil. The addition of topsoil coupled with the ECBs ensured a dense stand of vegetation that would ultimately provide permanent erosion protection to the pond slopes.

The vegetation flourished as it grew through the excelsior matrix. This is important because vegetation may struggle to penetrate denser and thicker products, which causes the product to be lifted upward. This process is sometimes referred to as product "tenting" and results in the loss of intimate contact between the product and the soil surface. Intimate contact between an ECB and the subgrade is a critical component to successful erosion control before vegetation becomes established.
