Case Study - Iowa Department of Transportation I-80 Median Project

The Challenge

The Iowa Department of Transportation (DOT) had a challenging 2.25 mile-long ditch median near the Interstate 80 Avoca interchange. The long run caused concentrated flows in the median that “standard” erosion control products would not withstand. Extensive soil erosion in the median was not only an eye sore to motorists, but the erosion was causing a public safety concern to the roadway. The project also crossed two branches of the Nishnabotna River so successful erosion and sediment control was a must to protect the precious waterways. To further complicate matters, the cross-over that was required for the resurfacing project increased the concentrated flows to the median. The highway median had gullies 18 to 24 inches deep and a couple of feet wide before the final solution was devised. As the project owner, the Iowa DOT turned to its specifications for special ditch control that allow double-netted aspen excelsior wood fiber ECBs or double-netted coconut fiber ECBs. Products used on this project included Curlex® II .98 ECBs and Curlex® Sediment Logs (See Figures 1-3).

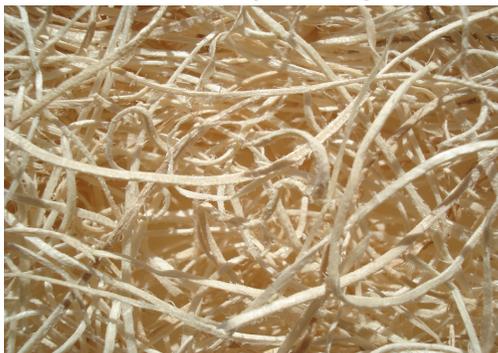
Figure 1. Curlex® Great Lakes Aspen Excelsior Fibers

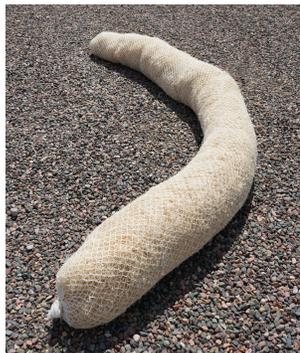
Figure 2. Curlex® Sediment Log®

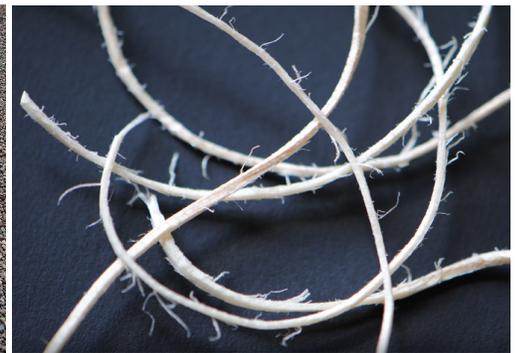
Figure 3. Curled & Barbed Curlex® Excelsior Fibers

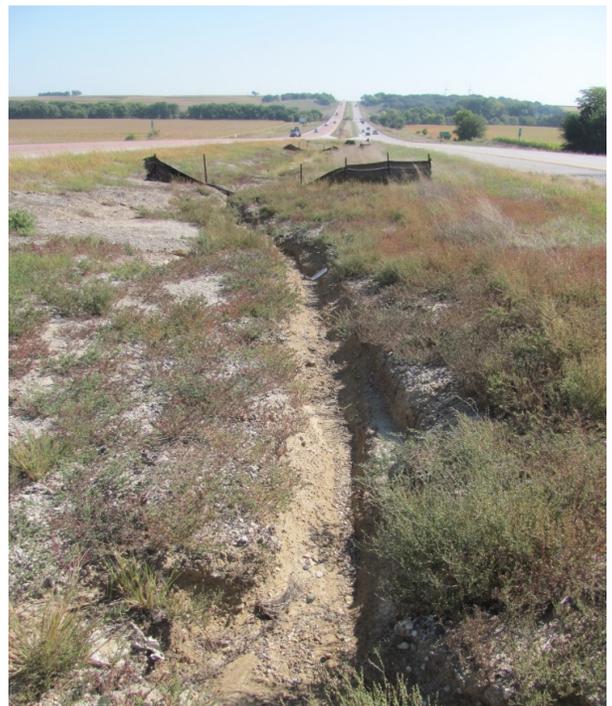
Figure 4. Scour under damming device caused severe erosion. These failures led to complete rework of the area with Curlex® II .98 erosion control blankets and Curlex® Sediment Logs.

Damming structures previously used in the highway median had to be removed first because they caused accelerated erosion in the median. Increased hydrostatic pressure created by ponded water in front of damming products can initiate the erosion process. As the water depth and hydrostatic pressure increase, the downward force can cause scour directly under the dense object. Moving water tends to take the path of least resistance. Thus, as downward force is continually increasing with water depth, the weakest point in the channel becomes the path of least resistance. Commonly, this weakest point in the channel is under damming devices. These basic physics commonly cause scour underneath damming products as seen in Figure 4. A direct conduit for contaminated runoff is created as soon as water scours under dense devices. When scour under a damming product occurs, it makes them almost obsolete in terms of environmental protection benefits because of the direct flow path under them.

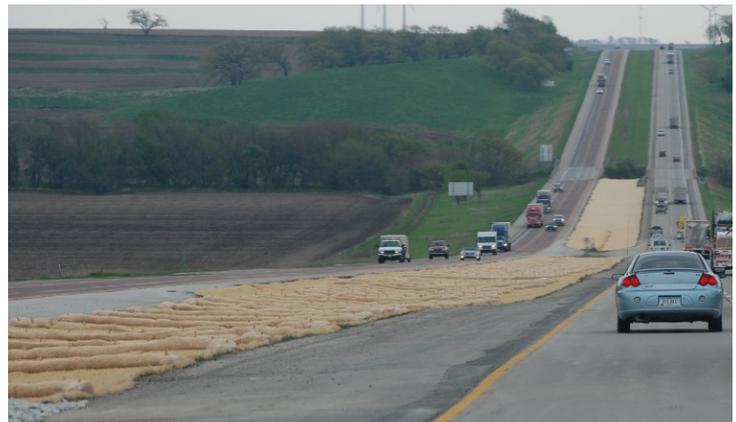
Figure 5. (May Year One): Curlex® II .98 erosion control blankets are double-netted for higher performance. They were installed in conjunction with Curlex® Sediment Logs which are porous and engineered to both dissipate velocity and filter stormwater runoff before the median discharges into the Nishnabotna River. Both products are made from sustainably harvested Great Lakes Aspen excelsior fibers.

A 20ft x 20ft splash pad was installed at the end of the culvert coming off the cross-over. Also, three inch nominal limestone was added at the culvert to help mitigate flow velocities coming off the cross-over before the flow entered the median. Porous filtering devices were needed in the highway median. The devices work with Mother Nature and allow flow through them, which may be a more suitable option for areas of concentrated flows. Filtering devices have a flow rate of at least 35 gallons per minute per square foot and dissipate runoff velocity as their flow rate is exceeded. Filtering devices give you “the best of both worlds” because they provide both velocity reduction and filtering. It is very important to allow flow through aspen excelsior products so contaminated runoff can contact the matrix and filtered water can be released. Dense designs do not allow water to contact the fibers, so filtering does not have a legitimate chance. Materials made of the exact same matrix can perform drastically different at different densities. Laboratory and field research has shown that more porous products work better because dense versions of the same exact matrix tend to cause scour in channelized flow applications. With this in mind, Curlex Sediment Logs were installed over the ECBs across the median, perpendicular to the flow of water to filter contaminated runoff and dissipate the flow velocity (see Figure 5). The logs contain engineered, curled and barbed Great Lakes Aspen excelsior fibers. 80 percent are a minimum of six inches long and 0.031 ± 0.008 inches wide x 0.027 ± 0.006 inches thick. These fibers have been proven to be ideal for sediment control filtering matrices. Larger wood fibers, or chips tend to float during hydraulic events. Smaller wood fibers such as mulch-like materials or saw dust tend to compact too much resulting in a dense, damming matrix.

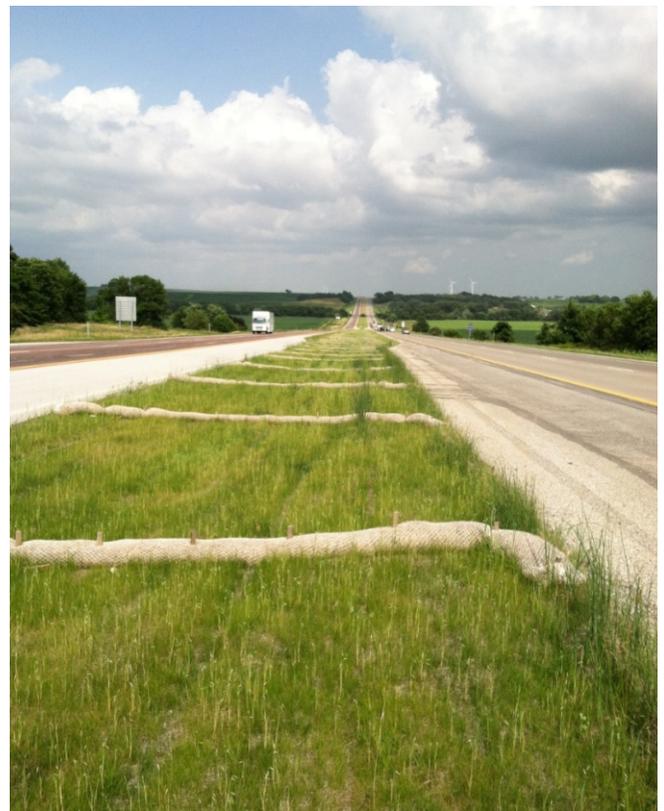
Figure 6. After (July Year One): The challenging highway median is becoming permanently stabilized by vegetation only approximately two months after installation of Curlex® II .98 erosion control blankets and Curlex® Sediment Logs.

In total, more than 26,000 yd² of ECBs and 26,800 ft of filter logs were used on the sensitive 2.5-mile project. According to Heller, the vegetation establishment is great and the project has not had any noticeable erosion or visually contaminated flows discharging from it (see Figure 6). Heller summarized the project by stating, “We were able to resolve a public safety concern and make it more aesthetically pleasing by using quality erosion and sediment control products to meet our challenging conditions.”
