Introduction

Project Scope

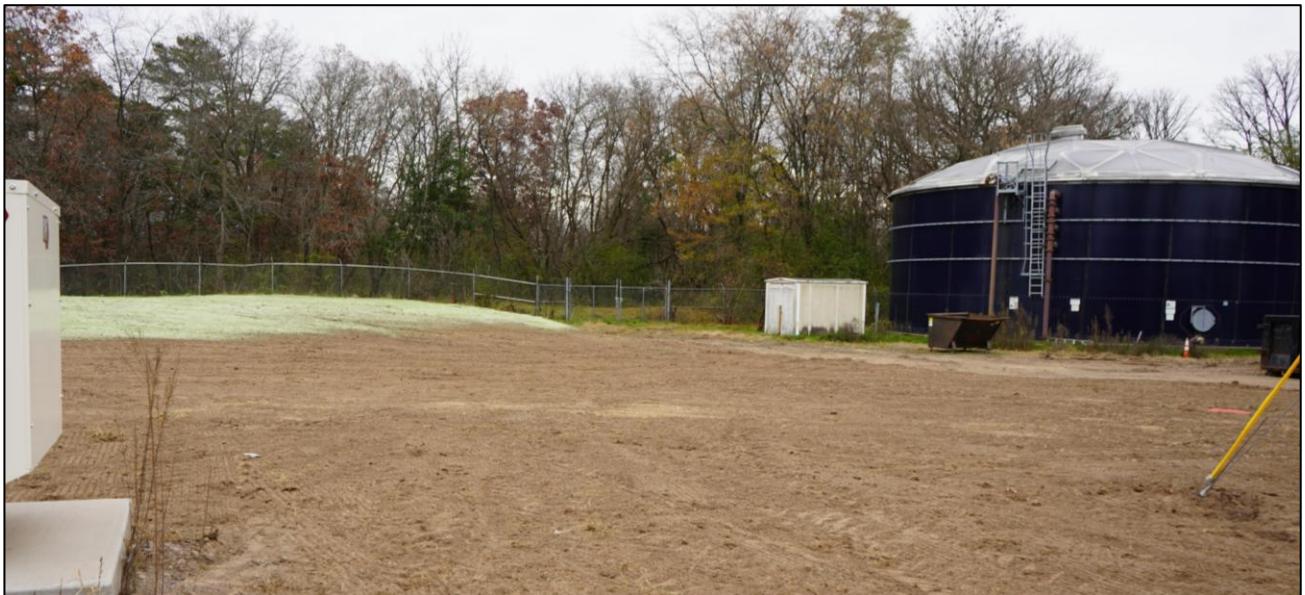
Figure 1: Newly graded bare soil area at the site of the former wastewater treatment plant after the first round of erosion control BMPs was applied.

- ◆ A municipal wastewater treatment plant in Wisconsin closed its doors for the final time after 40 years of continuous operation. Once construction of the new treatment plant was completed, project owners focused on returning the area containing remnants of the former plant to natural conditions. The first step in doing so was protecting and revegetating its bare soil areas (see Figure 1).

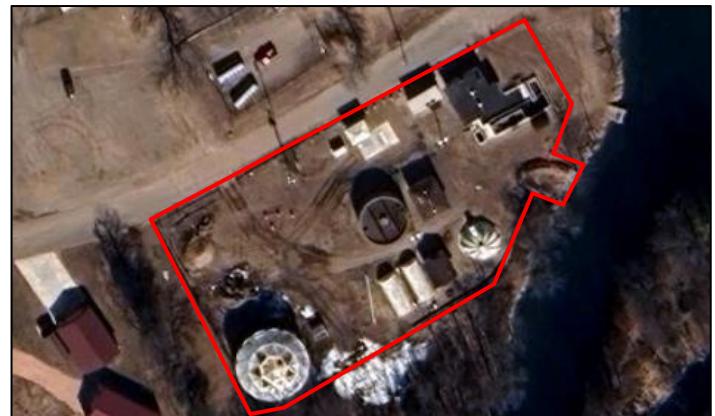
Figure 2: Aerial View of the site (boundaries highlighted in red) (source: www.maps.google.com).

- ◆ The former plant occupied approximately 1 acre of land, most of which was fenced in and separated from a nearby river by a wall of trees (see Figure 2). A $\leq 4H:1V$ sloped area provides a corridor to the river separated by rip rap, and areas formerly occupied by infrastructure were either flat or shallow-sloping. The selected erosion control Best Management Practices (BMPs) needed to be able to keep underlying soils in place and out of the nearby streets and river.

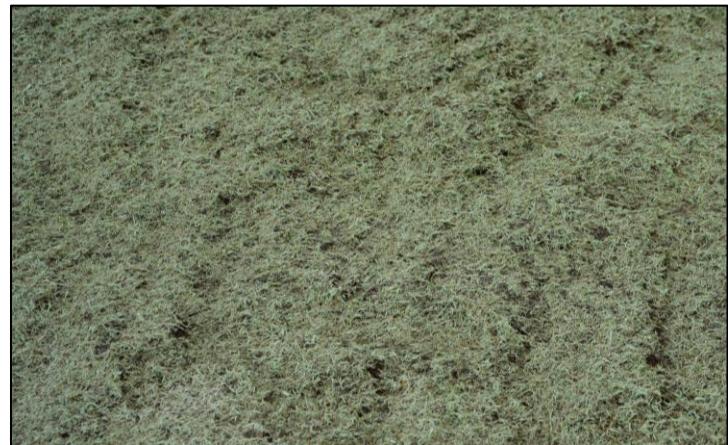
Figure 3: Close-up of Bindex Wood WT application.

American Excelsior Company's Bindex™ Wood WT HECP (see Figure 3) was selected to protect and revegetate the flat and shallow-sloped areas. It features 100% sustainably harvested great lakes aspen wood fibers (no blending of unknown outside materials) coupled with non-toxic tackifier and green dye materials to provide a cover to protect seeds, enhance germination, and hasten revegetation. Its efficient application of a uniform mix aids vegetation establishment.

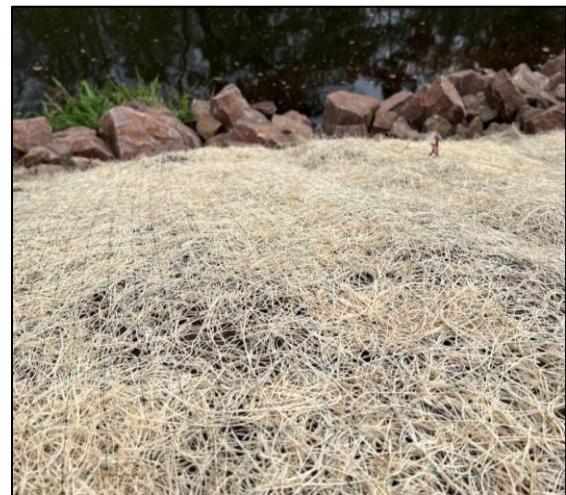
Figure 4: Close-up of Curlex I application.

Therefore, American Excelsior Company's Curlex® I RECP (see Figure 4) was selected to protect and revegetate the steeper sloped area adjacent to the river. Its engineered curled and barbed Curlex® fibers are mechanically bound together to form a Velcro-like connection to the subgrade that keeps soil in place while simultaneously reducing the force of raindrop impact and the effects of sheet flow due to the fiber matrix's naturally high roughness factor. Curlex fibers also expand and contract when exposed to moisture, allowing Curlex I to create a "greenhouse effect" that fosters favorable seed germination and establishment conditions when wet and return moisture to the seed bed when dry.

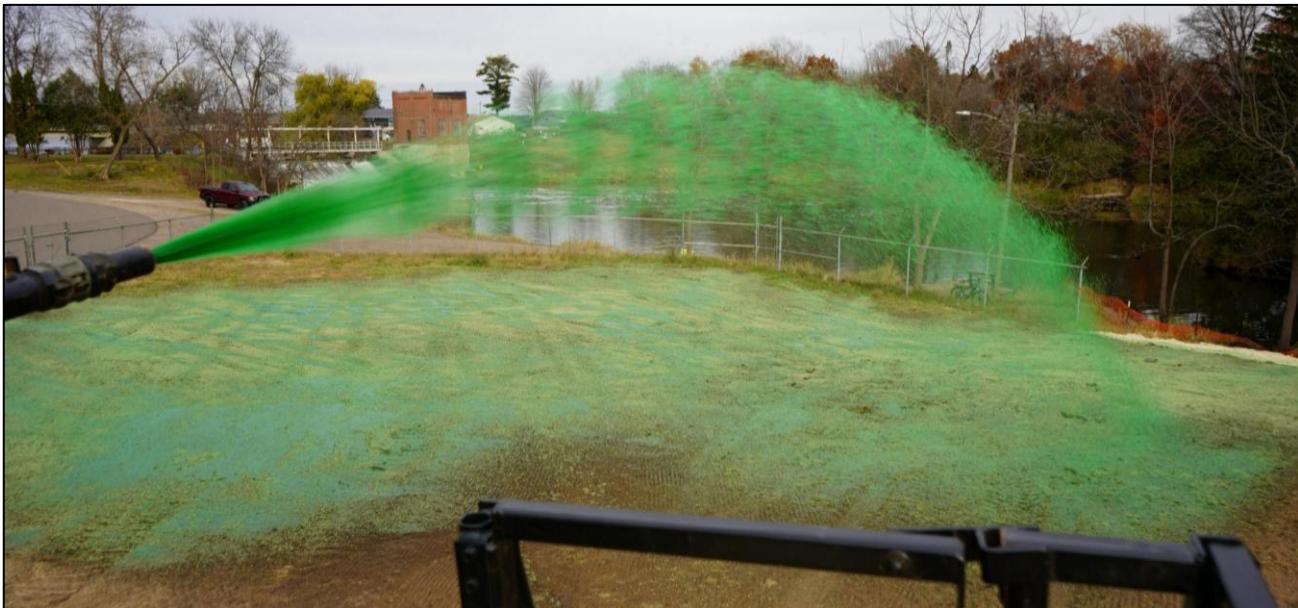
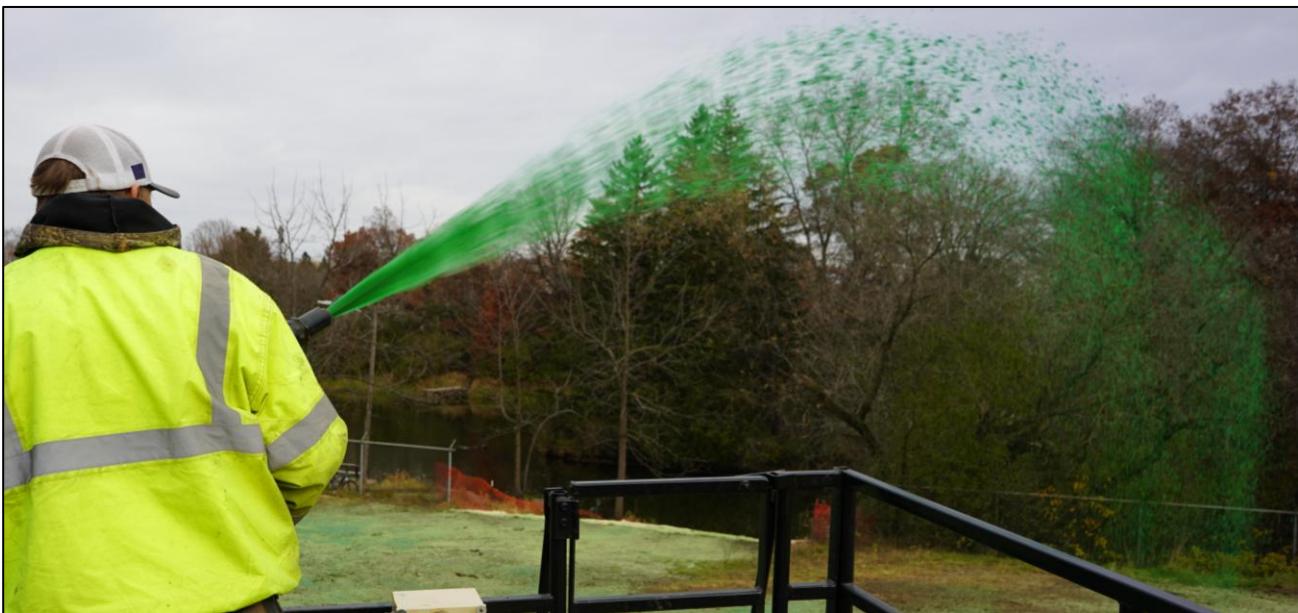
Figure 5: Project personnel hydraulically applying Bindex Wood WT at the site.

- Grading and RECP installation took place before HECP application. Per its corresponding Installation Guidelines on www.Curlex.com, Bindex Wood WT was applied at approximately 2,000 lbs/acre (see Figures 5, 6, and 8), and Curlex I was anchored across the sloped area (see Figure 7). Both products were installed in conjunction with WI DOT No. 40 seed mix.

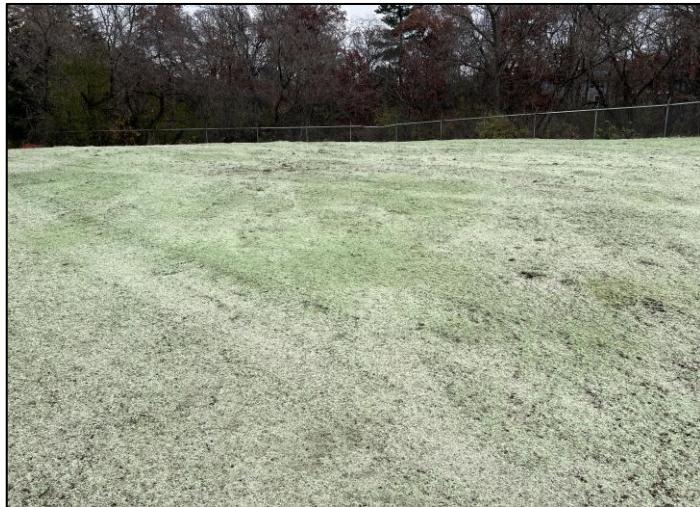
Figure 6: Bindex Wood WT applied on a shallow-sloped area at the site.

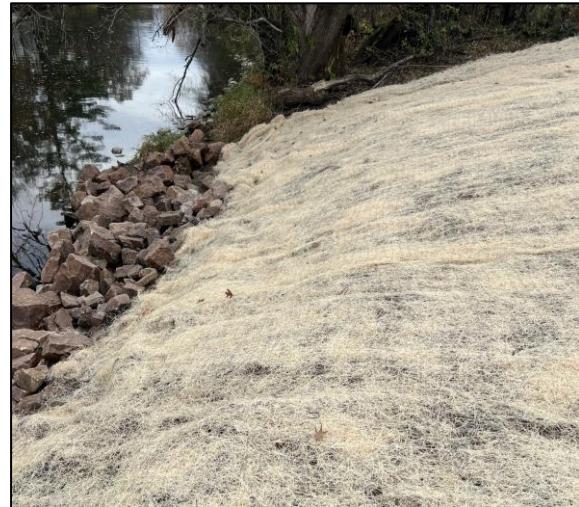
Figure 7: Curlex I installed on the $\leq 4H:1V$ sloped area adjacent to the nearby river.

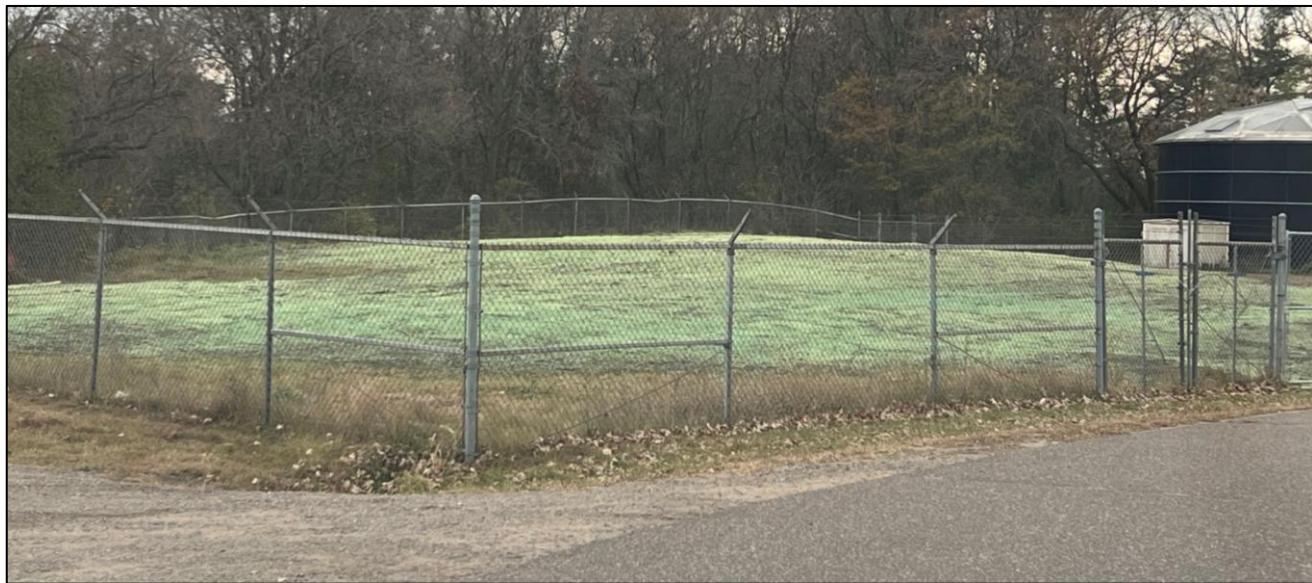
Figure 8: Bindex Wood WT application on the site's flat and shallow-sloped areas.
