## I. Introduction

## IV. Restoration Plan and Installation

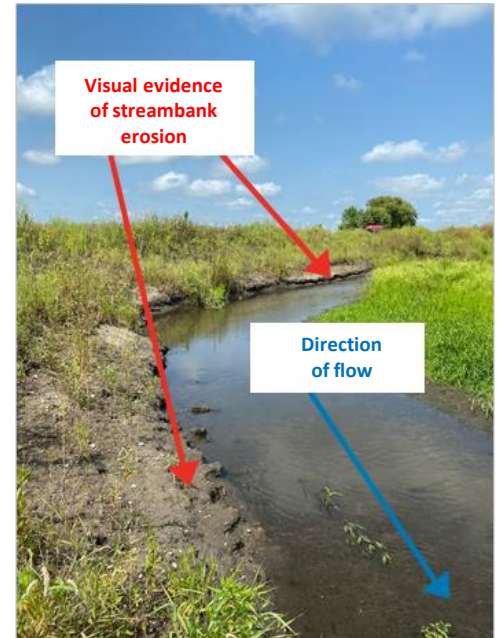
Figure 1 provides the basis for the case study. This is a view of a stream that is in the early stages of down-cutting and it is beginning to erode the outside bend in the stream. These real-life stream conditions continue to be exacerbated by changing climate conditions. Across the country we continue to see more frequent intense storms occurring with short recurrence periods. These storms typically discharge large volumes of precipitation in shorter periods of time. This then causes large run-off volumes to be conveyed through stream segments that are already in need of restoration. Further adding to the run-off discharge volumes is the continued development within the watersheds, that increase the impervious areas, which then changes the time it takes the peak flows from entering the streams. These peak flows reach the stream faster than they had in the past. This, coupled with the increased storm frequency and intensity, contributes negatively to the continued stability of the stream.

Figure 1: Existing stream bank conditions at project site.

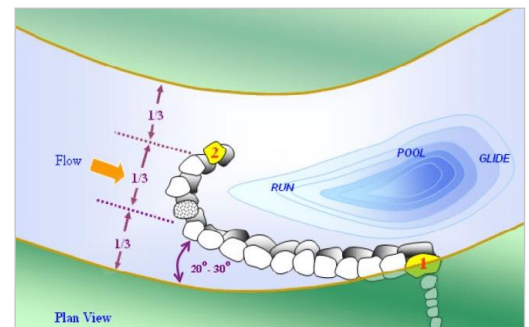
Figure 2: “J” Hook image courtesy of US Fish and Wildlife Service.

These streambank conditions continue to exist in both rural and urban settings nationwide. With the continued stress of climate change on weather patterns, local climates and economic pressure associated with development, the future of stream and channel stability is an ongoing challenge. For this case study, the restoration includes 60 linear feet of streambank. Figure 3 provides information on the location of the restoration. This segment was selected as it is upstream of the bend in the stream. By restoring this segment, the likelihood of reducing the bank erosion immediately downstream is minimized. Migrating the flow more towards the center of the channel will also help to fully migrate the flow to the center, a “J” hook structure should be installed at the downstream end of the restoration segment. This not only migrates the flow towards the center, but it protects the restoration segment and allows it to stabilize and establish vegetation.

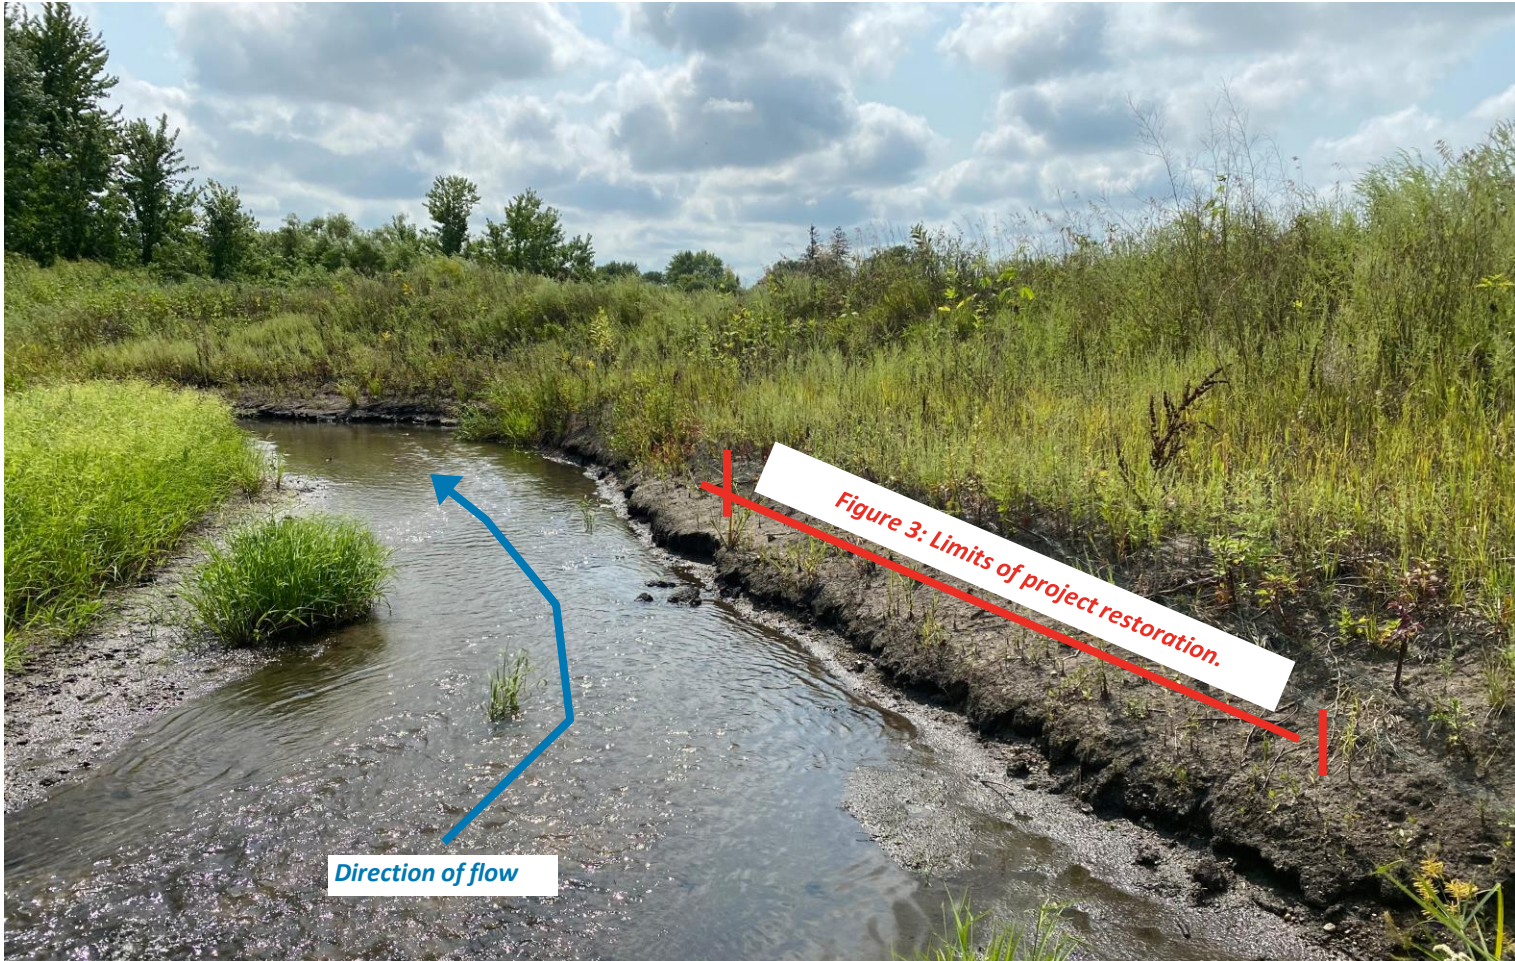
Figure 3: Limits of project resources

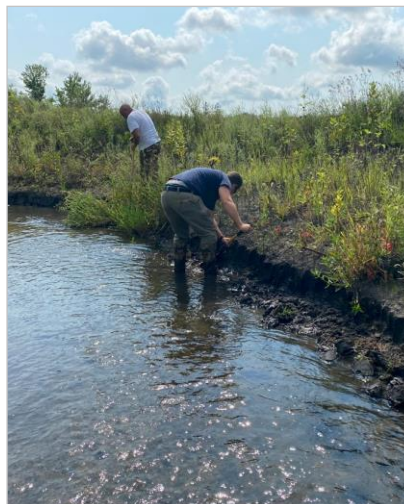
This step required preparing the restoration area for placement of the Blocs. Figure 4 shows bank preparation using hand tools to form a level bench for placement of the Blocs. Note the vertical nature of the stream bank wall. This is necessary to achieve maximum contact between the bank and the Blocs and minimize any large voids the flow could get behind and cause erosion. Figure 5 shows the bank area prepared for Bloc placement.

Figure 4: Streambank excavation and preparation.

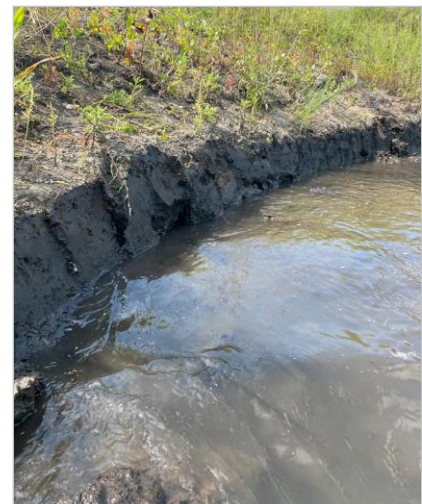
Figure 5: Restoration area ready for Block installation

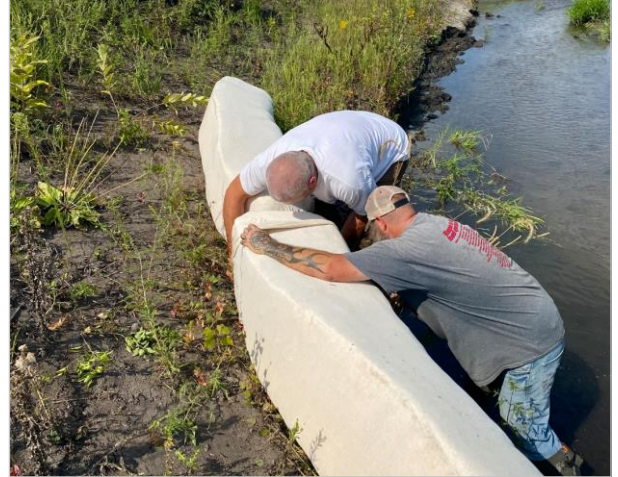
This step requires assembling Curlex® Bloc in 8' lengths. Each Bloc includes a sleeve at each end of the Blocs that needs to be fitted over the next Bloc to form the connected length for the restoration. Fitting the Blocs together was a bit challenging given the length and weight of the Blocs, however once they were lined up and butted together they formed a gapless joint between the Blocs. This step is optional, but does provide the best joint option. Figure 6 shows the Blocs being fit together with sleeves.

**Figure 6: Fitting two Curlex® Blocs together.**

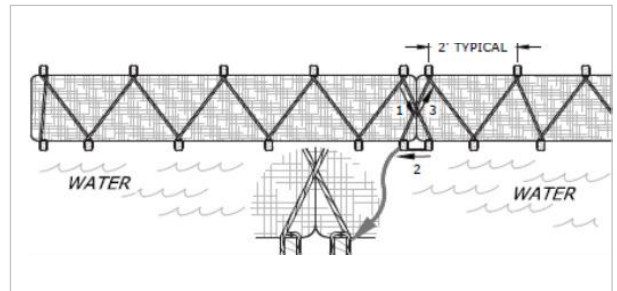
This step requires securing the Blocs into the excavated restoration area. The anchoring pattern requires 2 foot spacing with anchors placed on both sides of the Curlex® Bloc along the water face and bank face, driven a minimum of 2 feet into the ground. Figure 7 shows the anchor system installed. Once the anchor stakes are placed, rope was located per the anchoring techniques detail.

**Figure 7: Curlex® Blocs anchoring detail.**

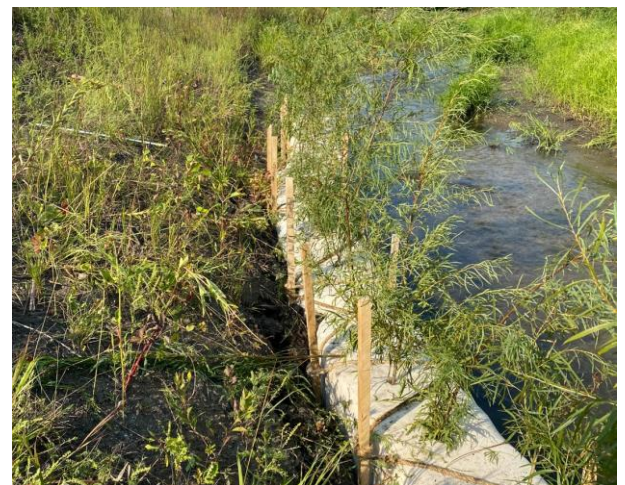
This step required placing live stakes along the length of the Bloc. Once these begin to establish root systems they will overtake the Bloc and form natural protection along the bank reducing future degradation of the bank. Figure 8 illustrates the planted Curlex® Bloc.

**Figure 8: Curlex® Bloc with live stakes inserted.**

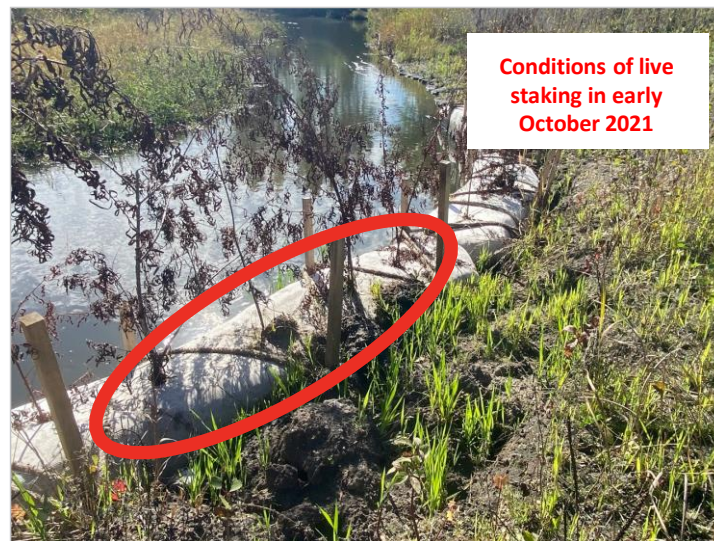
Figures 11 and 12 show the condition of the live staking as it looked during the October 5, 2021 field inspection. There are several items worth noting in the figures:

- Note the condition of the live staking.
- Note the establishment of vegetation in front and behind the Curlex® Blocs.
- Note the change in stream water level from the installation in early September to early October.

**Figure 11: Vegetation establishment behind Blocs and live staking.**

- New vegetation was noted in the stream in front of the Blocs and also behind the Blocs along the bank. If needed, additional live staking will be added in the spring of 2022.

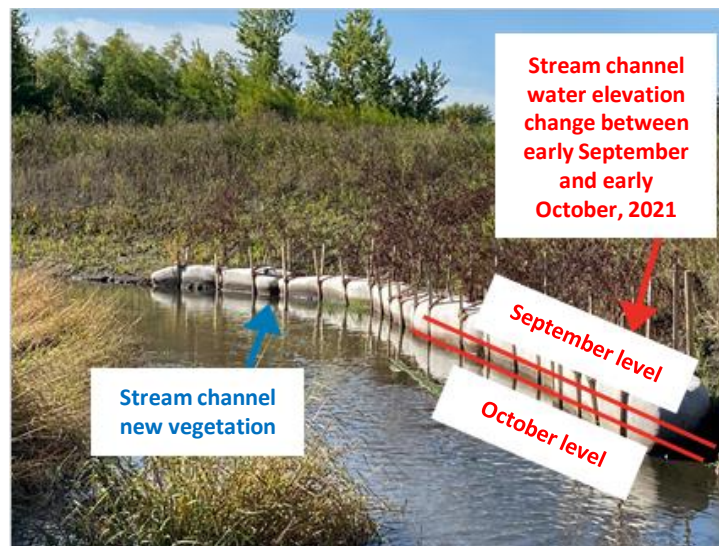
**Figure 12: October 5, 2021 Water level change and vegetation growth in the channel.**
