Introduction

The White Fox Wetland Mitigation Bank was established by a private landowner along the floodplain of the White Fox River in Wright County, Iowa. The 90-acre site was a former gravel mine and now is in row crop production. The landowner recognized that continuing to utilize this area for row crop production was not in his best interest from a financial or environmental perspective.

Figure 1. White Fox Mitigation Bank Restoration

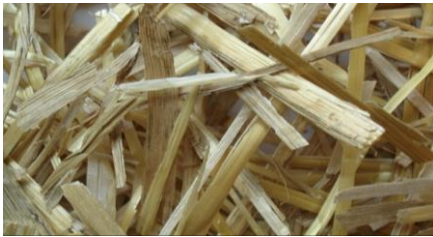
Figure 7. Straw Fibers

Straw is an agricultural by-product. It is straight and contains hollow and flat fibers. Straw fibers have their limitations, most concerning is that they float. More and more states do not allow straw in channels. Straw products inherently contain seeds, some of which may be noxious weeds.

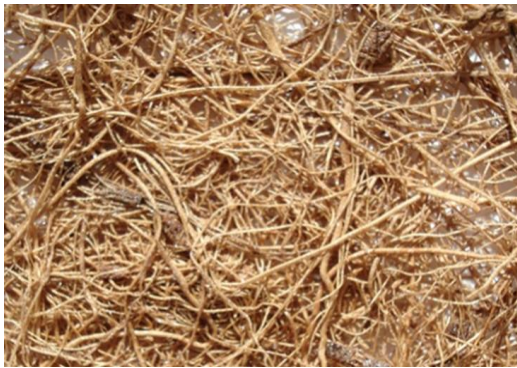
Figure 8. Coconut Fibers

Coconut fibers are typically imported from Southern Asian countries. Coconut is considered a durable long-lasting material. Thick, heavy mats do provide good protection, but if products are too thick, they can impede vegetation growth. Coconut is generally considered to have a poor carbon footprint. Coconut fibers introduce a nonnative matrix into the environment and their dark color may cause seed burn out before germination.

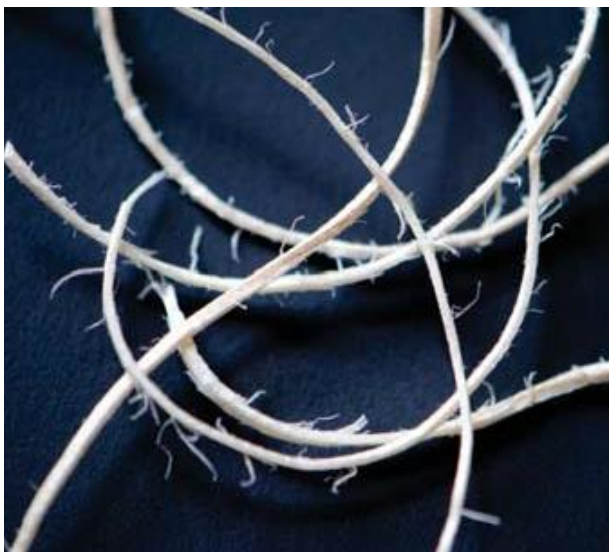
Figure 9. Curlex Fibers

Curlex excelsior fibers are a superior natural fiber for many reasons. Curlex expands and contracts to conform to irregularities and mechanically bind to the soil. Curlex has engineered curls and barbs (see Figure 9). Curlex has a higher Manning's n than straw. That "roughness" slows water velocity, resists shear stress, holds the blanket in place, and captures sediment from overland flow. Curlex is made from Great Lakes Aspen, which is naturally seed-free and domestically sourced from members of sustainable forestry programs. Unlike pine excelsior, Curlex contains no pitch or resin. Curlex fibers are listed as an EPA approved sorbent, which proves their effectiveness at removing polynuclear aromatic hydrocarbons (PAHs) from contaminated stormwater.

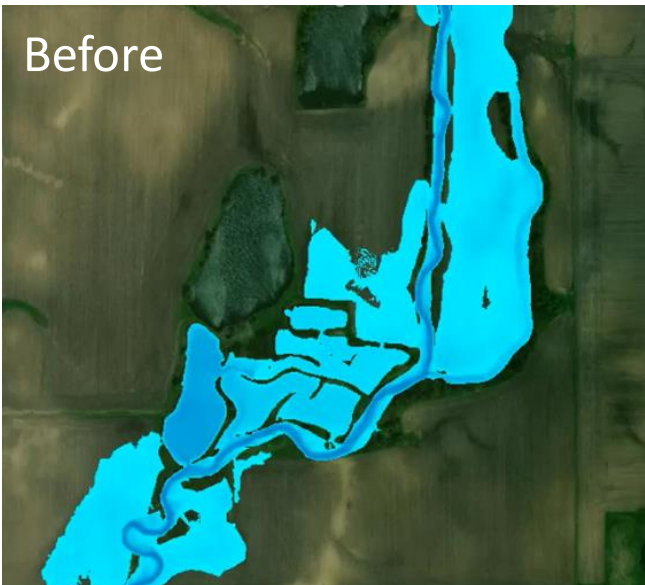
Figure 10. Before improvements, a large portion of the floodplain on the east side of the stream was not connected to the stream. This resulted from a large spoil pile that was left remaining from the gravel mining operation during the 1950s. A large portion of the west flood plain was only connected through water backing up through the remnant gravel pits. Water flowed rapidly across the east side of the flood plain, exiting quickly through a culvert with a flap gate.

The models below show the site before and after improvements (see Figures 10 & 11).

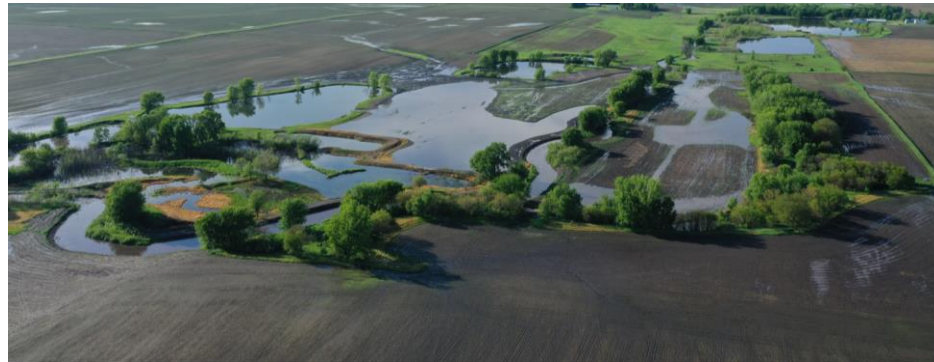
Figure 12. Flood Event

Work on the mitigation project was completed in March 2020. Just six short weeks later, there was a major flood event that could have had a significantly negative impact on the project (see Figure 12). Vegetation had not yet had the time to fully establish (see Figure 13). The only protection was the rip rap and the Curlex ECBs. The installer knew that Curlex excelsior fibers do not float, and that ensured they stayed in place, even under significant hydraulic forces. The installer also knew Curlex ECBs are proven to prevent erosion. What impressed the installer was the ability of the Curlex ECBs to capture a great deal of sediment flowing down the stream (see Figure 14). After the storm, there was 3-4 inches of sediment trapped by the Curlex ECBs along entire length of project. This sediment capture and retention prevented the sediment from flowing downstream, causing other problems.

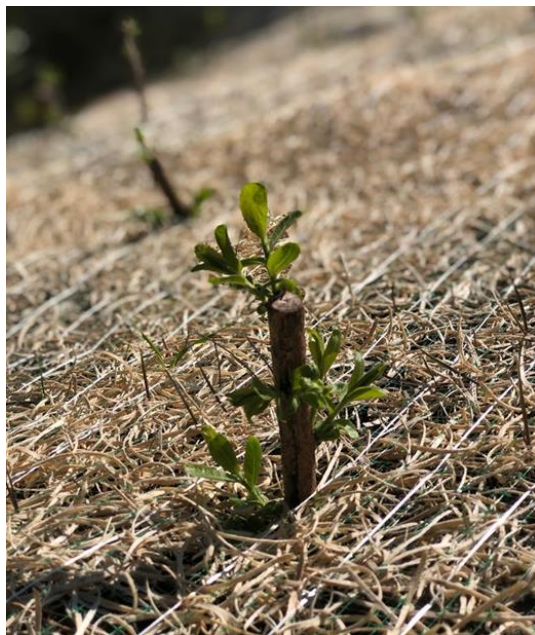
Figure 13. Black Willow Pre-Flood May 8, 2020

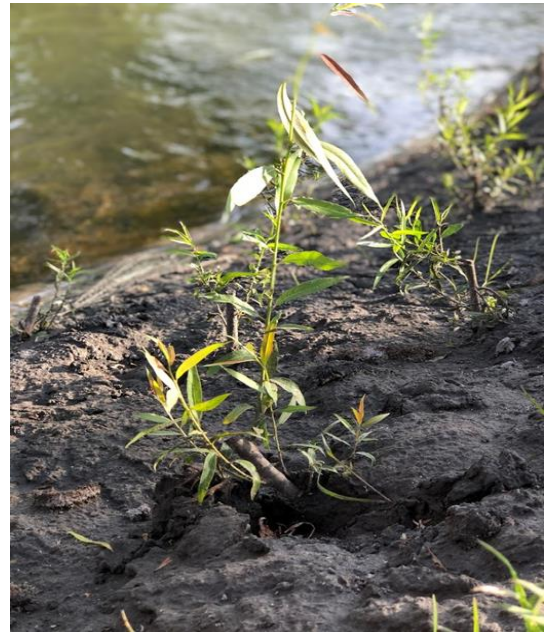
Figure 14. Black Willow Post-Flood June 14, 2020

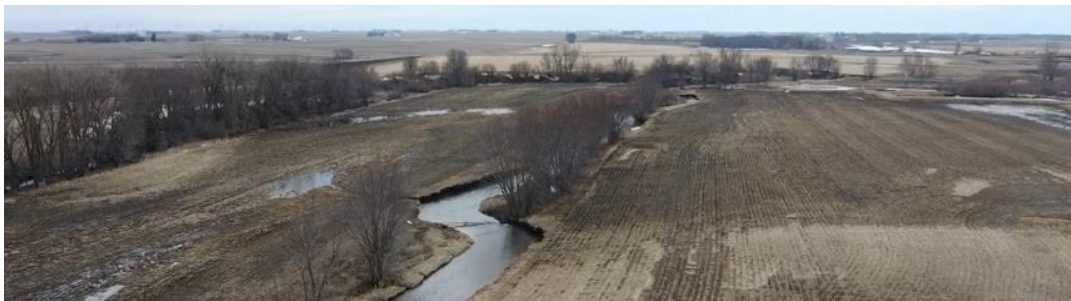
Figure 15. White Fox Before Mitigation Bank Restoration

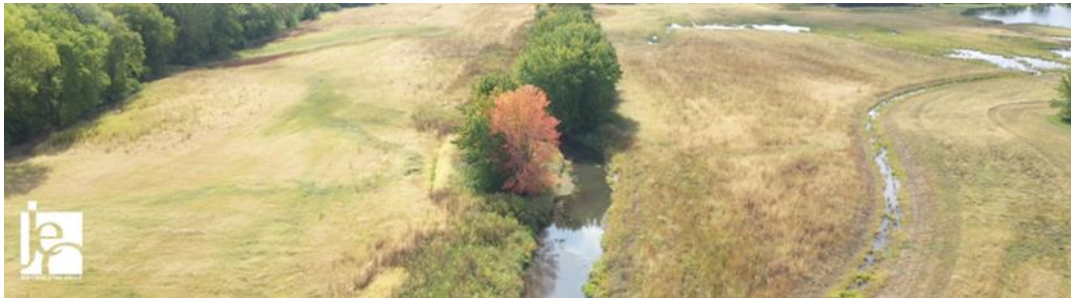
Figure 16. White Fox After Mitigation Bank Restoration

The designed site changes and BMPs used on the mitigation project have proven to be a success. The objectives have been met. The mitigation bank project created an ecologically sound restoration that avoided impacts to adjacent agricultural land, created resiliency, reduced downstream flooding, and maximized the potential value to the owner (see Figures 15 & 16). The site will be monitored over the next ten years to document the succession of the vegetation, hydrology, soils, aquatic life, and terrestrial vertebrates.
