Protecting Landfills with Rolled Erosion Control Products

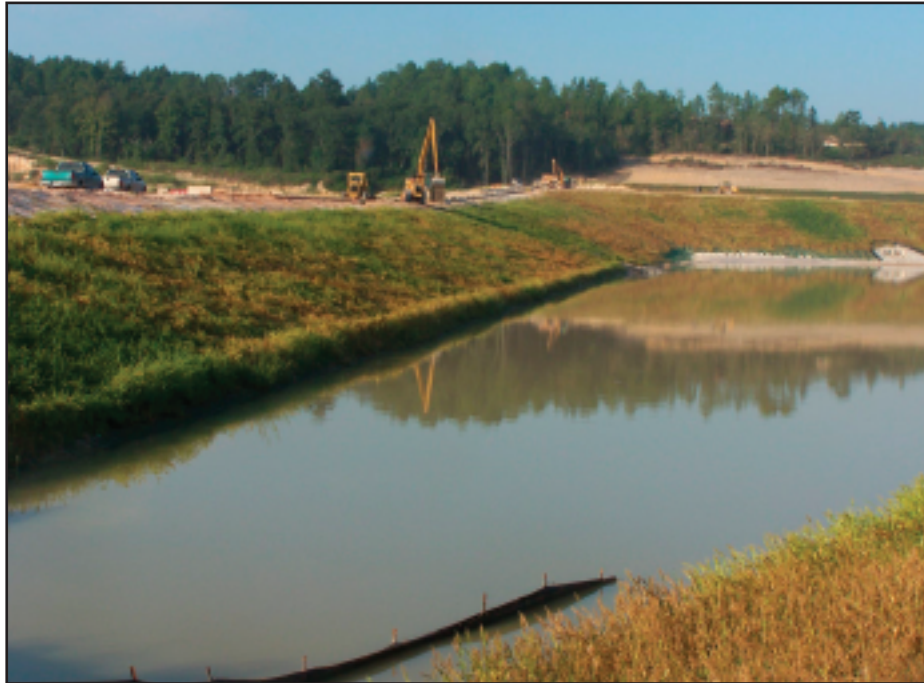
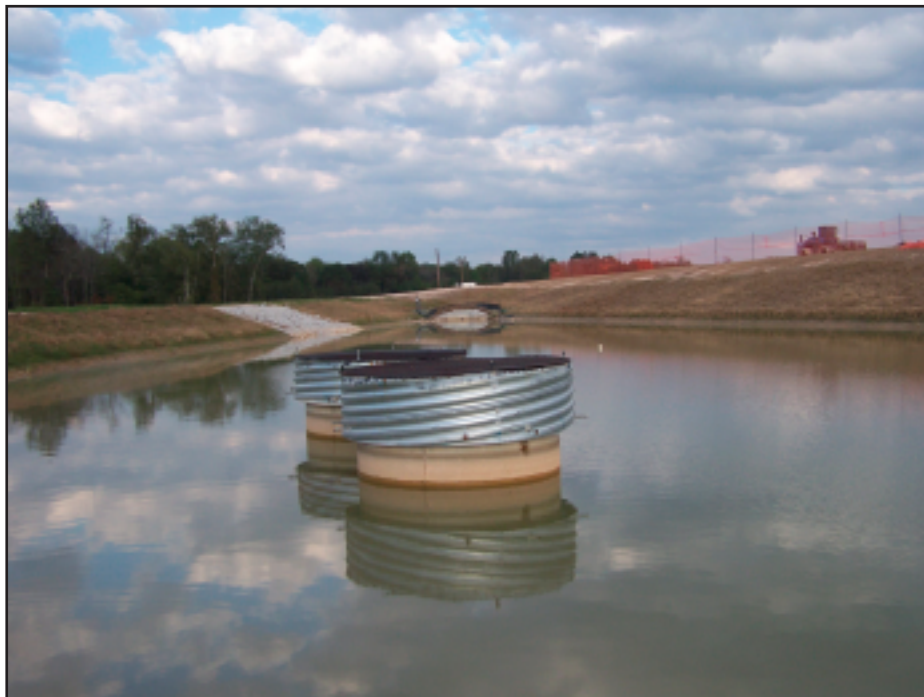
Top: Landfill expansion continues behind stormwater ponds. Below: Overflow structures in stormwater pond.

Environmental regulations in the state of Georgia required stormwater ponds for the landfill expansion based on the drainage area that will be disturbed. Stormwater ponds minimize flooding by

retaining runoff that would otherwise exit the site and potentially end up in nearby water bodies. In addition, sediments in the runoff settle out as flow velocities are greatly reduced in ponds.

The new section of the landfill contained an approximate 80 acre drainage area. Jordan, Jones, and Goulding, project engineer from Norcross, GA, designed two stormwater ponds for the site. The three acre and five acre ponds were designed to a 25 year storm event

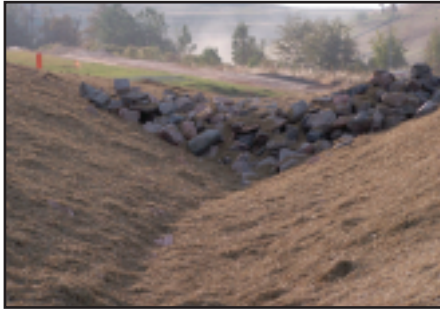
Rock check dam in ditch.

The general contractor for the expansion project, Cooper, Barnette, and Page (CBP) from Statham, GA, completed all earthwork activities including the excavation of both stormwater ponds. Rock rip rap check dams were installed to reduce flow velocities in down chutes leading to the ponds. CBP also installed silt fence lined with straw bales around the head-wall of the rip rap structures to prevent sediment from filling in the down chutes.

Little maintenance will be required at the site for years to come. Proper erosion control and stormwater planning prevented many potential maintenance issues. Silt fence lined with straw bales successfully kept the rip rap down chutes free of sediment. Rock check dams successfully reduced flow velocities,

which prevented scouring in the areas of concentrated flow. Erosion control blankets successfully protected the erodible slopes, which kept the soil on the slopes and out of the stormwater ponds. Lastly, the stormwater ponds safely and effectively contained runoff volumes from the drainage area.

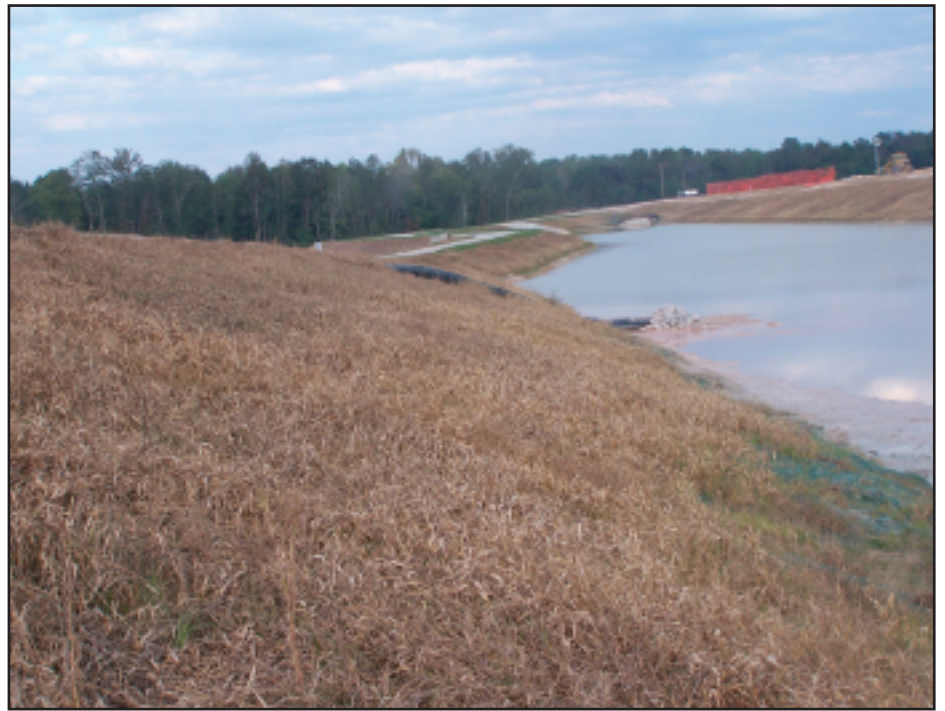
Vegetated side slope of stormwater pond.

The first step to protecting the slopes was to spread three inches of topsoil material across the surface. The topsoil material provided the necessary nutrients and organic matter for the vegetation to become established. The curled excelsior matrix of the ECBs enhanced the establishment of vegetation by storing moisture and slowly releasing it to the soil. The addition of topsoil coupled with the ECBs ensured a dense stand of vegetation that would ultimately provide permanent erosion protection to the pond slopes.

All slopes were seeded with a mixture of Brown Top Millet (*Panicum ramosum*), Common Bermuda grass (*Cynodon dactylon*), and the Pensacola variety of Bahia grass (*Paspalum notatum*). Brown Top Millet is an annual grass that provides excellent temporary erosion control

The vegetation flourished as it grew through the excelsior matrix. This is important because vegetation may struggle to penetrate denser and thicker products, which causes the product to be lifted upward. This process is sometimes referred to as product "tenting" and results in the loss of intimate contact between the product and the soil surface. Intimate contact between an ECB and the subgrade is a critical component to successful erosion control before vegetation becomes established.
