The Pikeview Quarry (see Figure 1), located on the eastern edge of the North American Rocky Mountains near Colorado Springs, CO, began operations in 1903. During the next 115 years, it supplied approximately half of the limestone used to build the city plus the limestone for the concrete used to construct the nearby United States Air Force Academy campus (source: www.pikeview.org).

Project Scope

The Plan

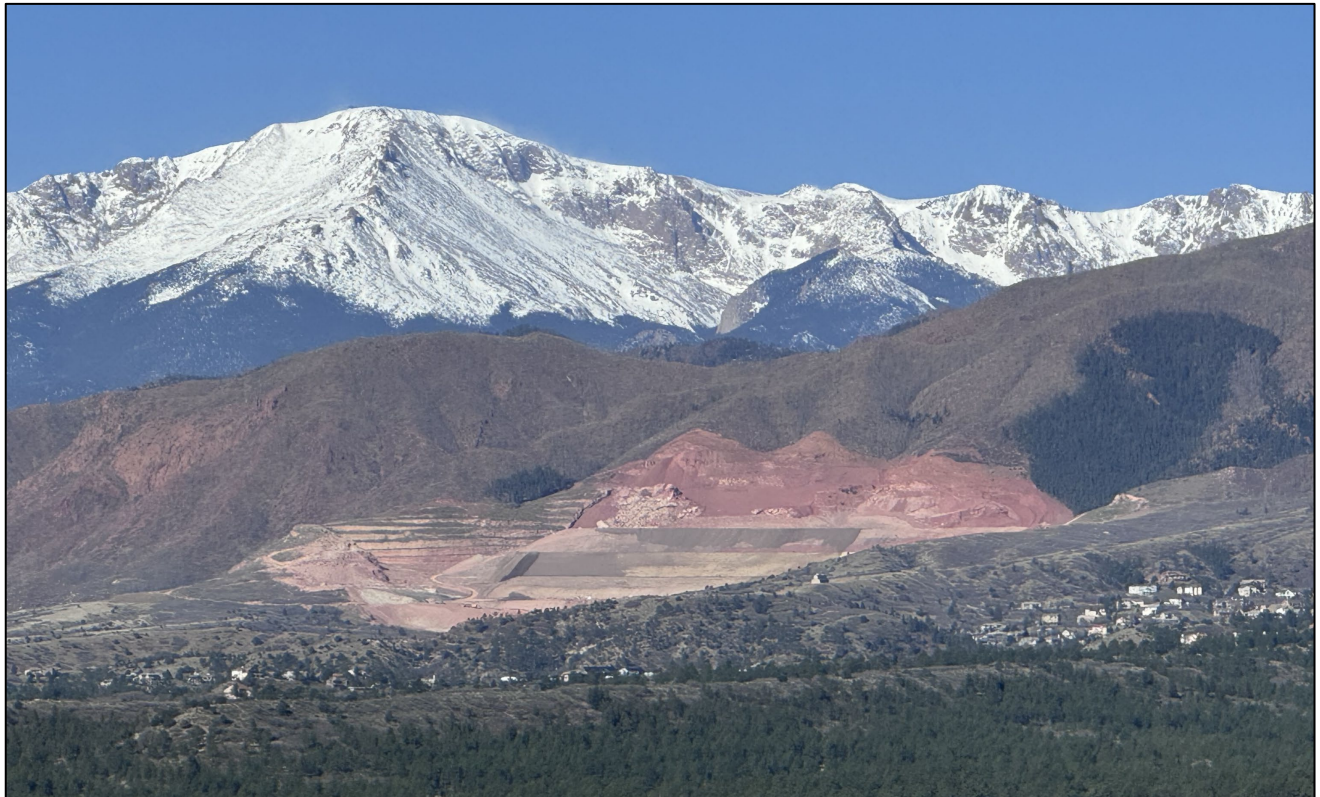
Figure 1: View of the Pikeview Quarry site (center of photo) with Pikes Peak (of the Front Range of the Rocky Mountains) and homes in the city of Colorado Springs for scale.

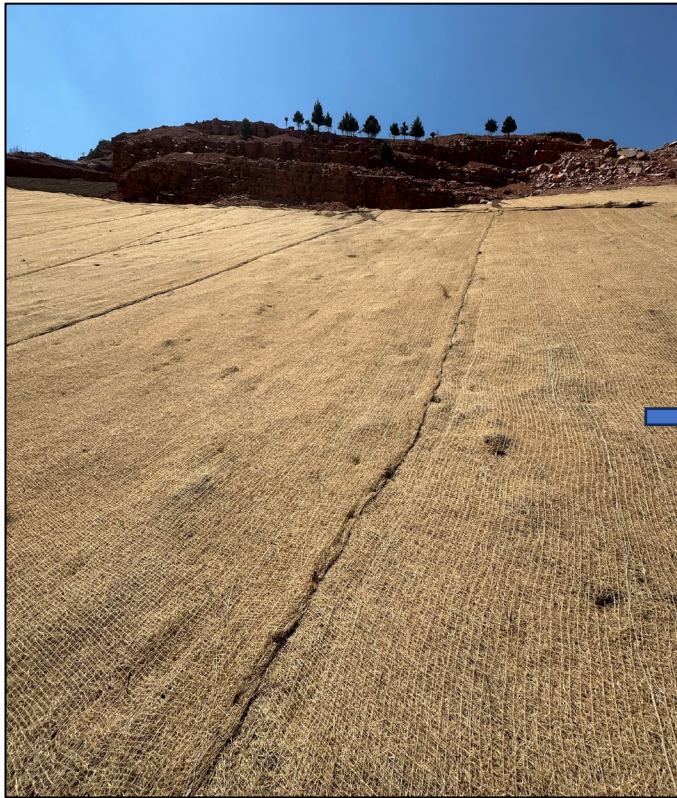
Figure 2: Curlex II FibreNet installed on a mountain slope with openings for tree plugs cut into the blanket.

A combination of drill seeding, biotic soil media, and fertilizer was chosen to revitalize the Quarry's soils and aid forthcoming vegetative growth on the slopes. Next, over 422,000 yd² of both 8' and 16' Curlex® II FibreNet™ erosion control blankets (ECBs), manufactured by American Excelsior Company®, were used to provide a 100% natural and wildlife/environmentally friendly cover against erosion (see Figure 2). Backed by decades of proven performance, the Curlex® ECBs helped foster superior germination and vegetative establishment conditions for this vulnerable seedbed.

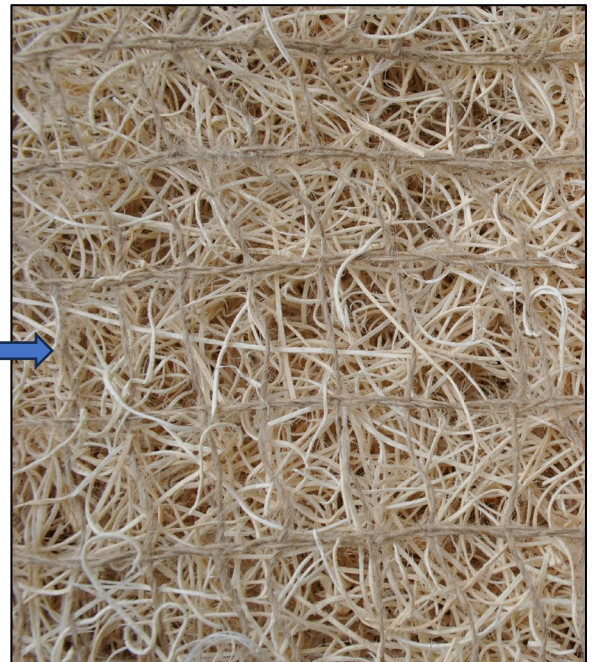
Figure 3: Close-up image of Curlex II FibreNet.

Curlex ECBs provide these benefits largely due to the natural mechanical functions of their fibers (see Figure 3). These Great Lakes aspen fibers are engineered to be curled and barbed, forming a “Velcro-like” connection that conforms to irregularities in the soil once installed. The curls and barbs also give the fibers a high Manning's *n* (hydraulic roughness) value relative to other ECB fibers, which decreases the amount of energy that sheet flow transfers to the soil and seedbed during precipitation events. A higher Manning's *n* helps slow water flow, increase water infiltration, and keep the underlying seed and soil in place.

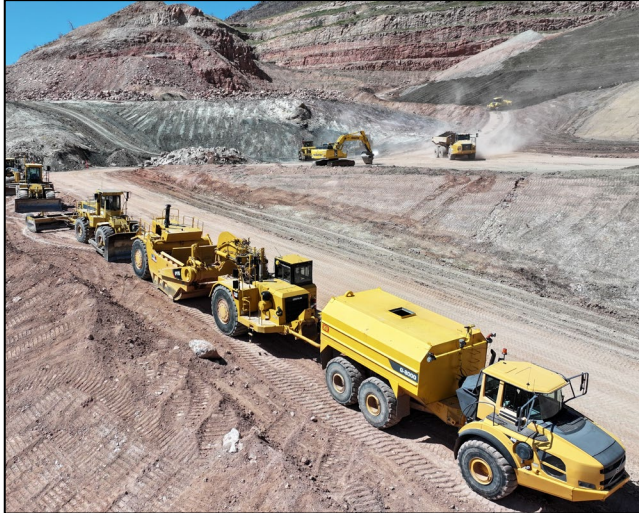
Figure 4: Heavy-duty vehicles and equipment transporting soil and other materials at the Quarry site.

Proper installation of specified BMPs is key to the success of any project. The following images highlight some of the key installation processes specific to this project (see Figures 4, 5, and 6).

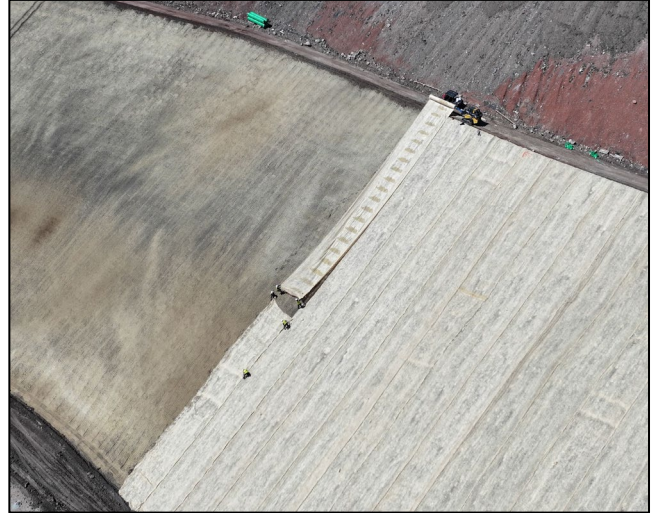
Figure 5: Aerial view of Curlex II FibreNet installation on one of the mountain slopes.

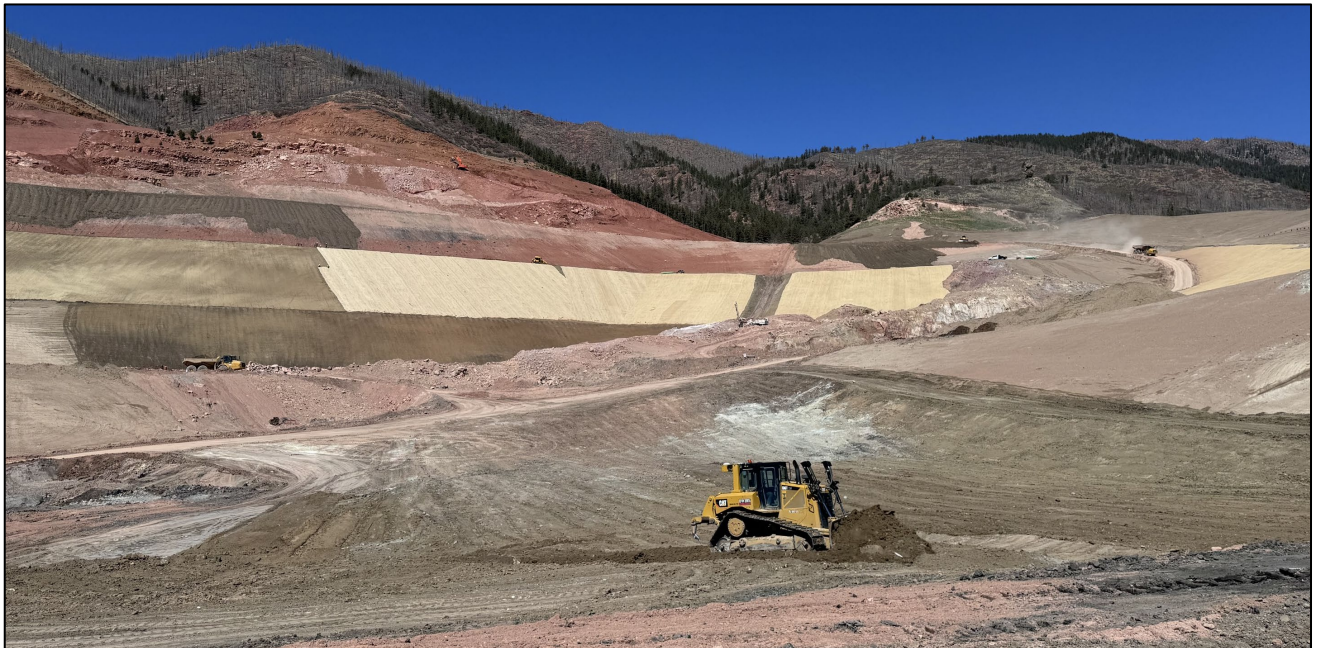
Figure 6: Landscape view of a section of the project with active grading occurring in the foreground and Curlex II FibreNet ECB installation in the background.

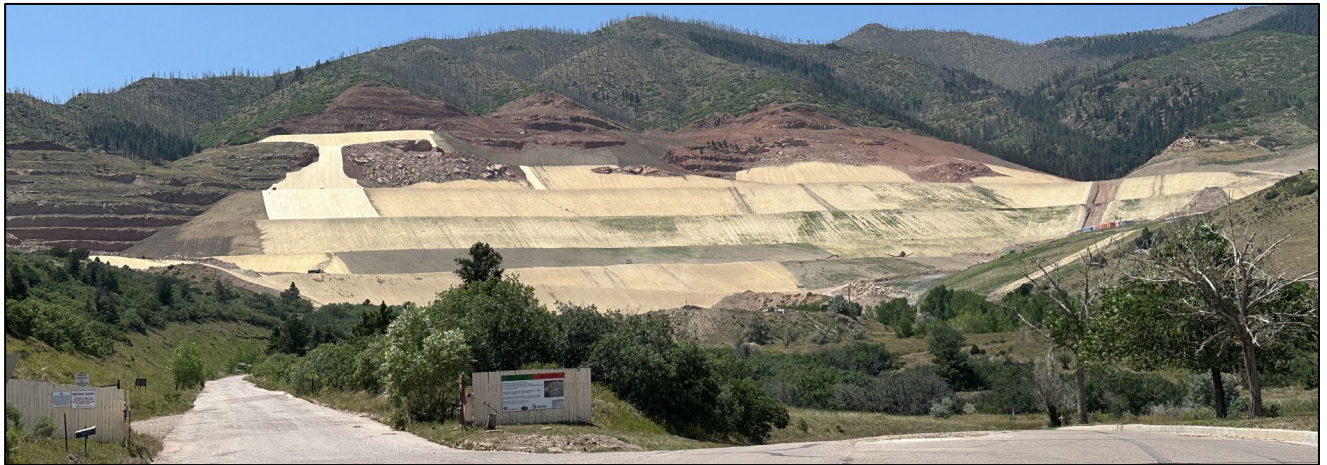
Figure 7: Landscape view of the Quarry site once all ECB installation had been completed.

By late July, all of the Curlex II FibreNet ECBs had been installed (see Figure 7). Vegetation had begun to emerge underneath the installations completed in late Spring (see Figure 8), and local wildlife was spotted traversing the site (see Figure 9).

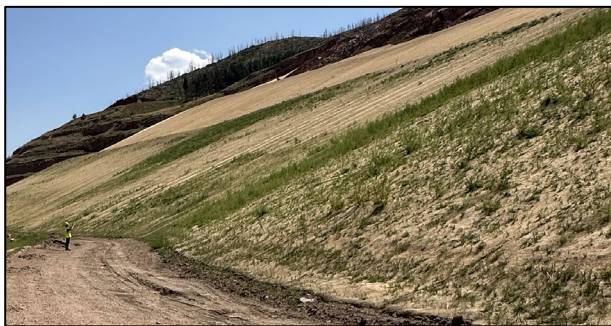
Figure 8: Emerging vegetation on one of the mountain slopes. The person on the left is shown for scale.
