Introduction

A series of swales on a Wisconsin farm are responsible for draining nearly 800 total acres of watershed. Three years ago, remediation work was carried out on the swales, and blown straw was chosen as the erosion control Best Management Practice (BMP). However, precipitation events over the following two years, including a spring downpour of 2.5" of rain within 45 minutes, washed away most of the topsoil and blown straw. Needless to say, the first attempt at completing this project failed because the selected BMP did not protect against erosive forces from concentrated flow, meaning more time and money were required to restore the site.

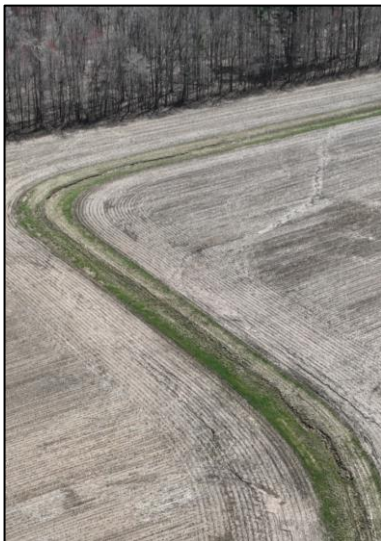
Figure 1: Aerial view of one swale on the property before excavation. Notice the large gully running down the middle of the swale from years of erosion.

To have the ability to withstand future flood events, the swales needed to be cleared of existing vegetation, widened, seeded with cool-season grasses, and covered by an appropriate erosion control BMP. The selected BMP had to be capable of dissipating energy from hydraulic forces, such as those generated by concentrated flow, while maintaining intimate contact with the subgrade and fostering proper seed germination and vegetation establishment conditions.

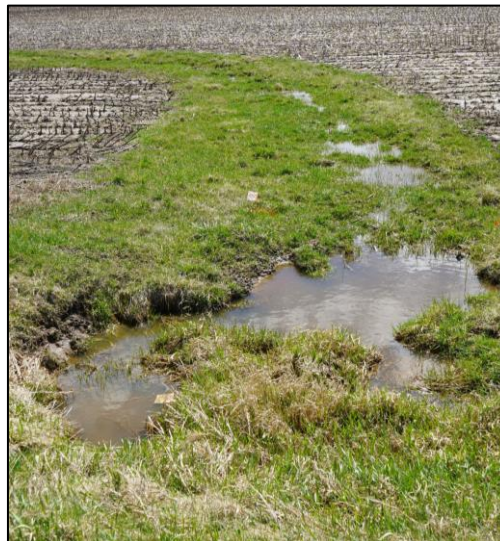
Figure 2: Surface view of one of the swales before excavation. The standing water from a prior precipitation event illuminates voids in the subgrade that resulted from years of erosion.

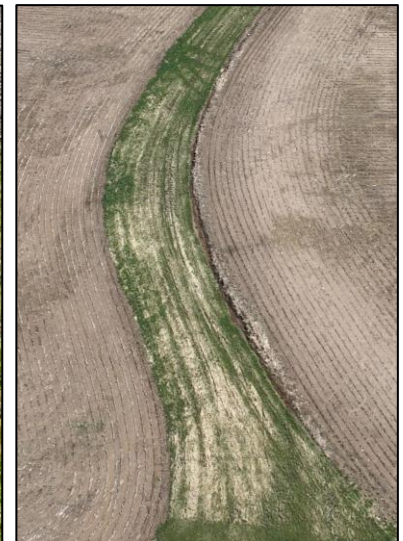
Figure 3: Aerial view of one of the swales before excavation. Notice the large gully running along the right side of the swale from years of erosion.

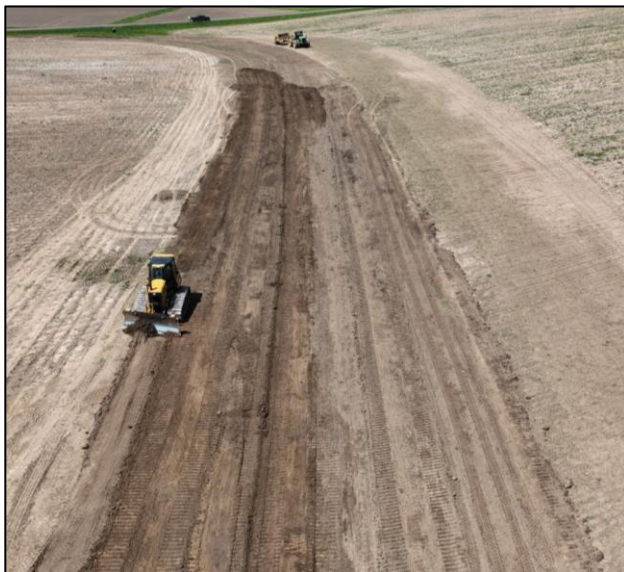
Figure 4: Heavy equipment performing grading work to widen one of the swales after its vegetation was cleared.

Proper installation of specified BMPs is key to the success of any project. The following images highlight some of the key installation processes specific to this project (see Figures 4 and 5).

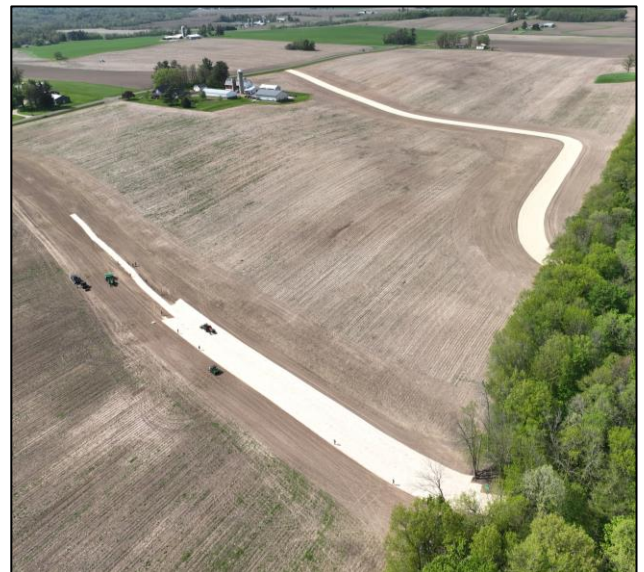
Figure 5: Curlex II ECBs being installed in 8' widths to cover each swale.

Curlex® II, a double-netted erosion control blanket (ECB) with a fully biodegradable Great Lakes aspen excelsior (Curlex®) fiber matrix, was selected as the BMP for this project.

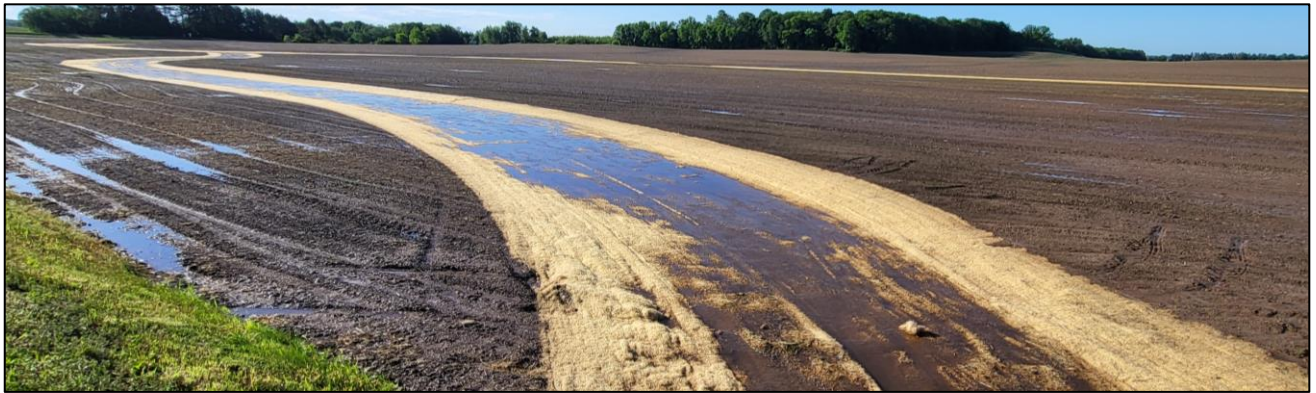
The project site experienced above-average rainfall during the months immediately following the excavation, seeding, and ECB installations. When a local conservation official visited the farm approximately two weeks after the ECB installations had been completed, he remarked that there was minimal observable erosion and that vegetation along the swales' sides "came in beautifully". However, they also noted that some of the seeds had failed to germinate in the centers of the swales because they had drowned. Figure 6, taken after a 0.75" rain event, illustrates the reason for this outcome. The combination of naturally shallow gradients (~0.4%), low-infiltration silty soils, and compaction from grading activities resulted in soil saturation issues that drowned the seeds in these areas.

Figure 6: Among other factors, this swale's gradient is ~0.4%, allowing water to pool easily after extensive precipitation.

The swales were re-seeded in hopes of revegetating the centers before cold seasonal temperatures arrived. Unfortunately, right after re-seeding, the rainy summer ushered in a comparatively dry early fall. Still, the Curlex II's fibers captured moisture from the air and rainfall and returned it to the soil and seed bed, thus fostering vegetation establishment (see Figure 7).

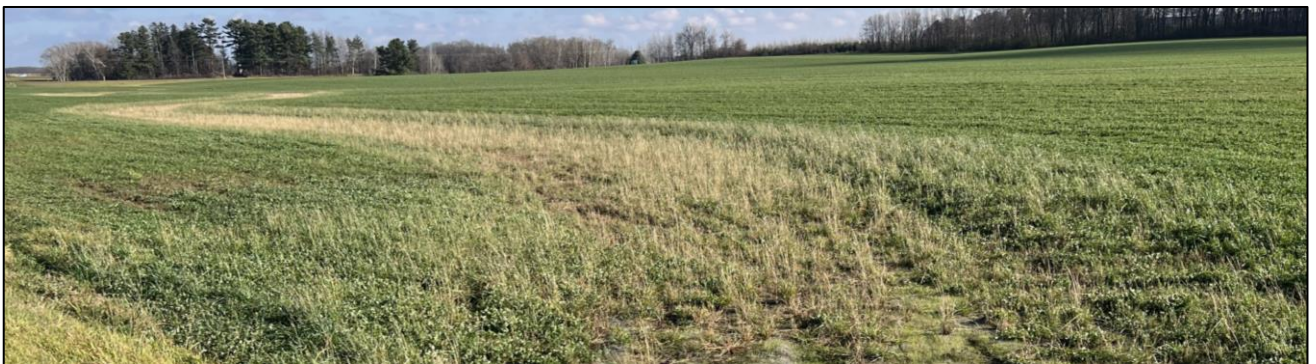
Figure 7: Photo of the swale in Figure 6 taken in November, a few weeks after the drowned seeds were replaced.

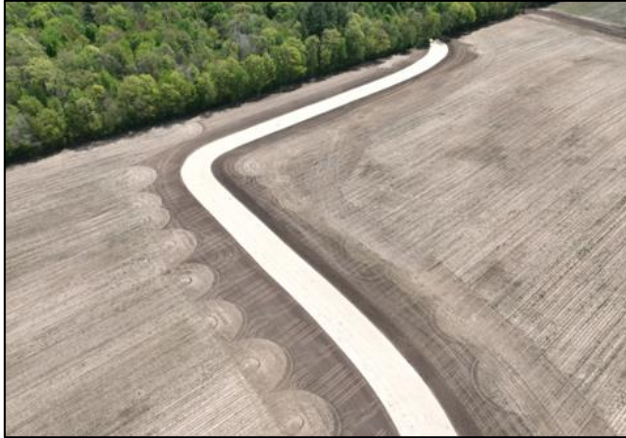
Figure 8: Aerial view of one of the swales shortly after Curlex II ECB installation (photo taken in late spring).

Amidst soil saturation issues, vegetation gradually emerged across the swales into the fall season because of the naturally insulating effect of the Curlex ECBs (see Figures 8 through 10).

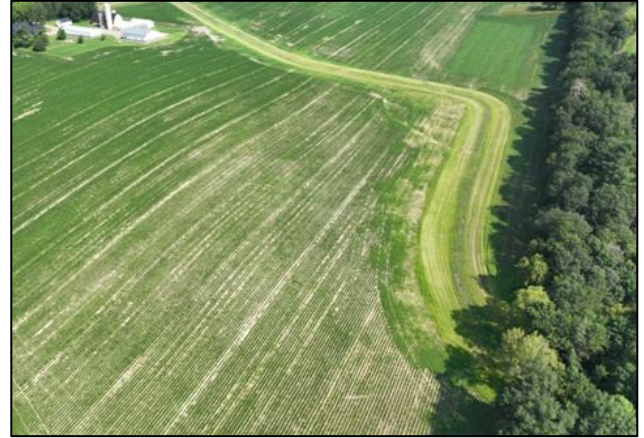
Figure 9: Aerial view of one of the swales (photo taken in mid-summer).

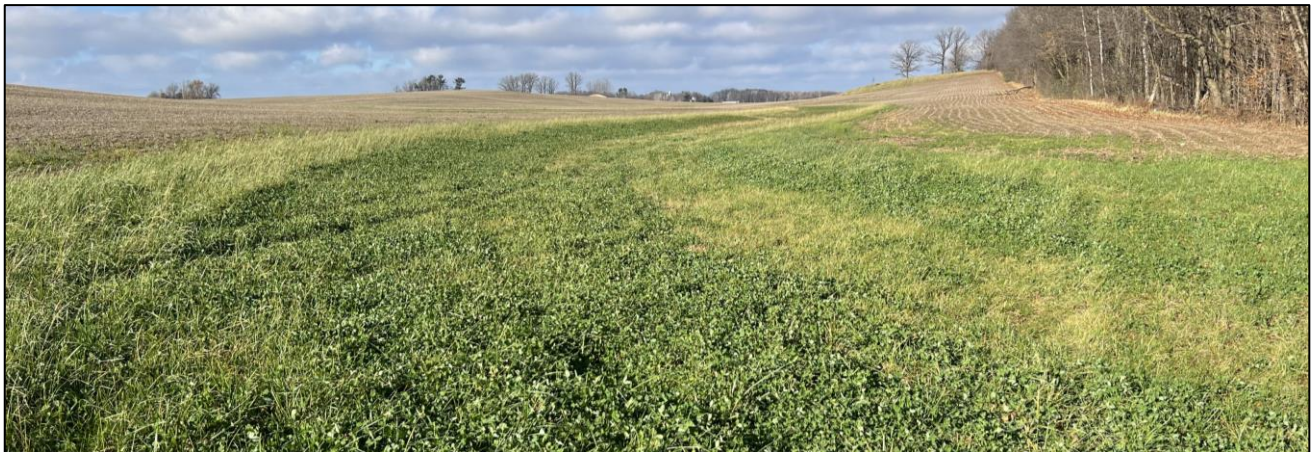
Figure 10: Surface view of one of the swales (photo taken in late fall).
