#### Introduction

# TriNet® Recyclex® TRM Stormwater Channel Remediation

Case Study - Vegetated Channel Solution

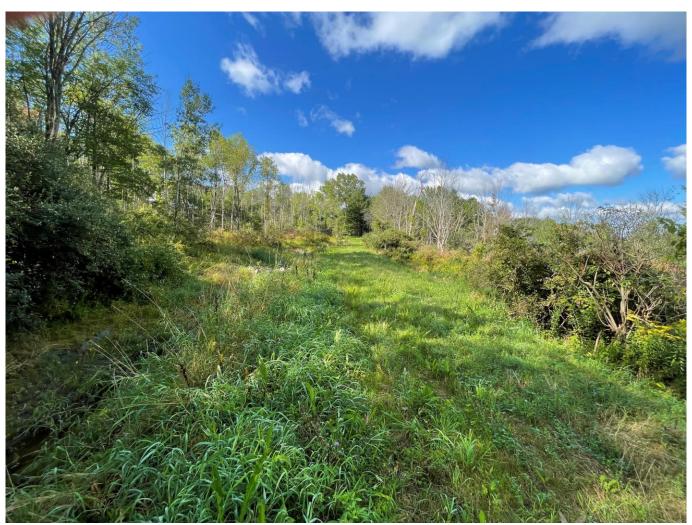
Figure 1. Vegetated Stormwater Channel Reinforced by TriNet® Recyclex® TRM

The decision was made to protect the land from erosion and scour by investing in a comprehensive overhaul of the failing stormwater channel system (see Figure 1).

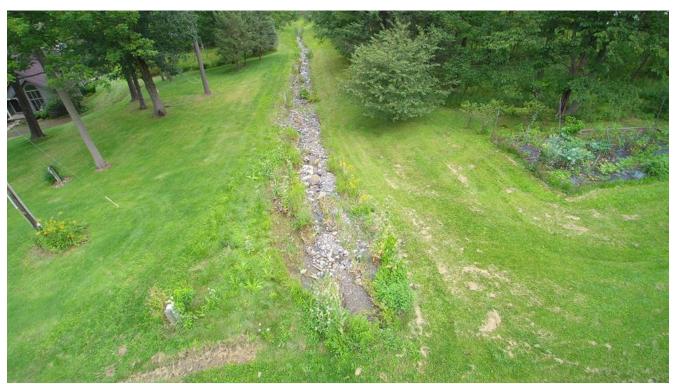
No modern Best Management Practices (BMPs) were used in the original channel design, so property damage and maintenance problems occurred with each large rainfall and snowmelt event. Extensive soil erosion in the channels was an eyesore, and during large rain events, the stormwater volume exceeded the containment capacity of the existing channels.

To complicate matters, upstream channels that crossed private property were altered for aesthetic purposes over the years. These alterations significantly reduced the system's ability to slow the water velocity entering the lower channels. The existing stormwater channels were lined with rip rap and had eroded swales approximately 4' wide and 24" deep (see Figure 2).

Figure 2. Outdated and Eroded Stormwater Channel

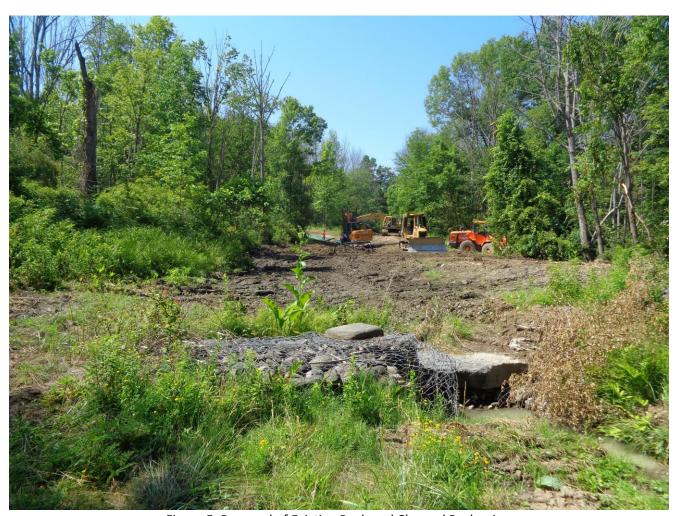
Existing channels were excavated, and the existing rock channel bottom was removed. The channels were then reshaped, deepened, and widened to create more stormwater capacity and stormwater infiltration (see Figure 5). After excavation was completed, the channels were compacted and fine graded to remove any rills. The contractor also made sure that the channel was free of obstructions such as tree roots, large rocks, and other foreign objects. Topsoil was evenly distributed at a depth of 4" to prepare for seeding then the TRMs and ECBs were installed.

Figure 5. Removal of Existing Rock and Channel Reshaping

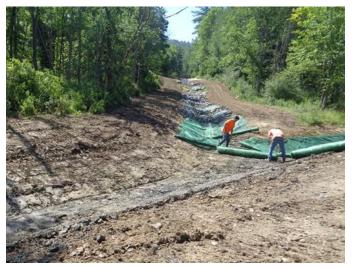
After the channels were repaired and reshaped, they were seeded and fertilized. A cover crop of grain rye was applied at 20 lb/ac and the specified upland low-growing wildflower and grass mix was applied at 30 lb/ac. After the seeding was completed, the swales were lined with TriNet Recyclex and new rock check dams were installed on top of the TRM. Side slopes were covered with AEC Premier Straw ECBs (see Figures 6-9).

Figure 6. Installation of TriNet Recyclex

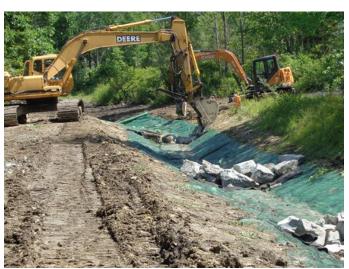
Figure 7. New Rock Check Dams Over TriNet Recyclex

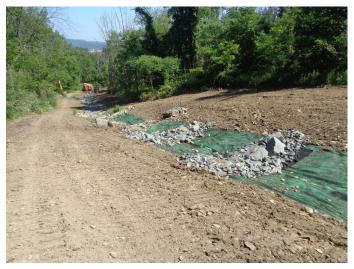
Figure 8. TriNet Recyclex and New Rock Check Dams

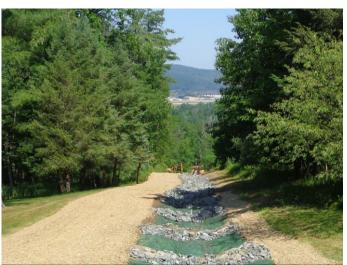
Figure 9. AEC Premier Straw Installed Outside Channel

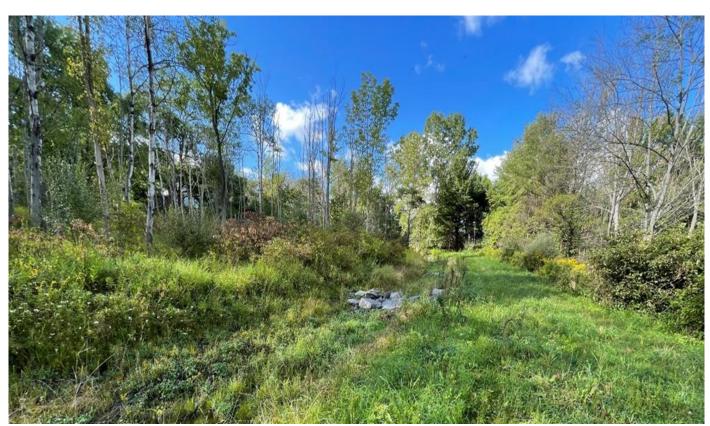
In total, more than 6,500 yd<sup>2</sup> of TriNet Recyclex TRMs and 3,000 yd<sup>2</sup> AEC Premier Straw ECBs were used on the complex, ecologically sensitive two-mile long project (see Figure 10).

Figure 10. Completed Vegetated Swale Reinforced by TriNet Recyclex TRM

The design team understood the shear stress capability of vegetation alone would not survive the design flows of the channel. TriNet Recyclex TRMs successfully protected the channels and reinforced the vegetation, allowing it to withstand high stress events and to carry runoff from the site. Paired with rock check dams, the BMPs protected the site and surrounding area.
