## Introduction

The Town of Big Flats, New York had a challenging series of stormwater channels on a public right-of-way. The series of stormwater channels transported rainwater and snowmelt that originated from a steep hill, crossed right of ways, and eventually emptied into a stream. The long downhill run caused concentrated flows in the channels that temporary rolled erosion control products (RECPs) could not withstand.

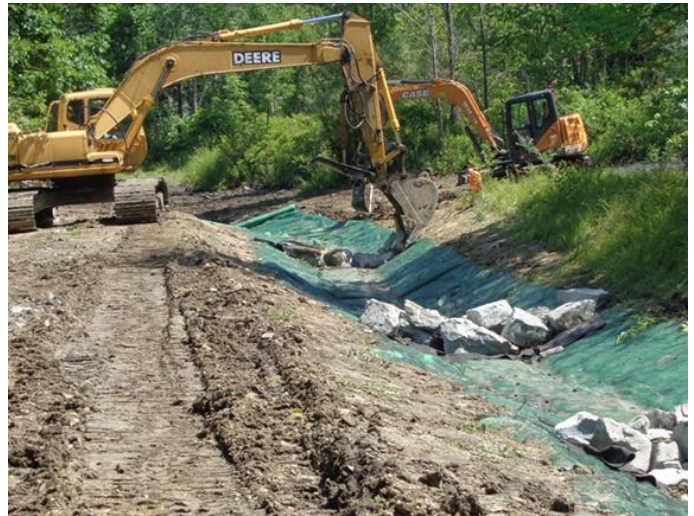
Figure 7. New Rock Check Dams Over TriNet Recyclex

After the channels were repaired and reshaped, they were seeded and fertilized. A cover crop of grain rye was applied at 20 lb/ac and the specified upland low-growing wildflower and grass mix was applied at 30 lb/ac. After the seeding was completed, the swales were lined with TriNet Recyclex and new rock check dams were installed on top of the TRM. Side slopes were covered with AEC Premier Straw ECBs (see Figures 6-9).

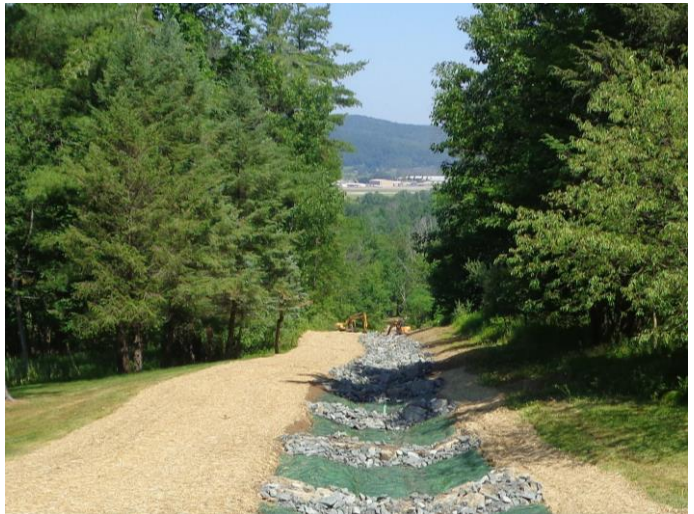
Figure 9. AEC Premier Straw Installed Outside Channel

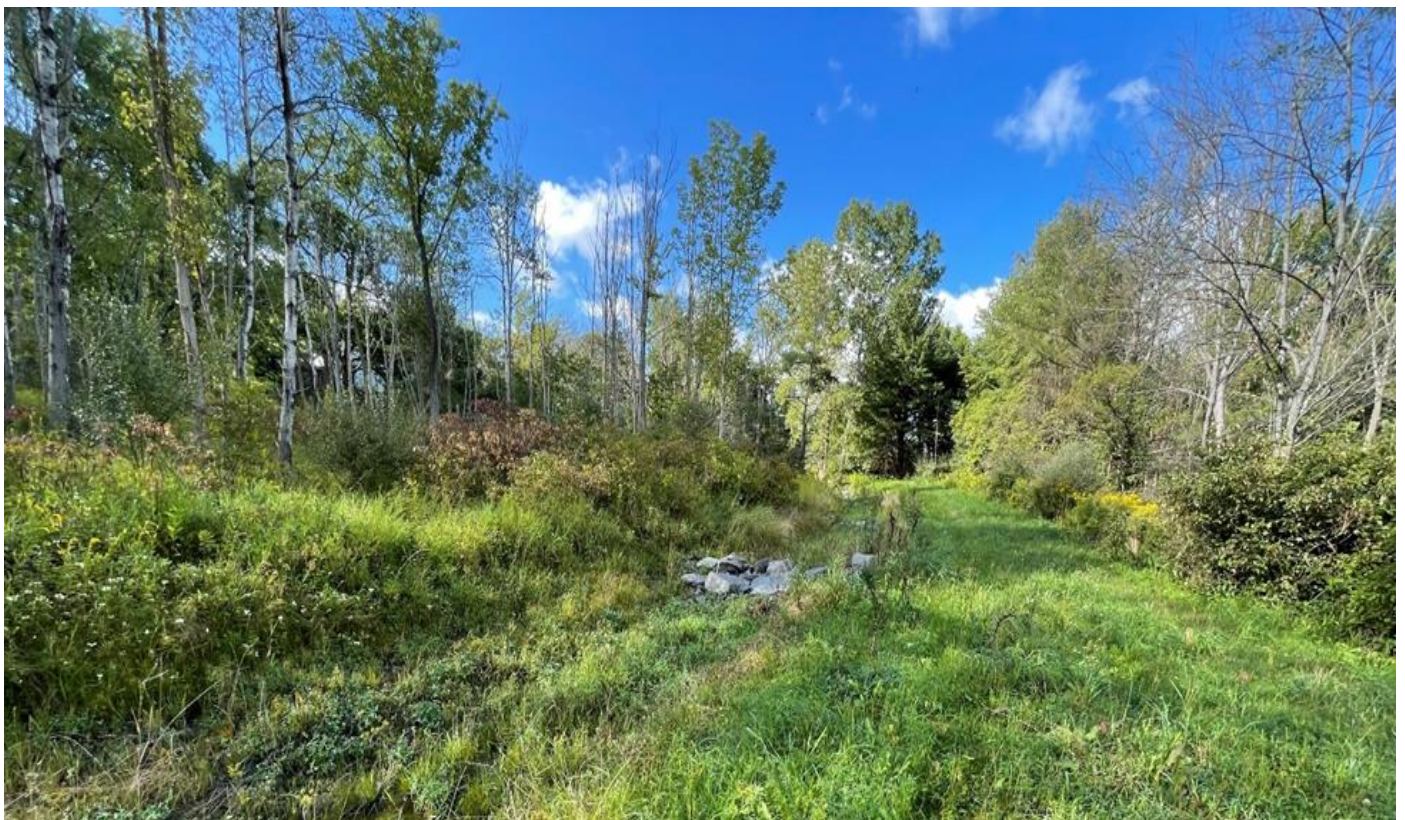
Figure 10. Completed Vegetated Swale Reinforced by TriNet Recyclex TRM

The design team understood the shear stress capability of vegetation alone would not survive the design flows of the channel. TriNet Recyclex TRMs successfully protected the channels and reinforced the vegetation, allowing it to withstand high stress events and to carry runoff from the site. Paired with rock check dams, the BMPs protected the site and surrounding area.

In total, more than 6,500 yd<sup>2</sup> of TriNet Recyclex TRMs and 3,000 yd<sup>2</sup> AEC Premier Straw ECBs were used on the complex, ecologically sensitive two-mile long project (see Figure 10).
