# Revisiting a Classic-IDOT Route 6 Project

## A Case History - Chillicothe, Illinois

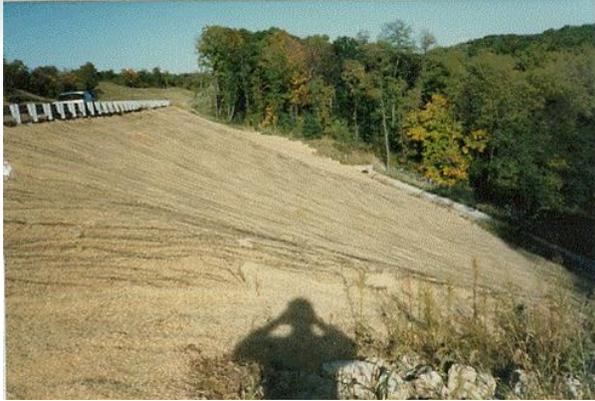
**Figure 1.** Curlex HV slopes in 1987.

All slopes consisted of loam soils and were seeded with IDOT standard roadside mix, which is comprised mainly of perennial rye, red fescue, and blue grass. 55,000 yd<sup>2</sup> of Curlex HV were installed on the steep road side slopes (1.5H:1V up to 200 ft long) and ditch bottoms at a rate of 600 yd<sup>2</sup> per man hour. 145,000 yd<sup>2</sup> of Curlex I were installed on the slopes along the remaining 3,000 linear feet of the project at a rate of approximately 30,000 yd<sup>2</sup> per day. The majority of the Curlex I slopes were 2.5H:1V and contained one terrace to break up the 300 ft long slopes.

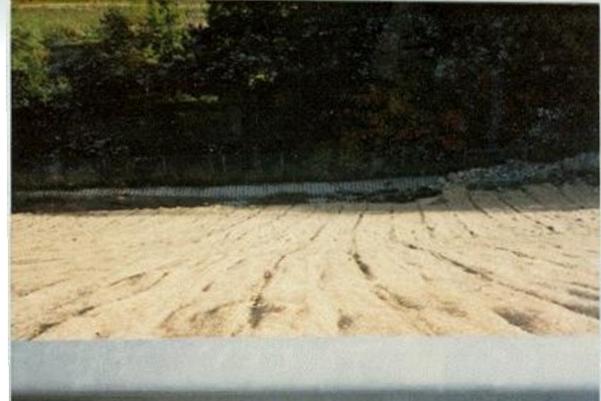
**Figure 2.** Steeper Curlex HV slopes 1987

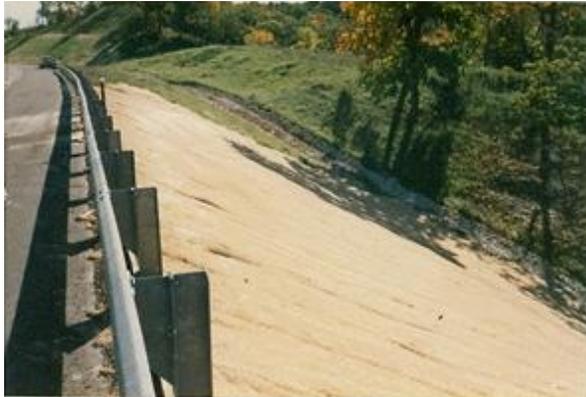
Figure 3. Curlex HV 1987.

Full vegetation was established on the 2.5H:1V Curlex I slopes after approximately 25 days. The steeper slopes were fully vegetated after approximately 30-45 days and the structural root system was established before the 1.62 lb/yd<sup>2</sup> of excelsior had degraded. All slopes were successfully protected along the project, which resulted in the roadbed being preserved and sediment-free runoff around the receiving water ways.

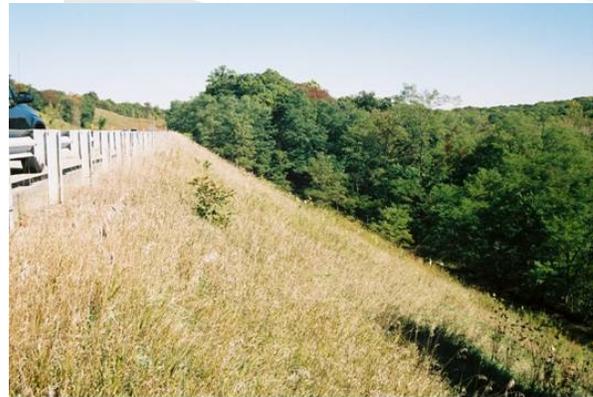
Figure 4. Figure 3 slope in 2004.

A look back at this exciting project shows the products did their jobs back in 1987. Curlex I slopes were established within a month and remain unblemished today. Curlex HV blankets did not biodegrade until almost four years after installation, thus the product provided heavy duty slope protection during the critical development phase of a structural root system into the long, steep slopes. The project remains a poster boy for the erosion control industry.

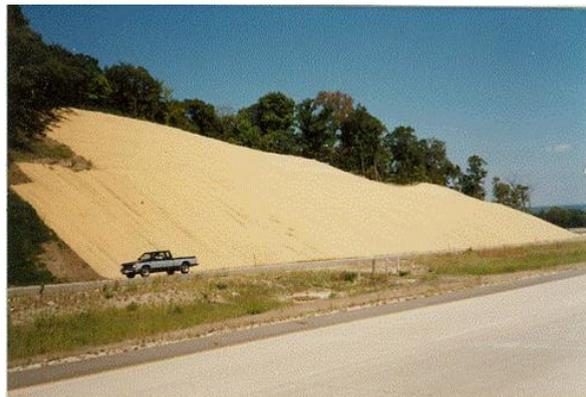
Figure 5. Curlex I slope 1987.

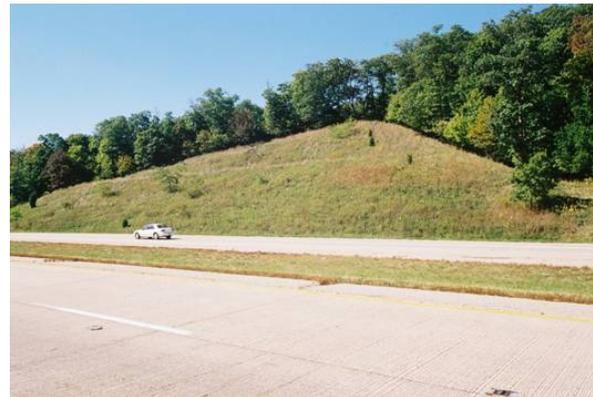
Figure 6. Figure 5 slope in 2004.
