INTRODUCTION

THE CHALLENGE

In spring 2015, the Iowa Department of Transportation (DOT) had a challenging 2.25 mile-long ditch median near the Interstate 80 Avoca interchange. The long run caused concentrated flows in the median that "standard" erosion control products would not withstand. Extensive soil erosion in the median was not only an eye sore to motorists, but the erosion was causing a public safety concern to the roadway. The project also crossed two branches of the Nishnabotna River so successful erosion and sediment control was a must to protect the precious waterways. As the project owner, the Iowa DOT turned to its specifications for special ditch control that allow double-netted aspen excelsior wood fiber ECBs or double-netted coconut fiber ECBs.

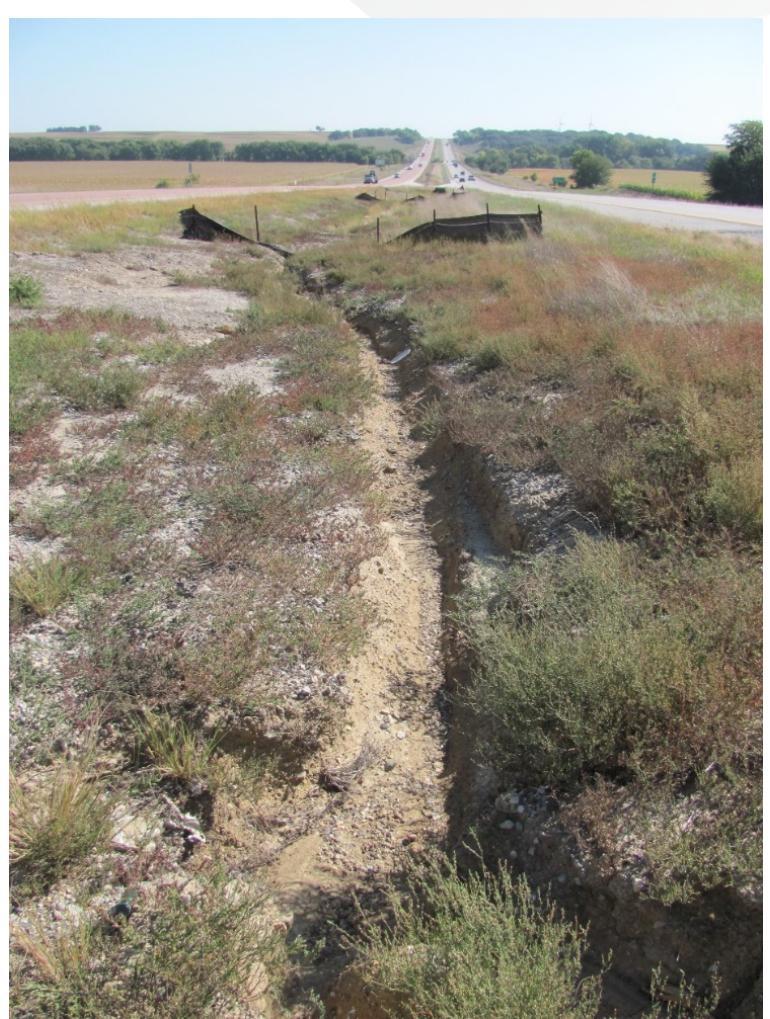
Figure 1. Before (September 2014): Increased hydrostatic pressure caused by the damming structures originally installed caused accelerated erosion in the highway median.

Damming structures previously used in the highway median had to be removed first because they caused accelerated erosion in the median. Increased hydrostatic pressure created by ponded water in front of damming products can initiate the erosion process. As the water depth and hydrostatic pressure increase, the downward force can cause scour directly under the dense object. As seen on a daily basis, moving water tends to take the path of least resistance. Thus, as downward force is continually increasing with water depth, the weakest point in the channel becomes the path of least resistance. Commonly, this weakest point in the channel is under damming devices. These basic physics commonly cause scour underneath damming products as seen in Figure 1. A direct conduit for contaminated runoff is created as soon as water scours under dense devices. When scour under a damming product occurs, it makes them almost obsolete in terms of environmental protection benefits because of the direct flow path under them.

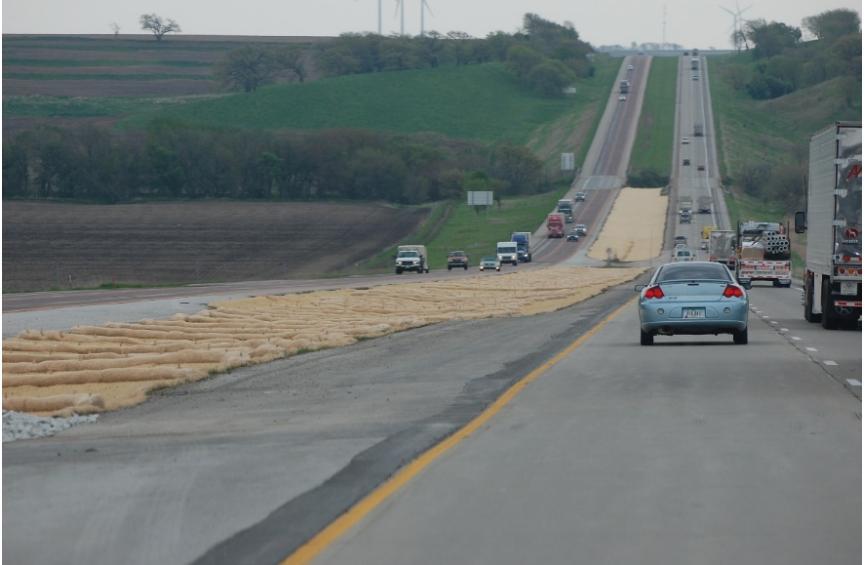
Figure 2. During (May 2015): Double-netted Great Lakes aspen excelsior erosion control blankets installed in conjunction with porous, filtering Great Lakes aspen excelsior sediment control logs to dissipate velocity and filter stormwater runoff before the median discharges into the Nishnabotna River.

scour in channelized flow applications. With this in mind, Curlex Sediment Logs were installed over the ECBs across the median, perpendicular to the flow of water to filter contaminated runoff and dissipate the flow velocity (see Figure 2). Engineered, curled and barbed Great Lakes aspen excelsior fibers containing 80 percent a minimum of 6 inches long that are 0.031 0.008 inches wide x 0.027 0.006 inches thick have been proven to be ideal for sediment control filtering matrices. Larger wood fibers, chunks, or chips tend to float during hydraulic events. Smaller wood fibers such as mulch-like materials or saw dust tend to compact too much resulting in a dense, damming matrix.

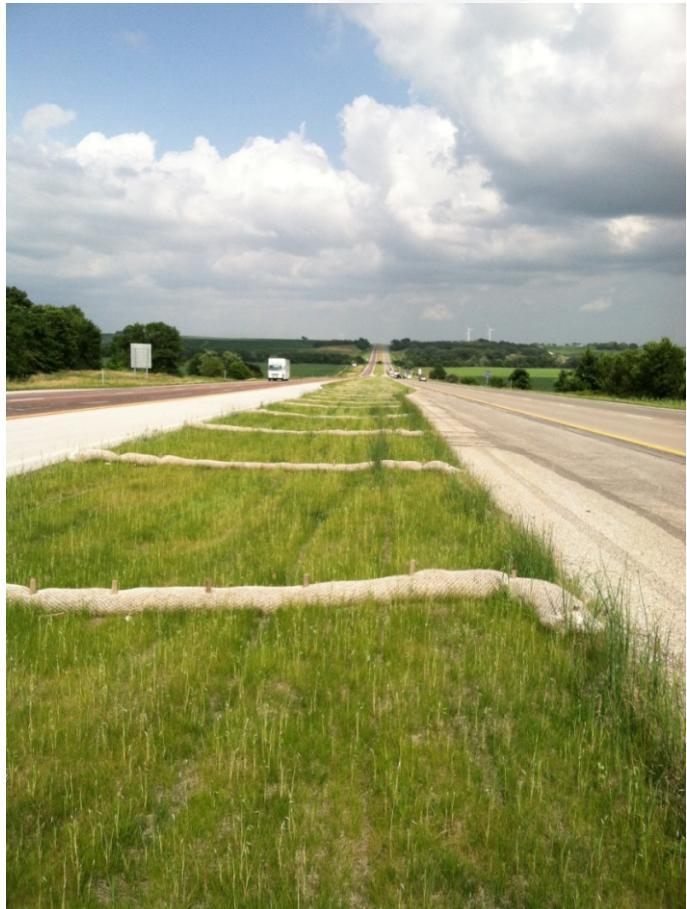
Figure 3. After (July 2015): The challenging highway median is becoming permanently stabilized by vegetation only approximately two months after installation of the Great Lakes aspen excelsior erosion control blankets and porous filter logs.

In total, more than 26,000 square yards of ECBs and 26,800 feet of filter logs were used in the sensitive 2.5-mile project. According to Heller, the vegetation establishment is great and the project has not had any noticeable erosion or visually contaminated flows discharging from it (see Figure 3). Heller summarized the project by stating, "We were able to resolve a public safety concern and make it more aesthetically pleasing by using quality erosion and sediment control products to meet our challenging conditions."
