Case Study – Residential Erosion and Sediment Control

Sustainably Sourced Curlex[®] & Recyclex[®] Products Tackle Residential Erosion Issues Case Study – Residential Erosion and Sediment Control

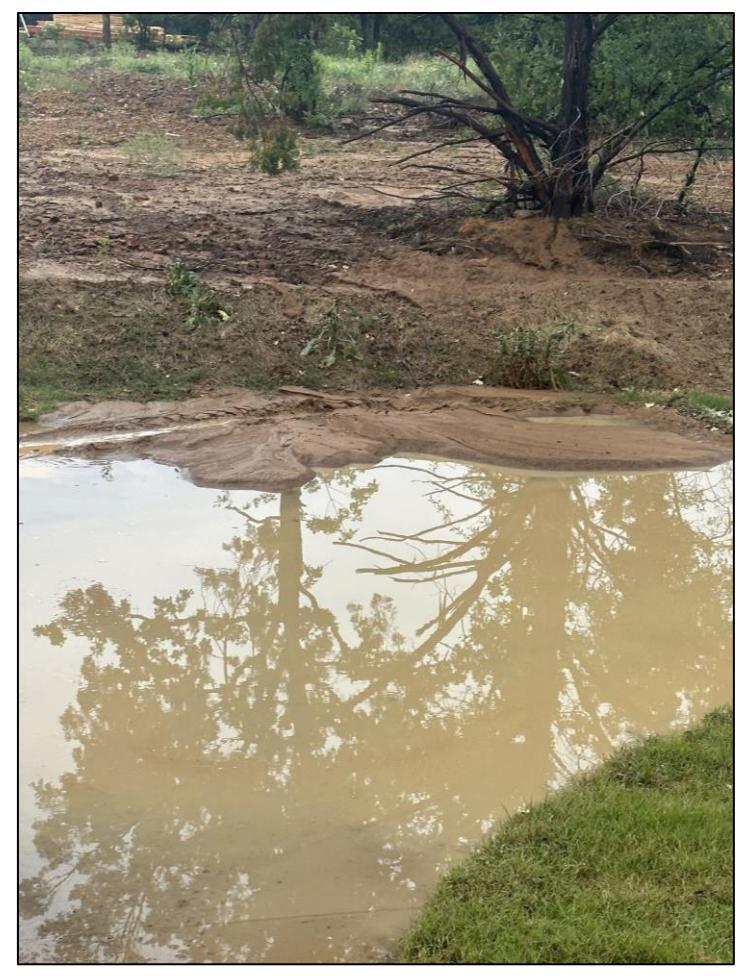
Figure 1: Sediment and standing water in the driveway after the 0.5" rain event.

Each of these factors contributed to the issues plaguing one of the homeowners in the subdivision. One year, during a 27-day stretch in mid-spring, their property received only 0.12" of total rainfall. They had nearly 0.5" the next day. Sparse vegetative cover across their yard did little to keep the soil in place after this rain event (see Figure 1), so approximately 3" of mud accumulated over a 20' x 20' area of their concrete driveway. The event also severely damaged what remained of the property's original sod.

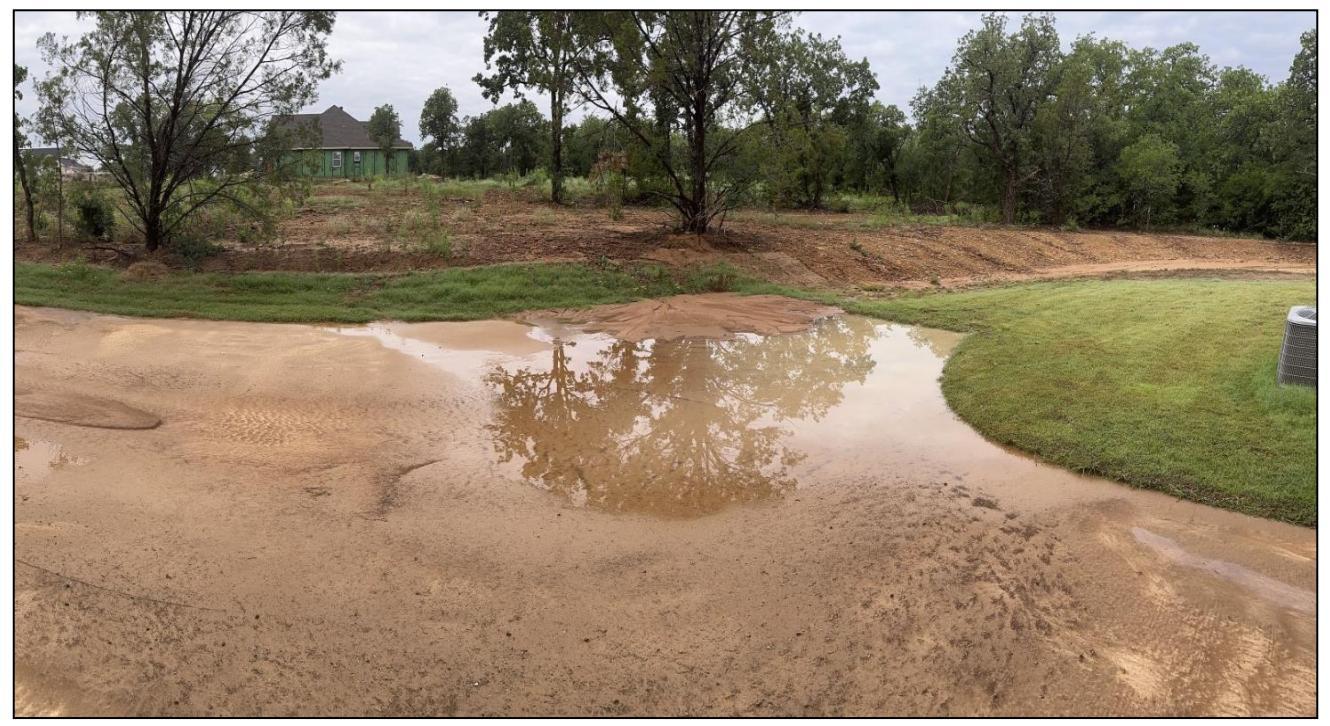
Approximately 1.5 weeks after the 0.5" event, the property encountered a total of 4" of rain within a 9-day stretch. Mud accumulation on the driveway reached 4" deep during this time (see Figure 2).

These precipitation events also caused a drainage channel along the edge of the property's tree line (right-hand corner of Figure 2) to increase in both width and depth. This channel drains via nearby tributaries into a creek and then into a river, which runs approximately one mile from the property. By mid-June, the channel's bottom was mostly exposed bedrock and was producing high-velocity flow during rain events, wiping out adjacent sod in the process.

Figure 2: View of the homeowner's driveway and yard after a 9-day stretch of rain. The remnant vegetation and the lack of erosion/sediment control measures caused multiple gullies to form on the slope leading to the drainage channel in addition to mud accumulation on the driveway.

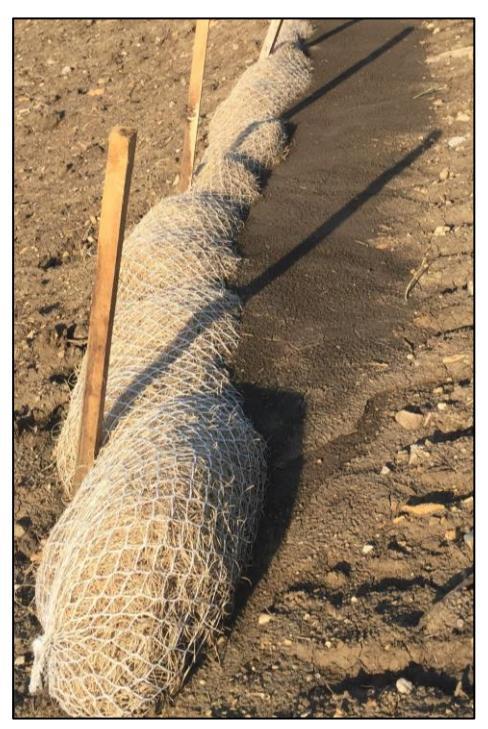
The homeowner's first objective was to stop the flow of sediment from repeatedly accumulating on their driveway. Curlex[®] Sediment Log[®] (see Figure 3), manufactured by American Excelsior Company[®], was selected as the first line of defense.

Curlex Sediment Logs are flexible filtering stormwater and sediment control BMPs comprised of engineered curled and barbed Curlex[®] fibers (from Great Lakes aspen trees) within a degradable containment material. Their porous nature allows water to filter through, not underneath, the diameter of the interlocked Curlex fiber matrix. As it does, velocity is naturally reduced, and sediment is collected on the upslope side of the Sediment Log as well as within the fiber matrix. The driveway's perimeter was lined with Sediment Logs in a U-shaped fashion to filter any runoff from the sparsely vegetated areas.

Figure 3: Example of a Curlex Sediment Log application with sediment trapped on its upslope side.

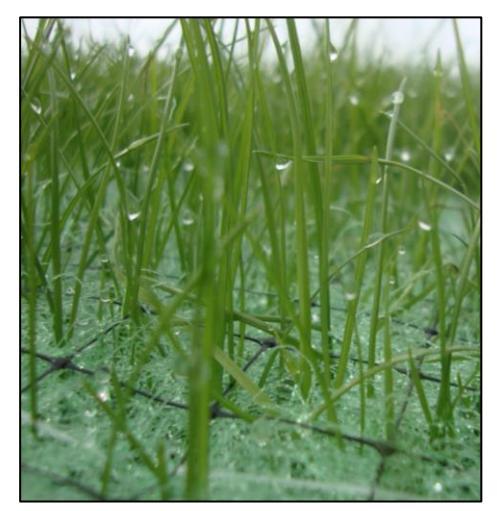
Without proper cover, the drainage channel along the edge of the property would continue to erode, encroaching further into the yard, destroying existing sod, and releasing additional sediment into nearby tributaries. Recyclex® TRM-V (see Figure 4), a turf reinforcement mat (TRM) manufactured by American Excelsior Company, was selected to line the channel.

Recyclex TRM-V features Recyclex[®], 100% post-consumer recycled poly fibers, stitched together between two strong layers of UV resistant poly netting. 80% of the Recyclex fibers in Recyclex TRM-V are 5" or greater in length, and all are tightly crimped and curled to allow the fibers to interlock. Crimping allows the fibers to conform to terrain details and train water to follow the fiber matrix, slowing flow velocity in the process. Further, Recyclex fibers have a specific gravity greater than 1.0, meaning they will not float during hydraulic events. Keeping TRMs close to the subgrade results in less erosion.

Figure 4: Close-up of a vegetated Recyclex TRM-V installation.

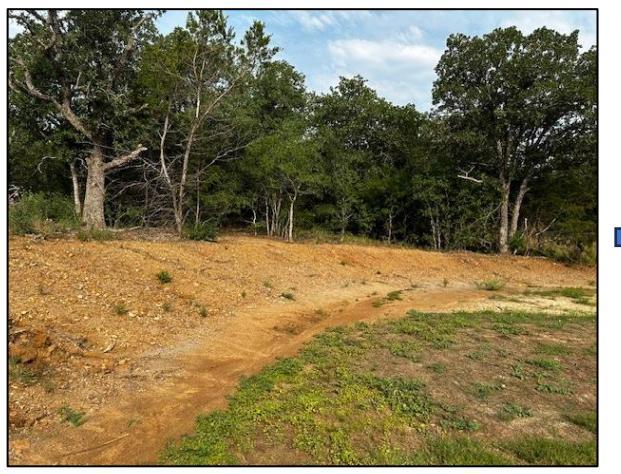
The drainage channel (see Figure 5) was lined with Recyclex TRM-V (see Figure 6); both the slope and driveway were lined with Curlex Sediment Logs (see Figure 7).

Figure 5: The drainage channel before the installation of Recyclex TRM-V.

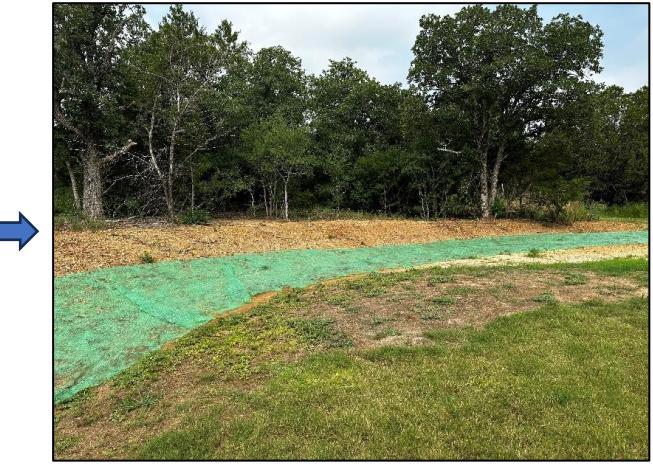
Figure 6: Completed Recyclex TRM-V installation in the drainage channel.

The drainage channel filled slowly and only began to overflow near the end of this event. The Recyclex TRM-V protected the channel and helped slow the water, allowing it to infiltrate into the soil and preventing the channel from encroaching further into the adjacent sod. The Sediment Log installation also kept the driveway nearly free of sediment-laden runoff; the only instance of sediment getting past the Logs came from an installation oversight.

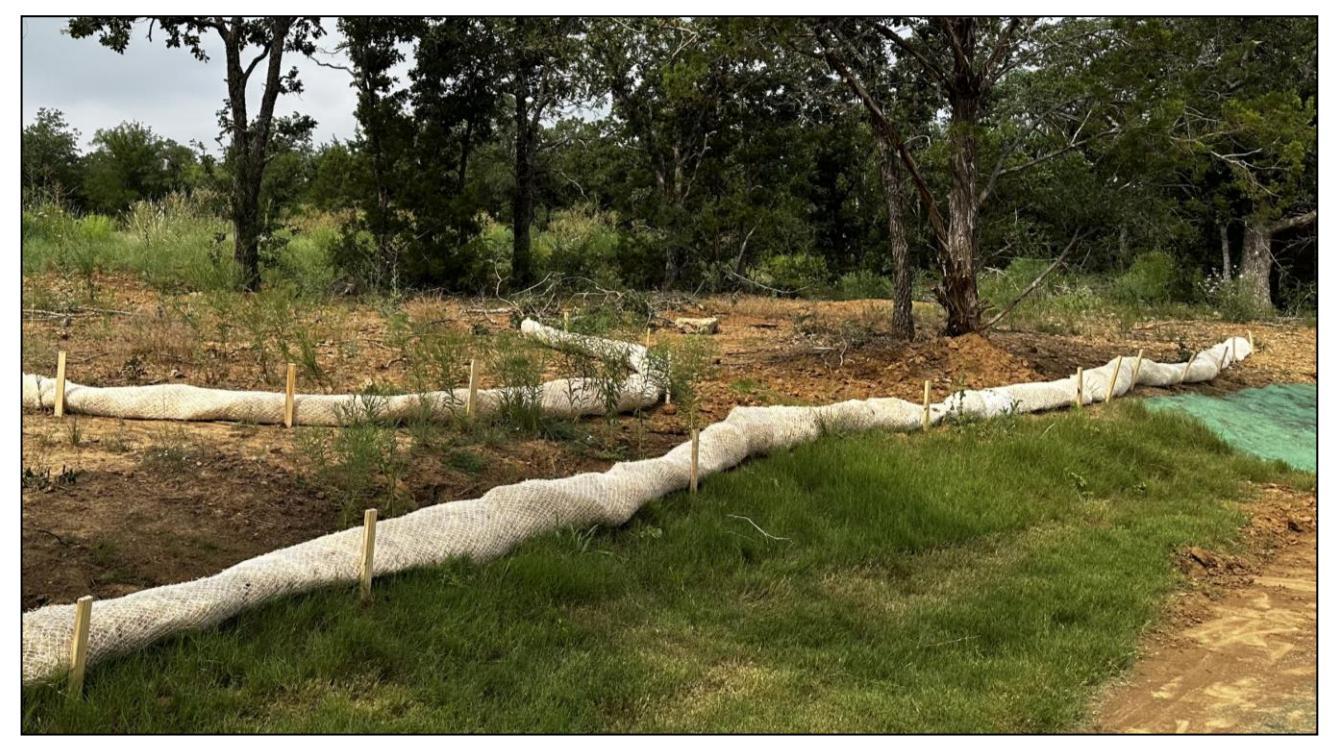
Figure 7: Sediment Logs lining the areas above the driveway.

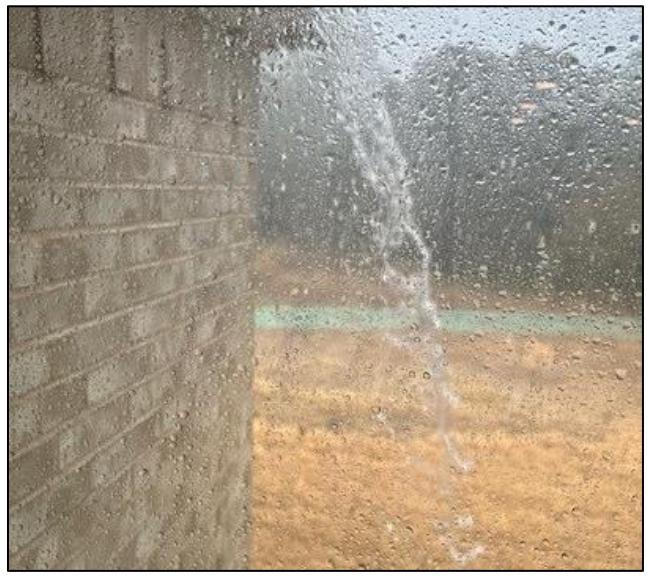
The property encountered no measurable precipitation for 70 days after the precipitation events causing sedimentation on the driveway. The following day, it encountered 0.8" of rain in 1 hour (see Figure 8).

Figure 8: View from inside the homeowner's house during the cloudburst.

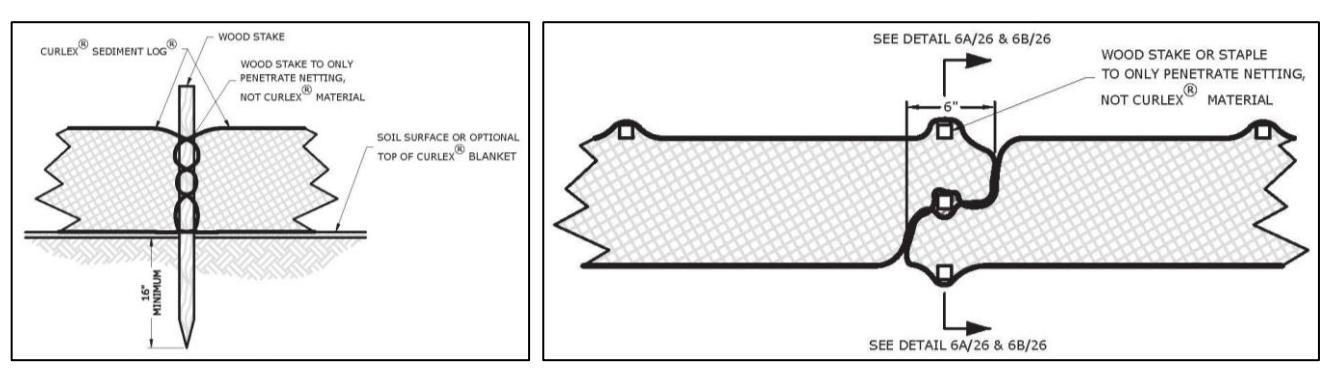
At least one wooden stake should be driven through the netting when two Sediment Logs are adjoined according to the Sediment Log Installation guidelines on <u>www.curlex.com</u> to provide stability during heavy ponding events. Visuals from Sediment Log CAD details (also on <u>www.curlex.com</u>) regarding joint types are shown in Figure 9; the common abutment joint is shown on the left, and the optional overlapping joint is on the right. These installation methods were followed after the minor oversight at the seam between the Sediment Logs early on during this project.

Figure 9: Curlex Sediment Log Perimeter Control Part 2 CAD details ("front view" on the left, "plan view" on right).

The final step for the new plan was to remediate the Sediment Log installation oversight by following the instructions shown in Figure 9. Additional Sediment Logs were also installed above the blankets on the slope leading to the drainage channel.

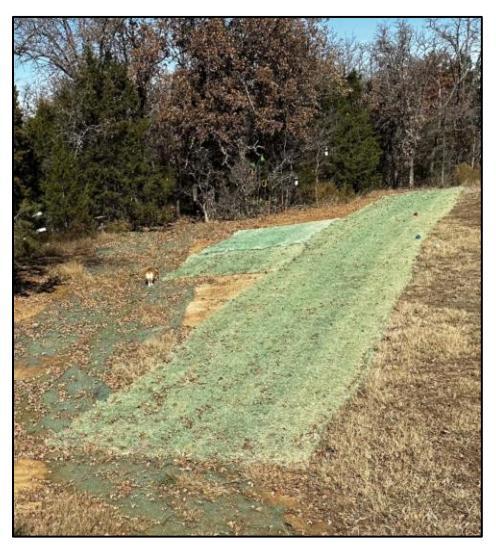
To aid in protecting and revegetating the homeowner's property, Curlex[®] I QuickGRASS[®] erosion control blankets (ECBs) were installed on the higher velocity flow areas surrounding the driveway, on the previously sodded areas adjacent to the drainage channel (see Figure 10), and underneath some of the Sediment Logs (see Figure 11).

Curlex I QuickGRASS ECBs feature the same Curlex fibers found in Sediment Logs; the only difference is that the Curlex I QuickGRASS's fibers are colored green to present a clean, finished look until vegetation is established. In ECB form, the Curlex fibers train water flow to follow the interlocking fiber matrix upon contact, slowing water flow velocity and breaking up rainfall impact. Gravity takes over once the water flow slows, leading to increased infiltration compared to other commonly used natural erosion control fibers.

Figure 10: Curlex I QuickGRASS installed to revegetate the previously sodded areas.

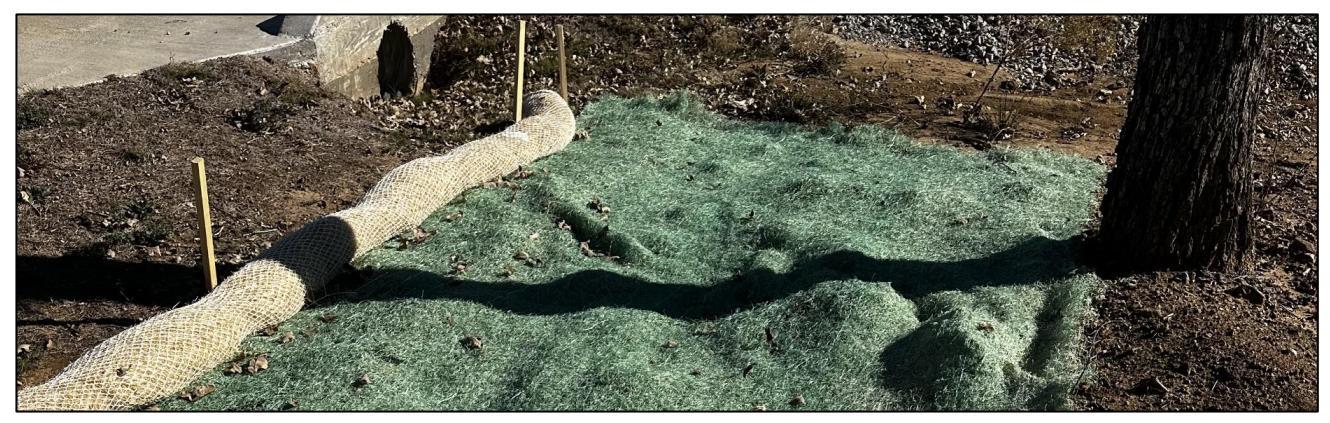
Figure 11: Curlex I QuickGRASS installed underneath the existing Sediment Logs close to the property's runoff ditch.

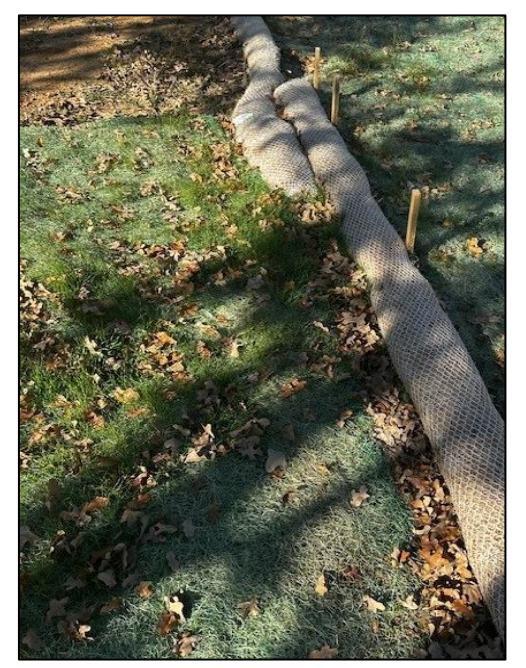
By December, vegetation had taken root in the drainage channel and was growing in and around the Curlex I QuickGRASS (see Figure 12). According to the homeowner, this amount of vegetation growth had not occurred before.

Figure 12: Vegetation emerging through the Curlex I QuickGRASS.

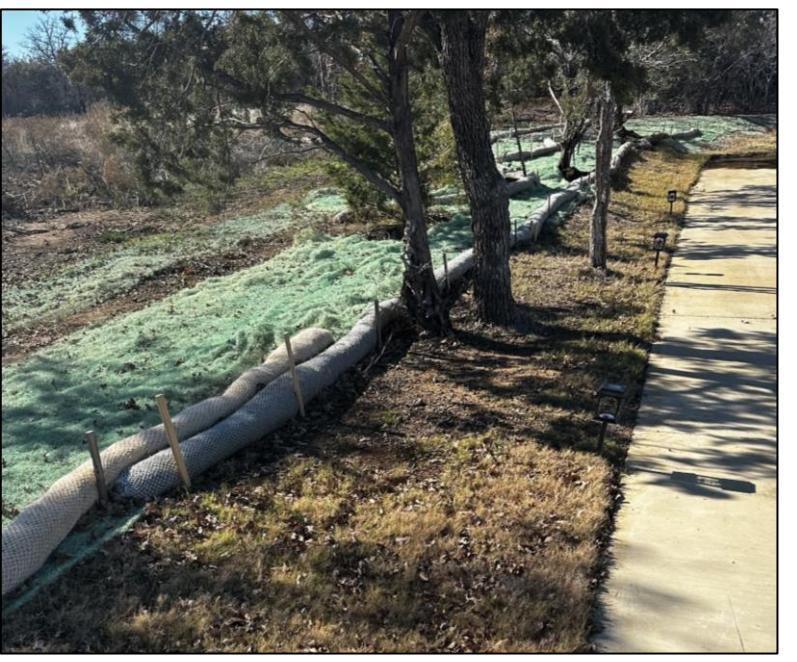
Several precipitation events tested the effectiveness of the new erosion control solution in the months following the Curlex ECB and additional Sediment Log installations. During a mid-December rain event of 0.64" over 2 hours, even though the rain could not infiltrate quickly enough to avoid becoming surface runoff, no sedimentation occurred on the driveway (see Figure 13).

Figure 13: The aftermath of the mid-December rain event at the property shows a sediment-free driveway due to the successful Curlex ECB, Curlex Sediment Log, and Recyclex TRM-V solution.
