Case Study – TriNet[®] Recyclex[®] Shoreline Solution

For nearly 30 years, residents of Altus, OK had discussed upgrading and modernizing the reservoir that had served as the emergency water supply for both the Town of Altus and the Altus Air Force Base since 1910. In May of 2023, their visions started becoming reality as construction commenced. The reservoir (see Figure 1) holds 140 surface acres (56.7 ha) of water, which is approximately 45.6 million gallons $(1.73_E^8 L)$. With approximately 2 miles of shoreline that encounters frequent wave action, a permanent, low-maintenance erosion control solution was required.

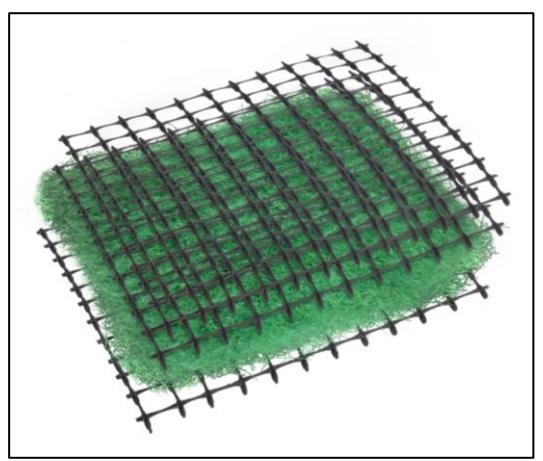
Figure 3: Three-dimensional rendering of TriNet Recyclex.

Originally, the project engineer had specified a nylonbased turf reinforcement mat (TRM) to provide slope protection above the hard armor installation at the reservoir's waterline. However, nylon-based TRMs have a specific gravity of less than 1 and float in water. The poly (Recyclex[®]) fibers used in American Excelsior Company's TriNet[®] Recyclex[®] TRM (see Figures 3 and 4) have a specific gravity of greater than 1 and do not float. Crimped Recyclex fibers also interlock with one another and to the soil which creates an intimate connection with the subgrade, allowing for ease of establishing root reinforcement through the TRM.

TriNet Recyclex fibers are made from 100% postconsumer recycled poly goods (i.e., soda bottles), and approximately 18 bottles are diverted from landfills for every pound produced. After comparing the nylonbased TRM to the poly-based TriNet Recyclex, it was determined that the features and benefits of TriNet Recyclex exceeded the project's design requirements while at the same time providing significant cost savings over the other TRM.

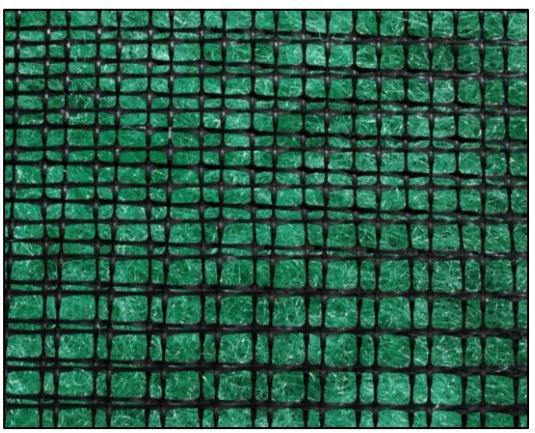
Figure 4: Close-up image of TriNet Recyclex.

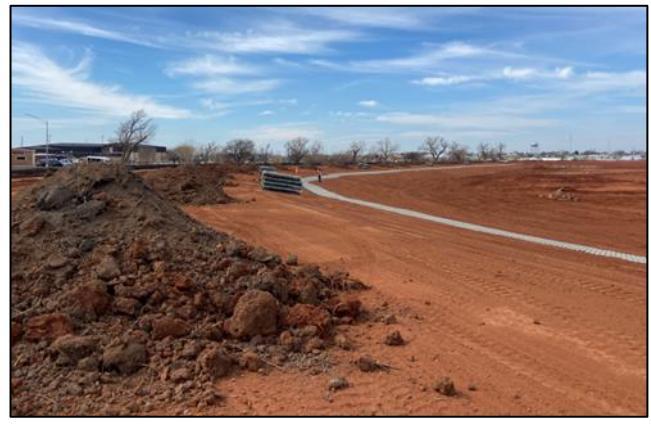
Figure 5: Southwest-facing view of the Altus Reservoir lake's shoreline after being drained and re-graded.

First, the entire area of the Altus Reservoir lake (west of the reservoir's dam) was drained, and the bottom was cleared and re-graded. Then, the shoreline was graded in preparation for the TriNet Recyclex TRM and hard armor installations (see Figures 5 and 6).

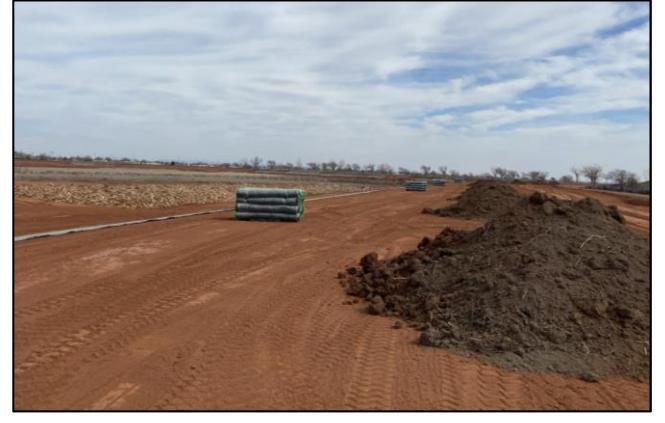
Figure 6: East-facing view of the Altus Reservoir lake's shoreline after being drained and re-graded.

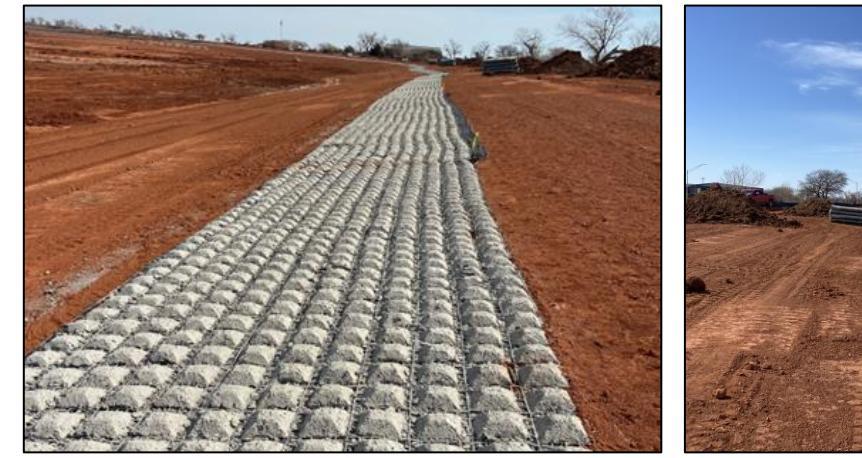
Figure 7: East-facing view of Flexamat hard armor installation after anchoring.

After the area had been inspected to ensure that satisfactory grading conditions were present, the Flexamat was rolled out and anchored to the subgrade with 18" rebar staples (see Figures 7 and 8).

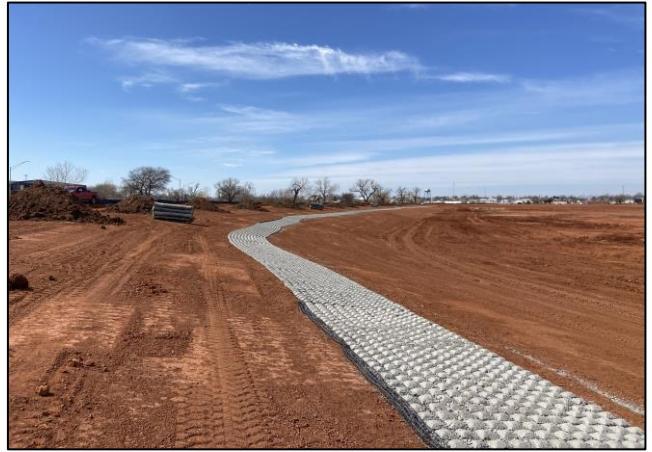
Figure 8: Southwest-facing view of Flexamat hard armor installation after anchoring.

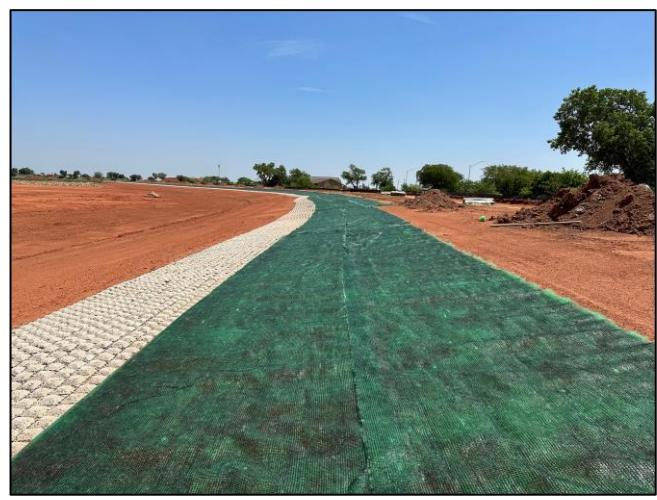
Figure 9: East-facing view of TriNet Recyclex after being anchored to the subgrade.

TriNet Recyclex was chosen to provide root reinforcement for the overlying Bermuda sod on the slopes above the Flexamat hard armor. After the area had been inspected to ensure that satisfactory grading conditions were present, TriNet Recyclex was rolled out horizontally across the width of the slope, trenched in under the Flexamat at the shoreline, and anchored to the subgrade with sod staples (see Figures 9 and 10). Either two or three 8.0 ft (2.4 m) roll widths of TriNet Recyclex were used to fully cover the shoreline slope areas; rolls were overlapped 6" on all sides, and each overlap was secured with a row of sod staples. Soil filling the TRM and installing Bermuda sod on top followed (see Figures 11 and 12). Finally, the entire installation was watered to spur vegetative root growth as quickly as possible.

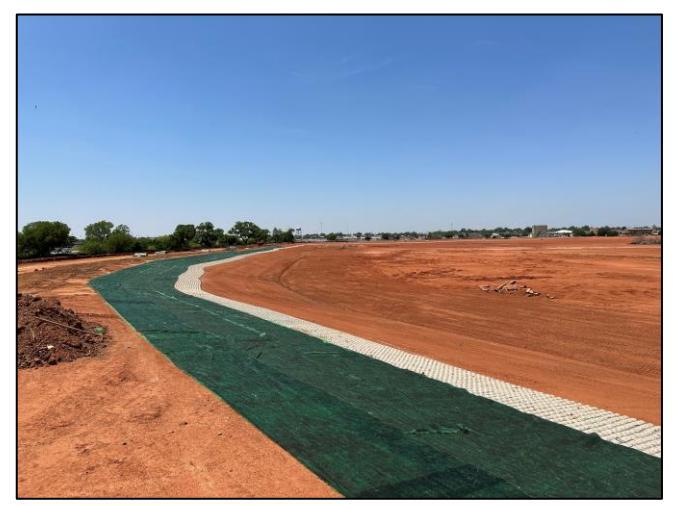
Figure 10: West-facing view of TriNet Recyclex after being anchored to the subgrade.

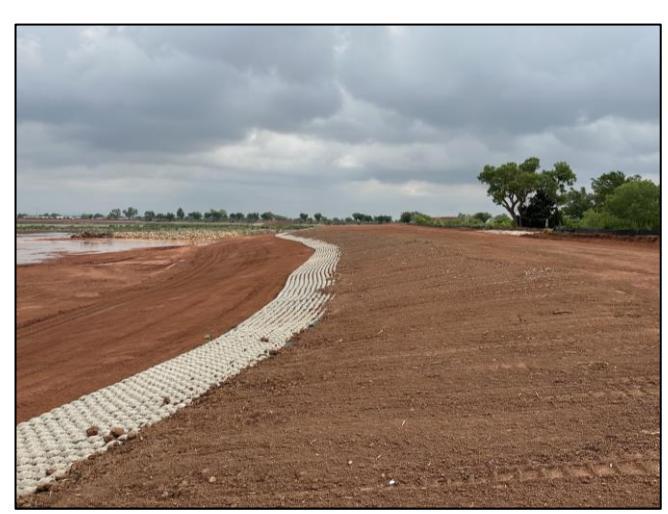
Figure 11: Soil infill installed on top of the TriNet Recyclex.

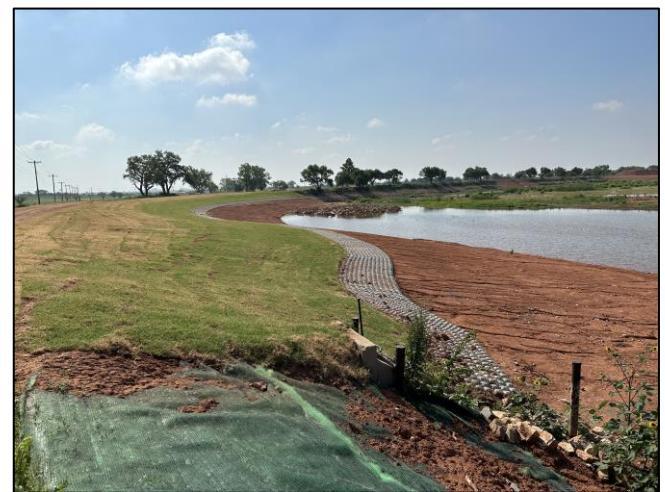
Figure 12: In-progress Bermuda sod installation on top of the soil-filled TriNet Recyclex.

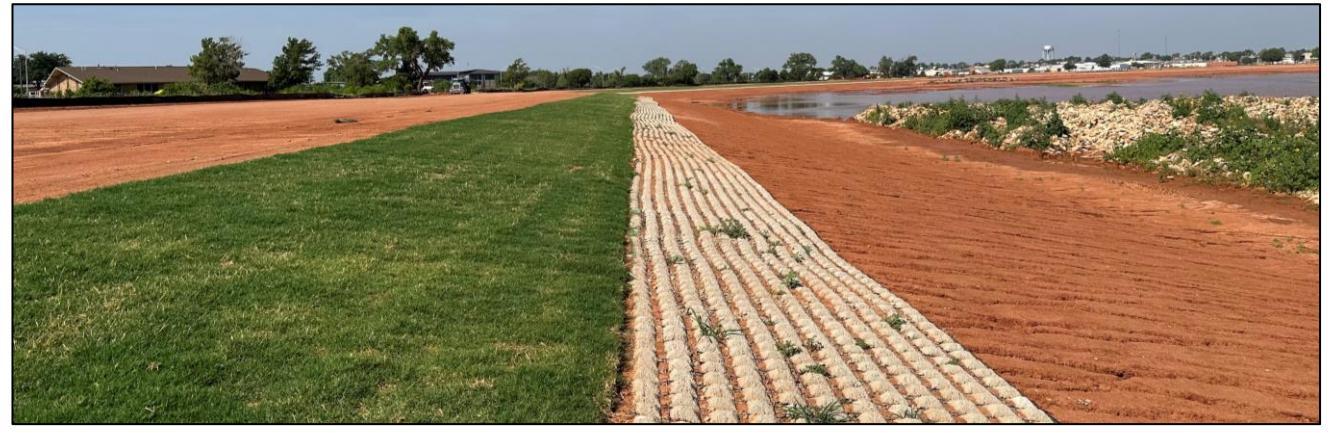
Figure 13: Southwest-facing view of the vegetated TriNet Recyclex TRM-Flexamat installation on the Altus Reservoir lake's shoreline.

The vegetated soil fill TRM and hard armor solution provided a clean, finished look to the reservoir's shoreline (see Figures 13 and 14) that will protect the area against erosive forces for years to come.

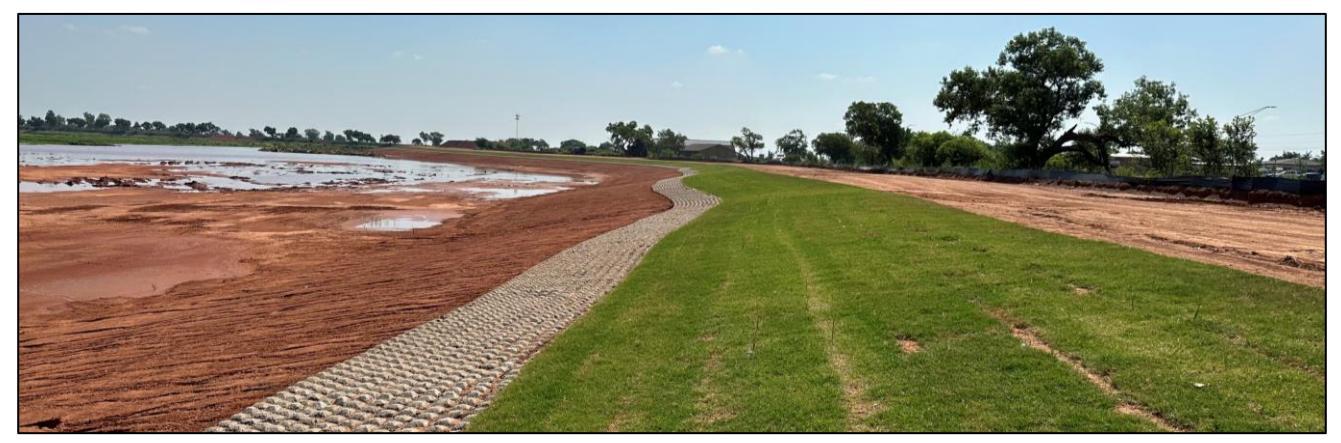
Figure 14: East-facing view of the vegetated TriNet Recyclex TRM-Flexamat installation on the Altus Reservoir lake's shoreline.
