# Enforcing Soil in Place

*Steep*, long slopes and erosive loess soils do not add up to ideal conditions for post-construction erosion and sediment control measures. These exact harsh conditions were encountered and mastered at a construction site located in Sioux City, IA. Proper planning, design, and product selection coupled to produce an impressive erosion control and revegetation project.

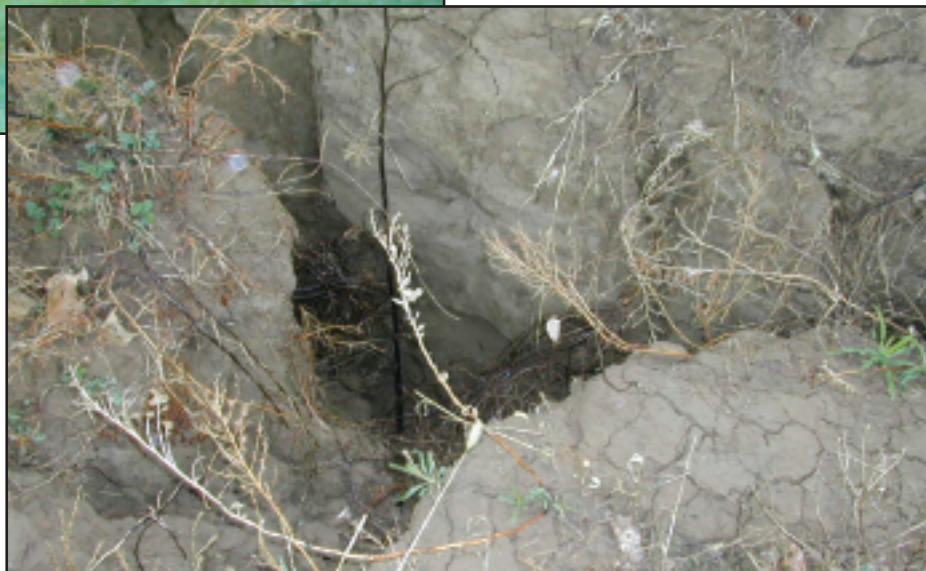
**Top photo: Composite turf reinforcement matting installation. Bottom photo: Erodible onsite loess soils.**

conditions. The AEC team recommended Curlex® Enforcer® QuickGrass® for the site. The product is a composite TRM, which contains dyed-green excelsior wood fibers and heavy duty, UV-stabilized polypropylene netting in a blanket-like configuration that provides surface cover to reduce erosion and hasten vegetation establishment. It was selected for the project based on the following four facts: 1.) Anticipated hydraulic forces would not require the performance level of the original product specified. 2.) Wood fiber biodegradable component enhances vegetation establishment better than long-term biodegradable matrices. 3.) Cost of erosion control materials would be reduced, while obtaining equal or better results. 4.) Green color of the product provides a finished look until vegetation becomes established. In addition, the project team liked the fact that the product provides permanent reinforcement to the vegetation.

Before the erosion control products were installed, six inches of topsoil material were spread across the graded slopes to help combat the highly erosive native loess soils. All disturbed land was seeded with native grasses and wildflowers. Oats were also included in the seed mixture to provide a quick cover. An eight man crew was used to install the erosion control products on site. The crew protected the top of the slope first and worked their way down to the toe of the slope. Nearly 50,000 yd<sup>2</sup> of the composite TRM material was installed to protect the slopes at the project.

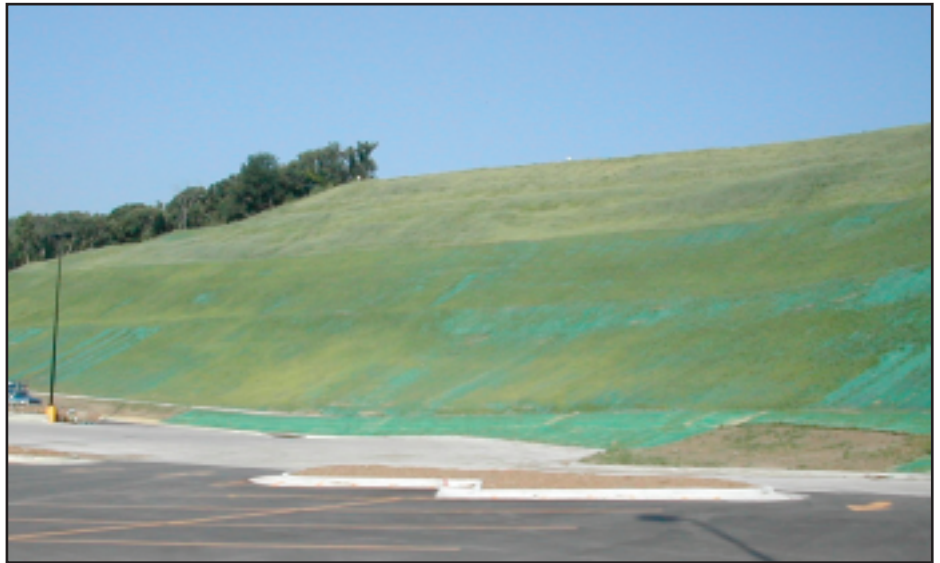
Protected slopes shortly after the completion of installation.

This project went smoothly from start to finish, but Mother Nature always seems to find a way to educate us. The area experienced some heavy rainfall events shortly after the benches were constructed and the erosion control material was installed. The system design withstood two separate heavy rainfall events that produced approximately three inches of rainfall followed by two inches. The third major storm event, nearly four inches, caused minor problems at the site. Storm drains on the benches had been

covered because excavation activity was still occurring on the slope. The largest storm occurred before the covers were removed from the drains. Water over topped the bench and channelized into an erosive river. When the event was over, only a small section of the 50,000 yd<sup>2</sup> project was affected. An area approximately 24 ft wide x 20 ft long needed to be repaired. Merthan stated, "We are all fortunate the system held up the way it did. The conditions encountered were not planned for, yet the design of the slopes endured the curve ball Mother Nature threw us."

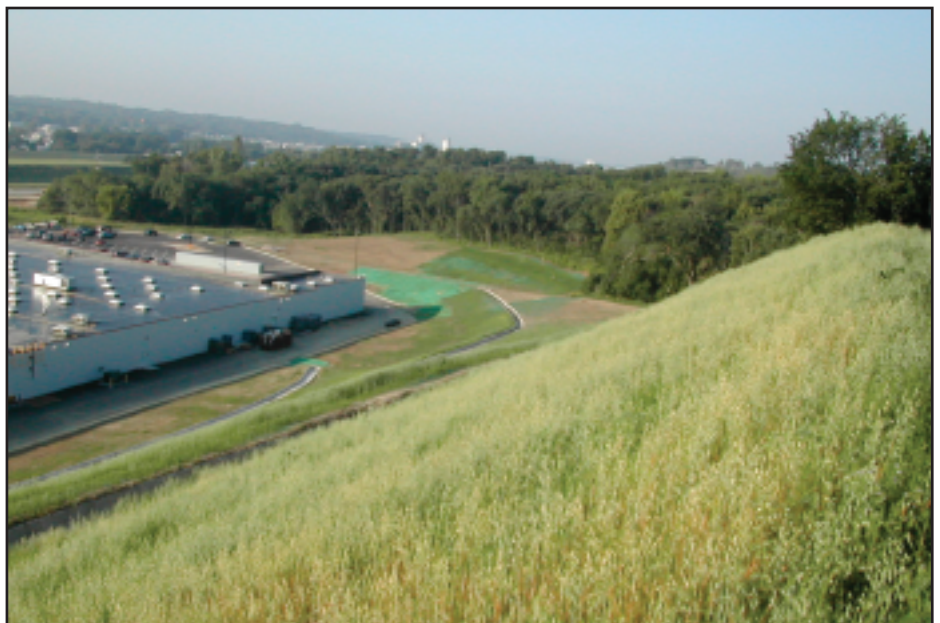
Plush, aesthetic vegetation now covers the once feared slopes.

Today, the system of benches and composite TRMs is an aesthetic, successful erosion control solution. The store and parking lot below the massive slope are permanently protected because the project team devised and executed a perfect erosion and sediment control plan.
