# Curlex® II QuickGRASS®

## *Bringing Green Roofs to Life with Curlex*

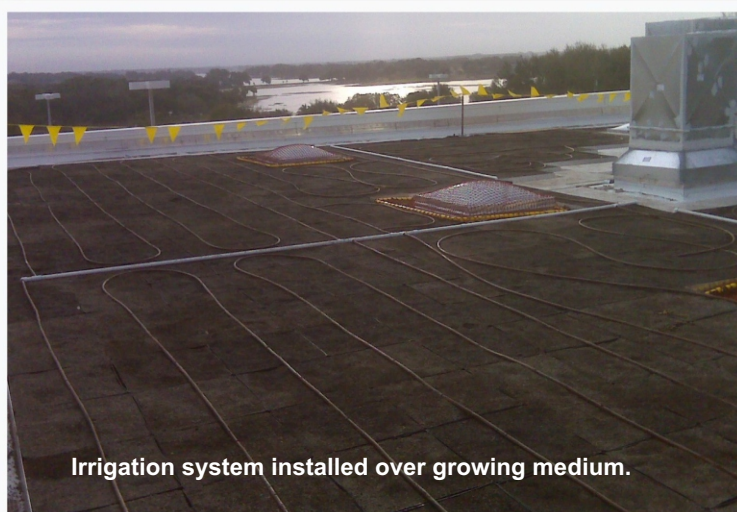
Irrigation system installed over growing medium.

An irrigation system was installed over the soil media after it was in place. Next, Curlex II QuickGRASS was installed to protect the growth media until the native wild flowers, which were plugged into the layered system, became established. Marty Wanielista said, "Bringing Green Roofs to Life is Helped with Curlex."

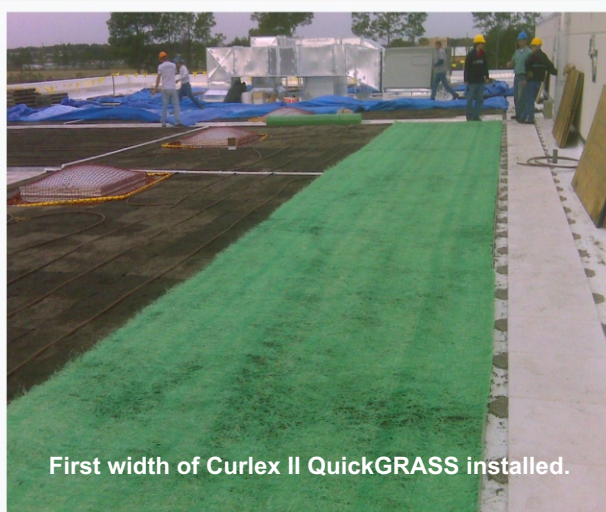
First width of Curlex II QuickGRASS installed.

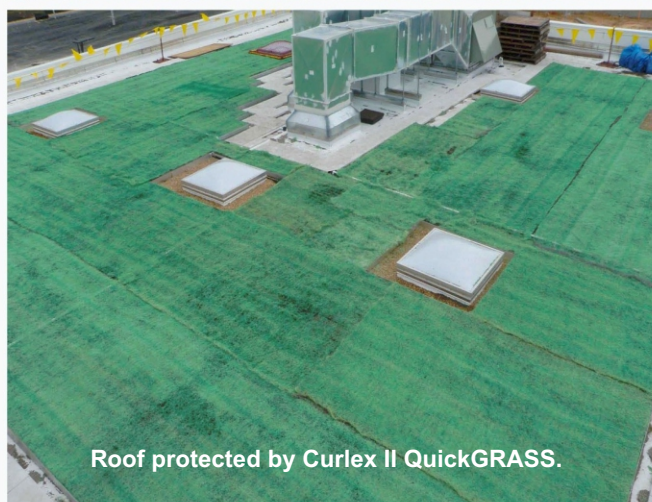
Roof protected by Curlex II QuickGRASS.

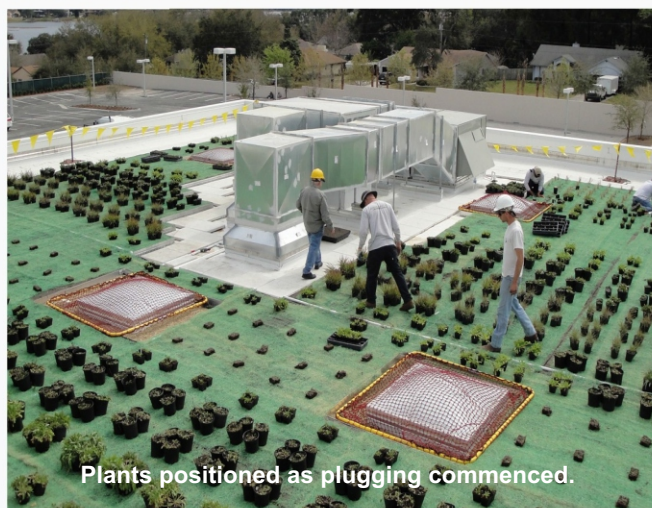
Plants positioned as plugging commenced.

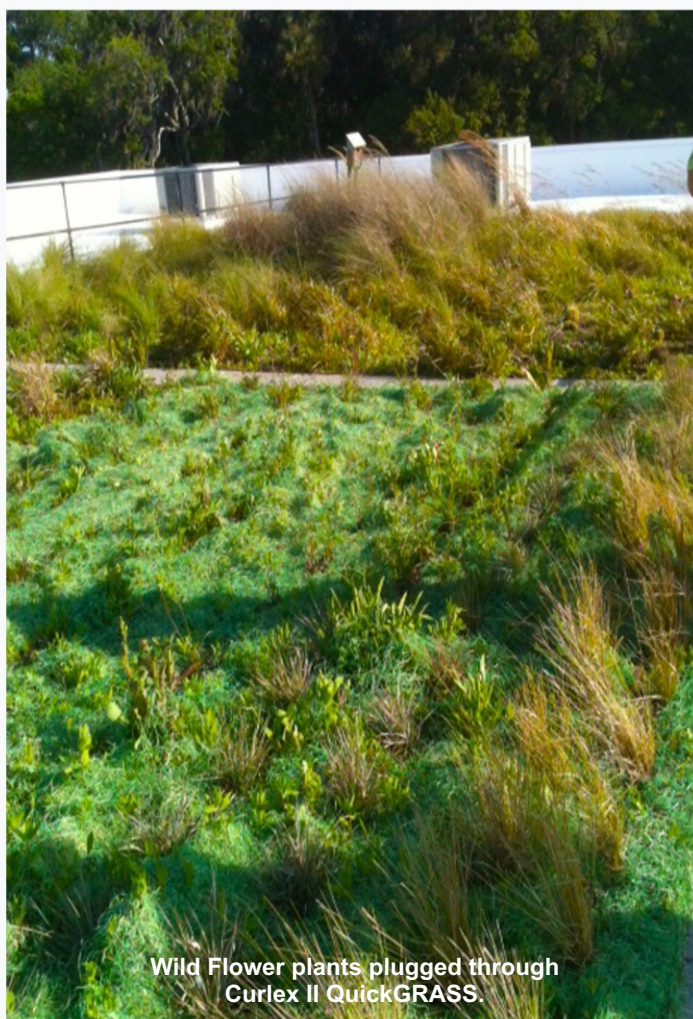
Wild Flower plants plugged through Curlex II QuickGRASS.
