# Fire and ice

Earth's weather extremes seem to demand equally different erosion control materials, but that's not necessarily the case.

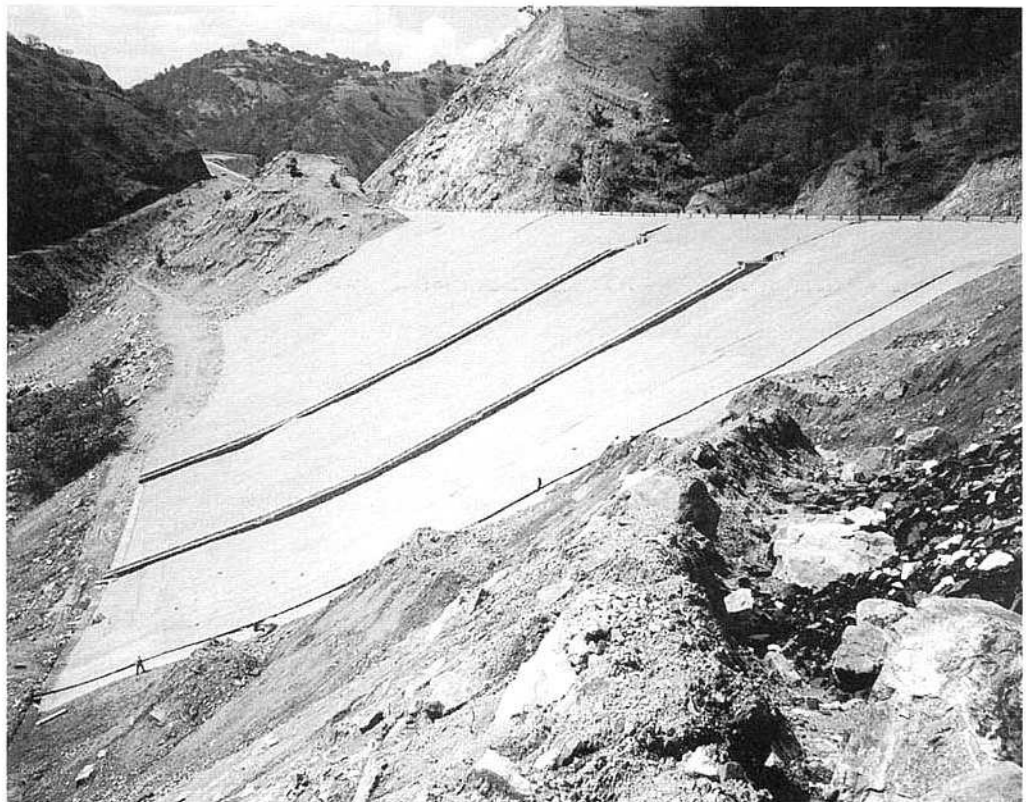
**Photo 1.** Green-dyed excelsior erosion control blanket protects 2H:1V slope along the Autopista north of Oaxaca, Mexico.

After field experiments with straw and coconut materials which achieved less than desirable results, the decision was made to use excelsior erosion-control blankets for the project. The material selected was Curlex-I Quickgrass, manufactured by American Excelsior Co., Rice Lake, Wis. The blankets were comprised of approximately 540 g/m<sup>2</sup> of aspen excelsior with UV-resistant polypropylene netting on the top side only. Due to the site's high visibility, the optional green-dyed color was chosen for its aesthetic qualities. Finally, to minimize the amount of joints, 2.4 m-wide rolls were selected.

The installation began on April 1, 1997 and continued periodically, as site preparation allowed, for about three months. Larger rocks were removed from the surface to create a fairly smooth, uniform subgrade. The blanket was rolled out in vertical strips down the slopes and was terminated in a shallow 15 cm-deep trench at the top.

Typical 15 x 2.5 cm steel wire staples were used to mechanically anchor the blanket to the subgrade. The strips were overlapped slightly to allow for installation of a common staple with an overall installation rate of approximately 1 staple/m<sup>2</sup>. When completed, the installation totaled approximately 58,300 m<sup>2</sup>.

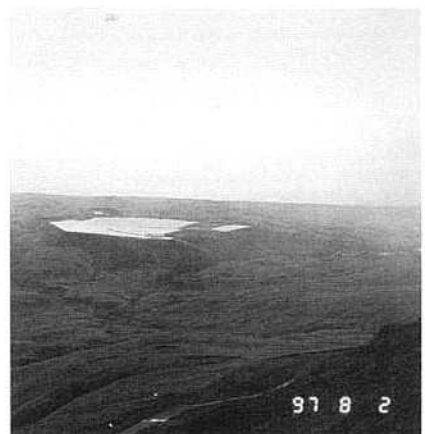
Photo 2. Excelsior erosion-control blanket covers Roberts Landfill, Adak Island, Alaska.

The Roberts Landfill project was awarded to Ahtna Construction, Glenn Allen, Alaska, which subcontracted the revegetation and blanket work to Tango Construction, Homer, Alaska. The White Alice Landfill was contracted to Nuggett Construction, Anchorage, Alaska, which chose to do the revegetation and blanket work in-house. Both firms ultimately opted to use an excelsior blanket similar to that used on the Oaxaca site. The only difference was the use of a natural, rather than green-dyed, color.

completed within the approved planting window, hydraulic seeding of the site with a mix of native species was completed. When unexploded ordinance was discovered on the Roberts Landfill, construction work and blanket installation were delayed until late 1997 or early 1998. Seeding will not take place until next spring. When completed, these installations will total approximately 226,000 m<sup>2</sup> (270,000 yd<sup>2</sup>).
